REPORT

ON THE DAMAGE CAUSED BY
THE FEBRUARY 2023 KAHRAMANMARAŞ EARTHQUAKE
ON ISLAMIC CULTURAL HERITAGE IN TÜRKİYE

Prepared by

Alidost Ertuğrul
Taha Zahid Özdemir
Hussein Al Ragabi

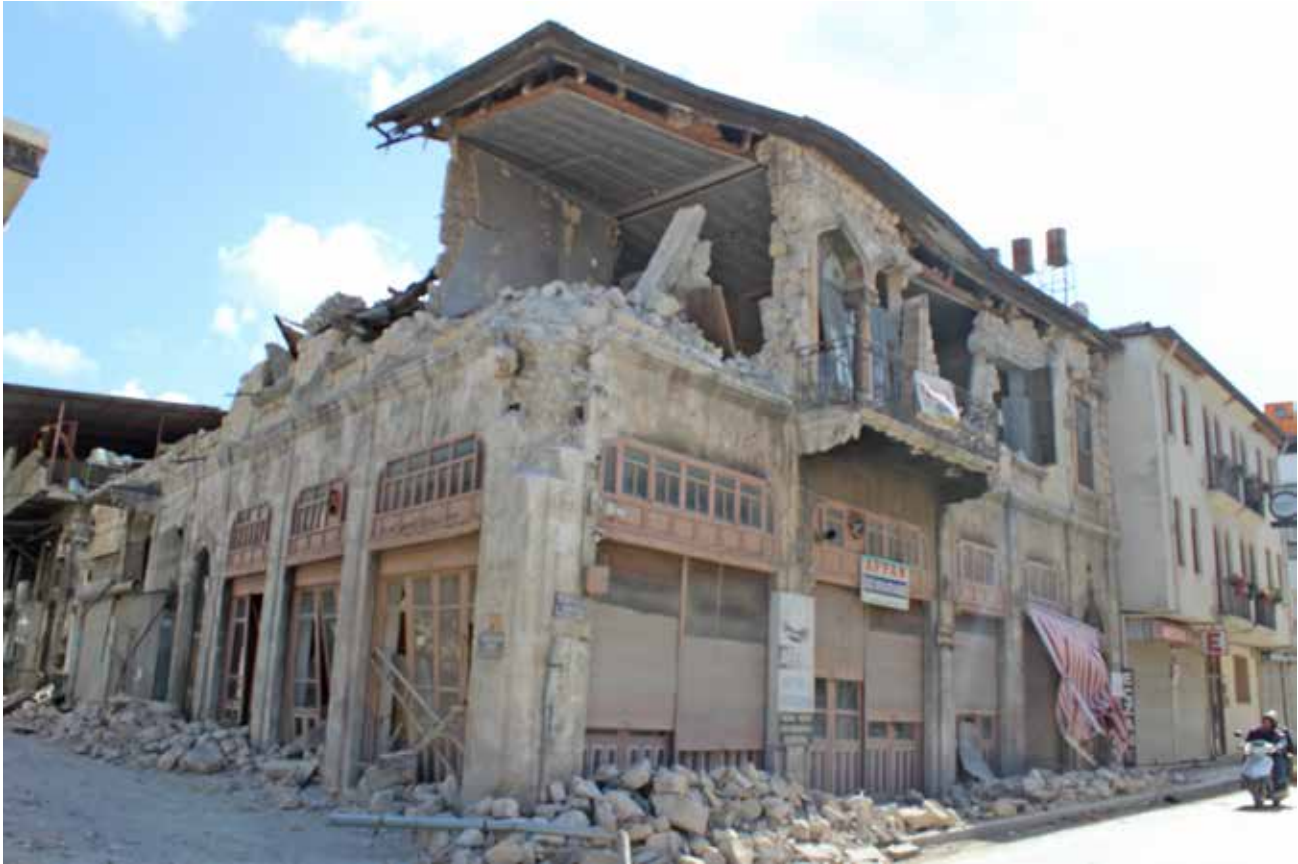
View 1.22 The historical Affan Coffeehouse after the earthquake

III
Unstable / Heavy Damage
Moderate structural or heavy non-structural damage. Roof and main facade were damaged.

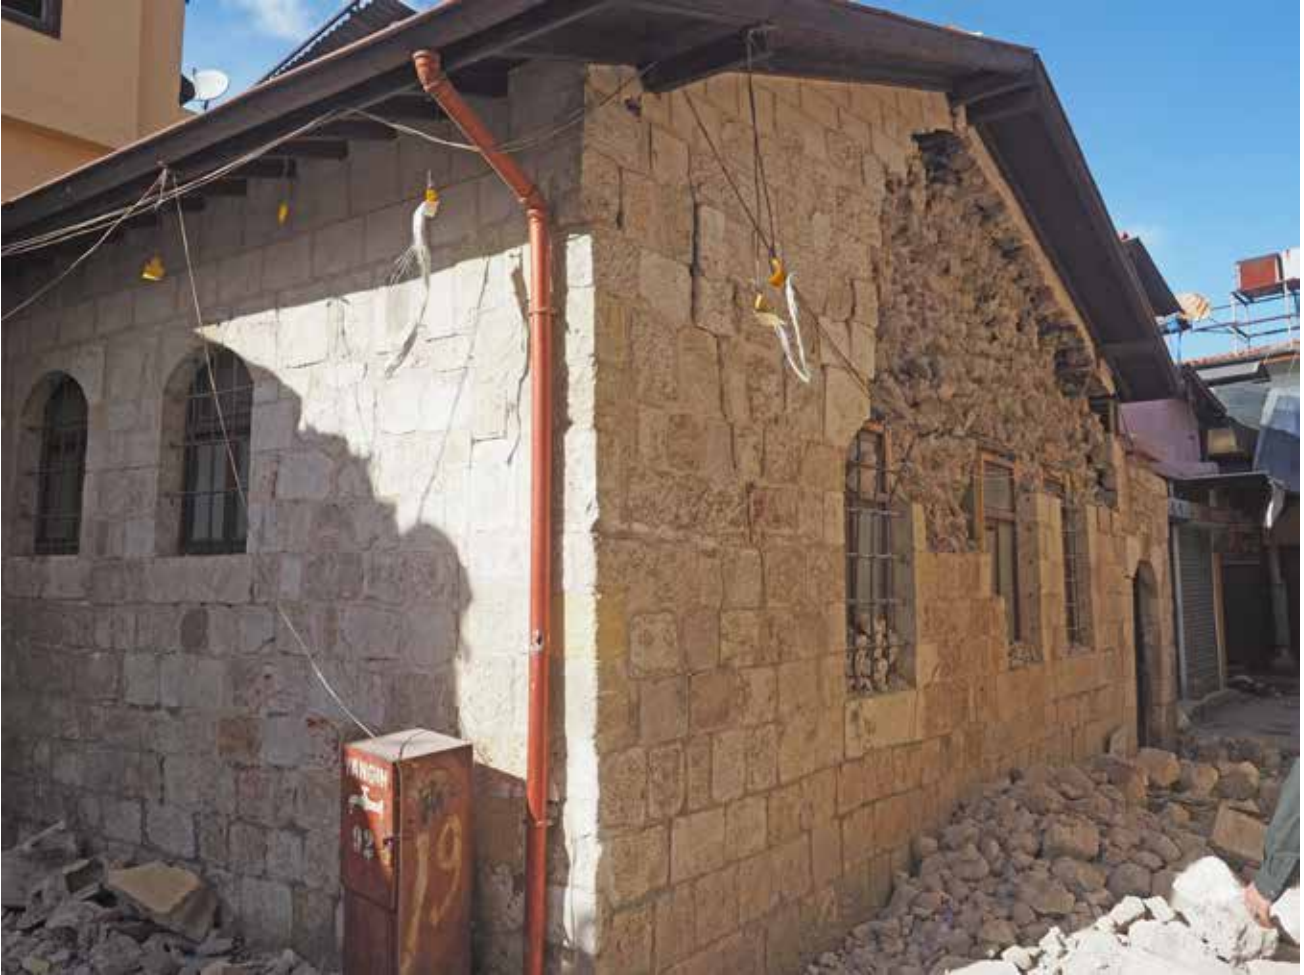
View 1.29 Debruz (Uzun Çarşı) Masjid after the earthquake

III
Unstable / Heavy Damage
Moderate structural or heavy non-structural damage.

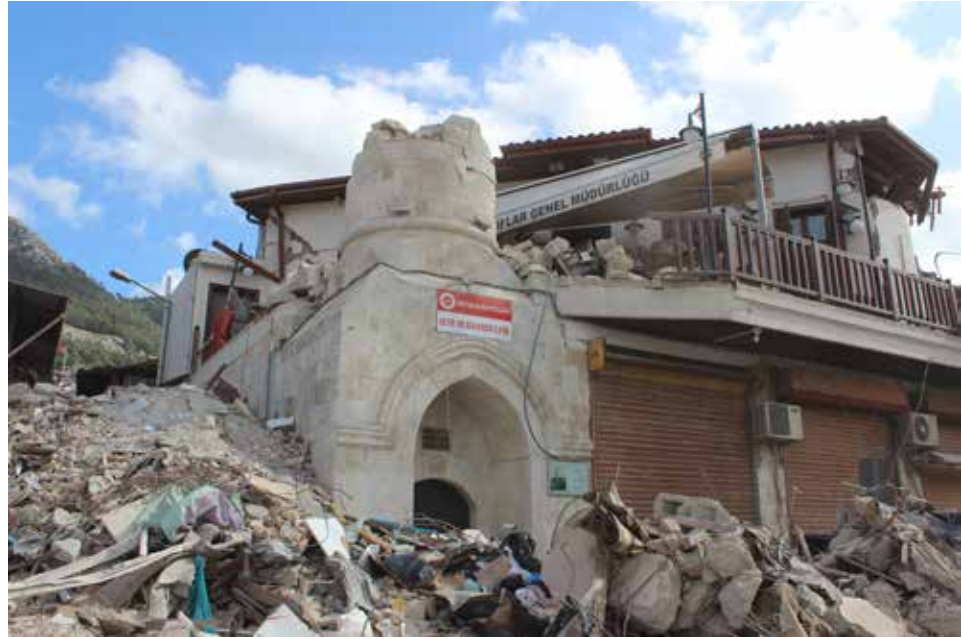
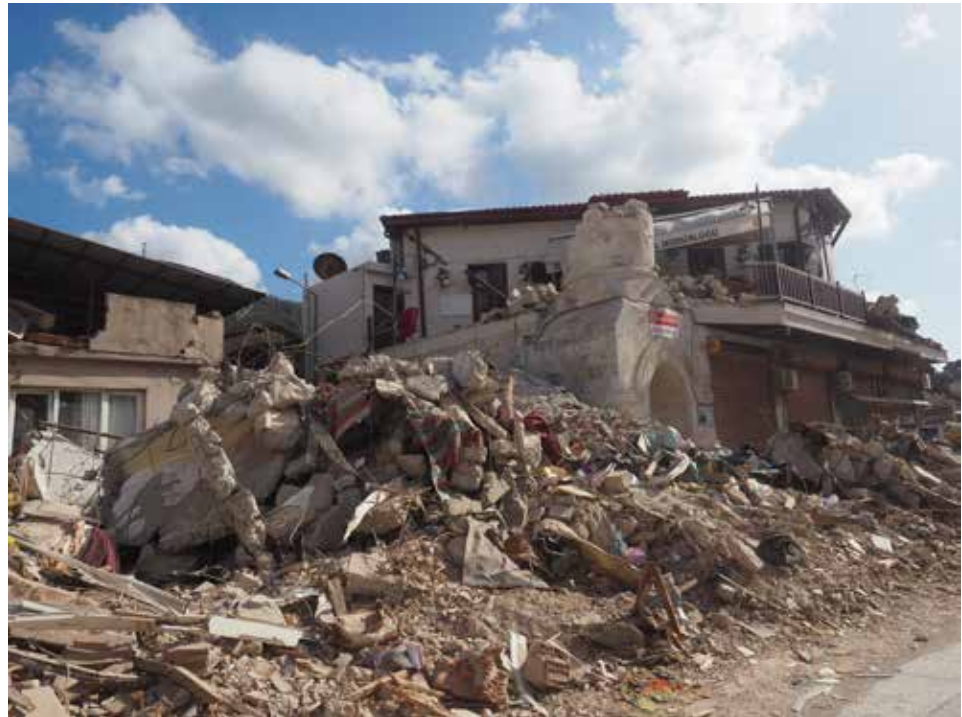
View 1.30 Şeyh Muhammed Mosque after the earthquake

IV
Irreversible / Very Heavy Damage
Heavy structural damage on minaret. Collapsed onto the roof of the mosque.

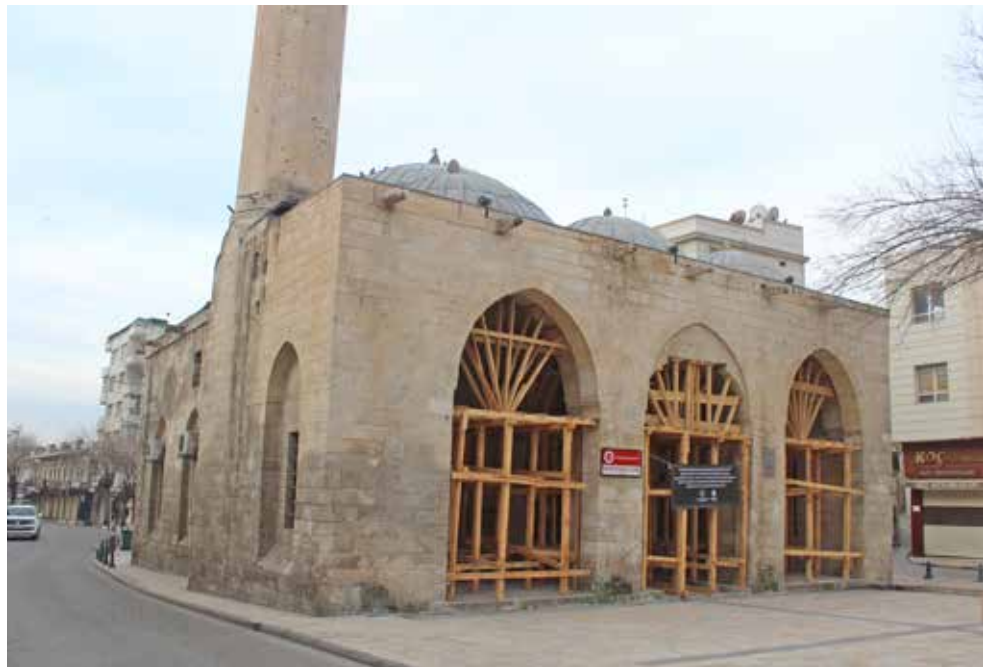
View 4.5 Hüseyin Paşa Mosque after the earthquake

I
Superficial / Slight Damage
Negligible damage. Some minor damage on minaret.

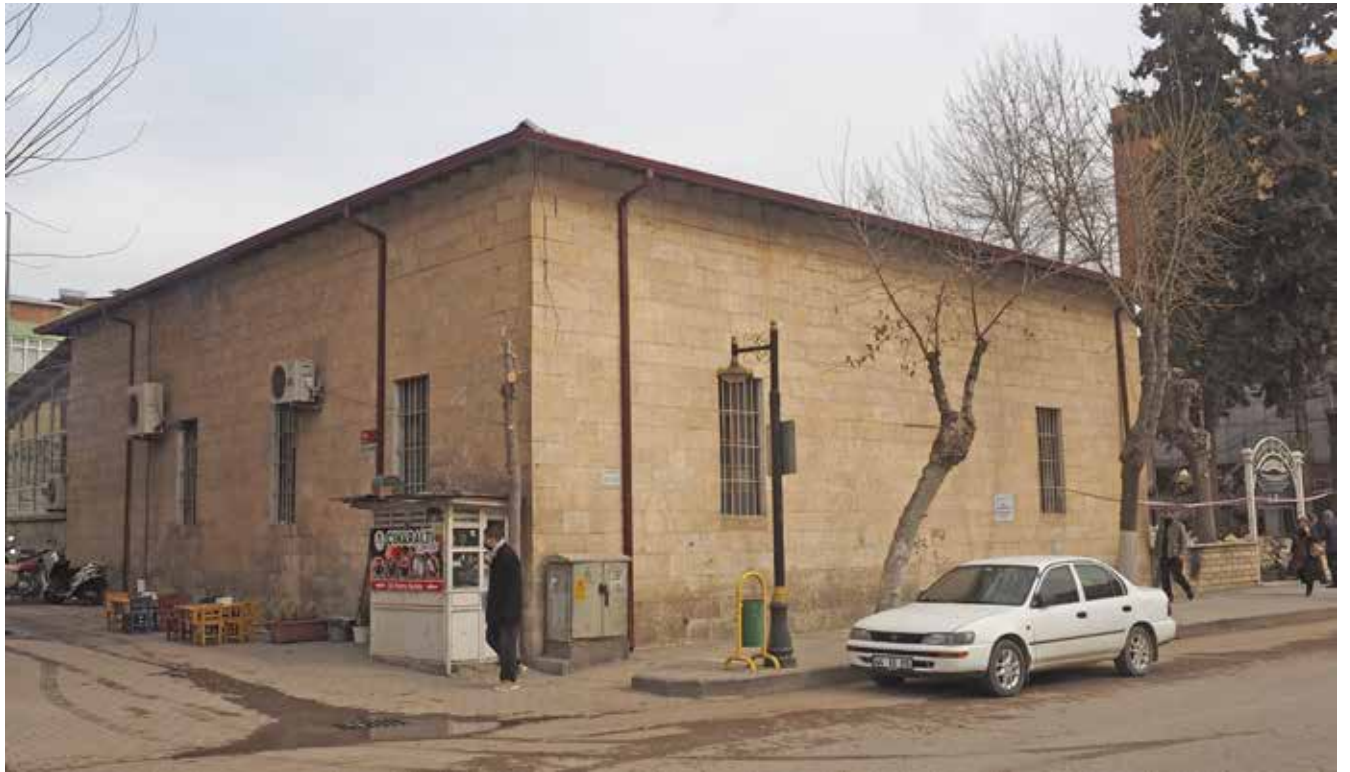
View 5.6 Eskişaray Mosque after the earthquake

III	IV
Unstable/Heavy Damage	Irreversible/Very Heavy Damage
Moderate structural damage on main building.	Heavy structural damage on minaret. Collapsed onto roof of the main building.

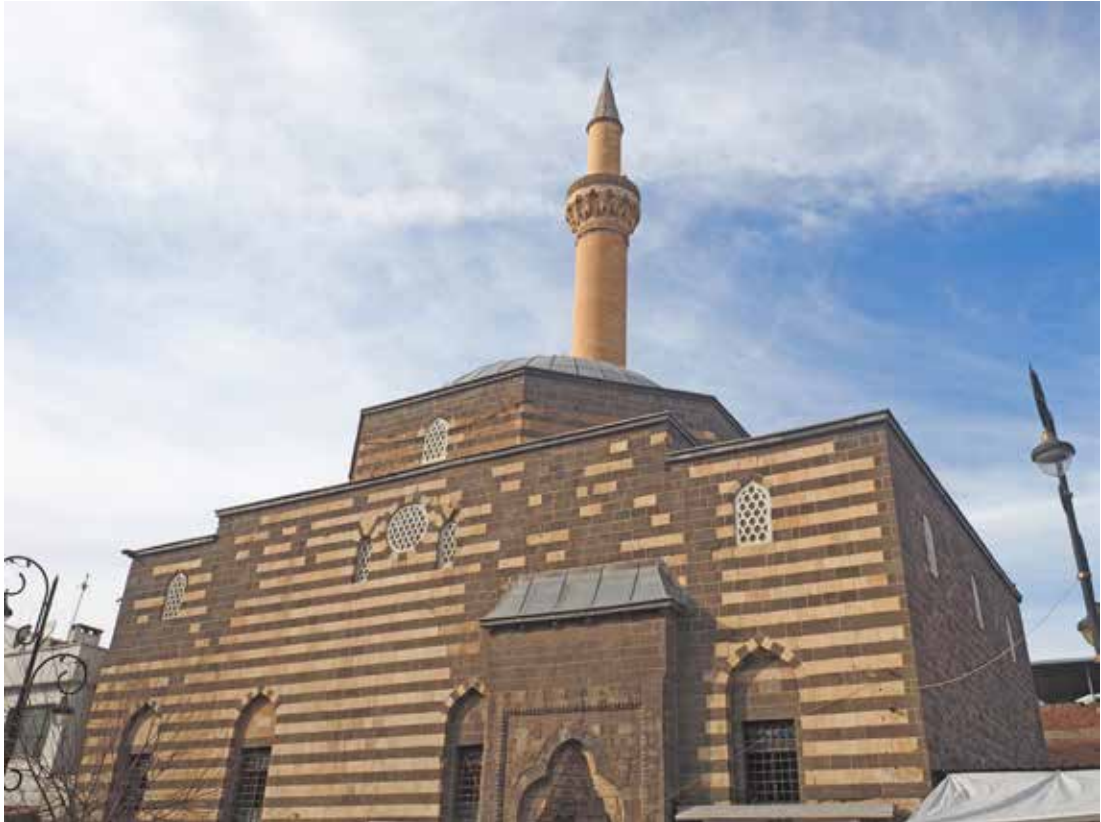
View 6.4 Melek Ahmet Paşa Mosque after the earthquake

II
Stable / Moderate Damage
Local structural and non-structural damages on minaret.

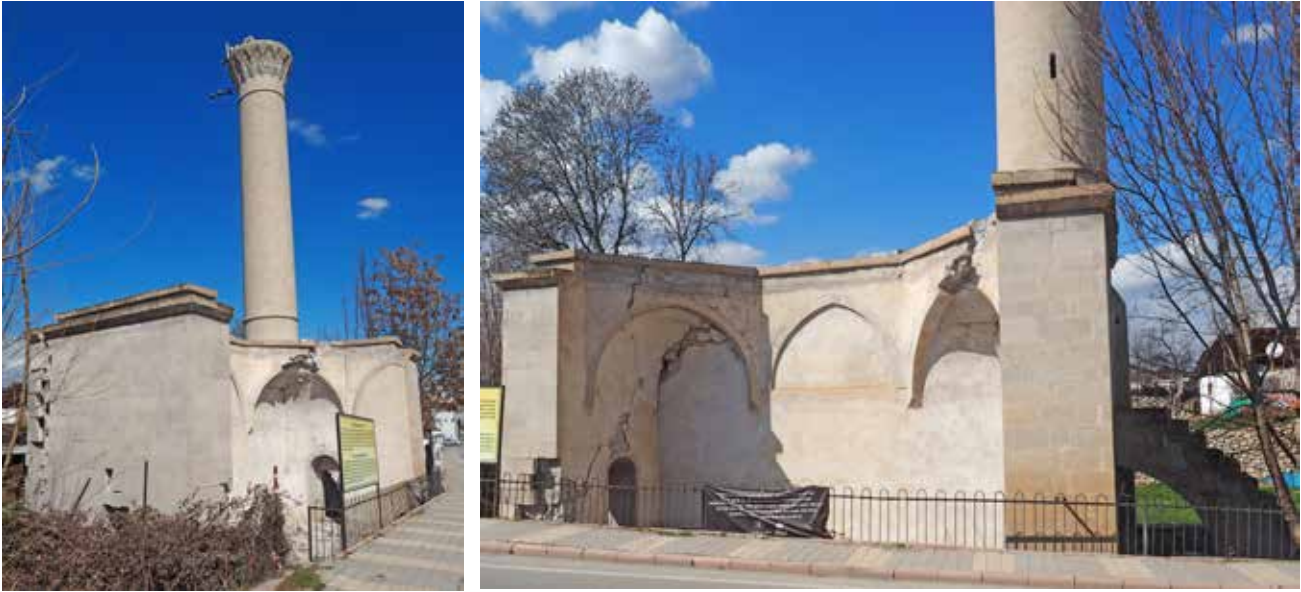
View 7.6 Sütlü Minaret Mosque after the earthquake

II
Stable / Moderate Damage
Local structural and non-structural damages.

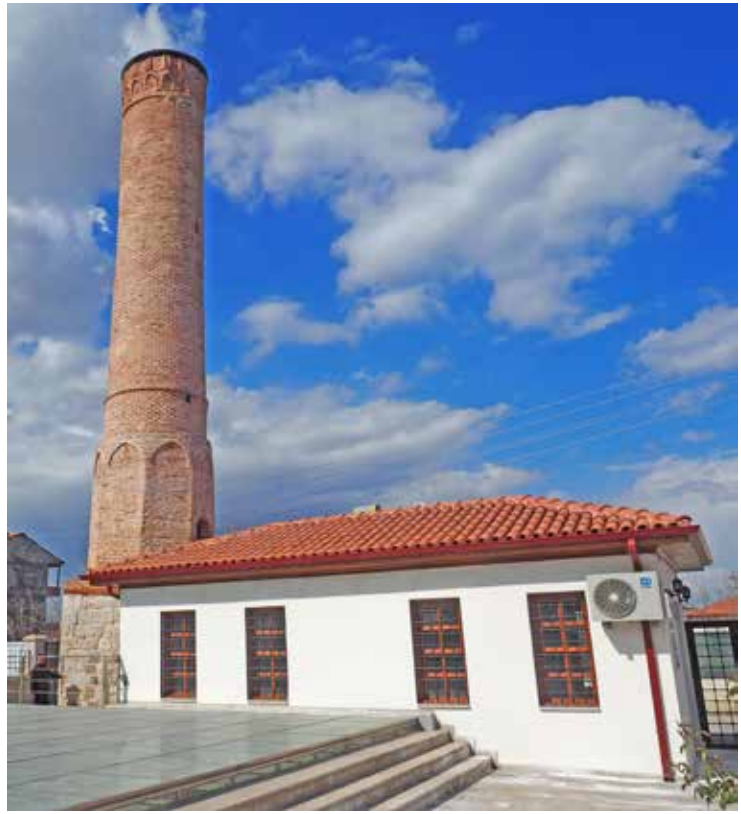
View 7.7 Vaizhoca Mosque -Melik Sunullah Mosque after the earthquake

I
Superficial / Slight Damage
Negligible damage. Some minor damage on minaret.

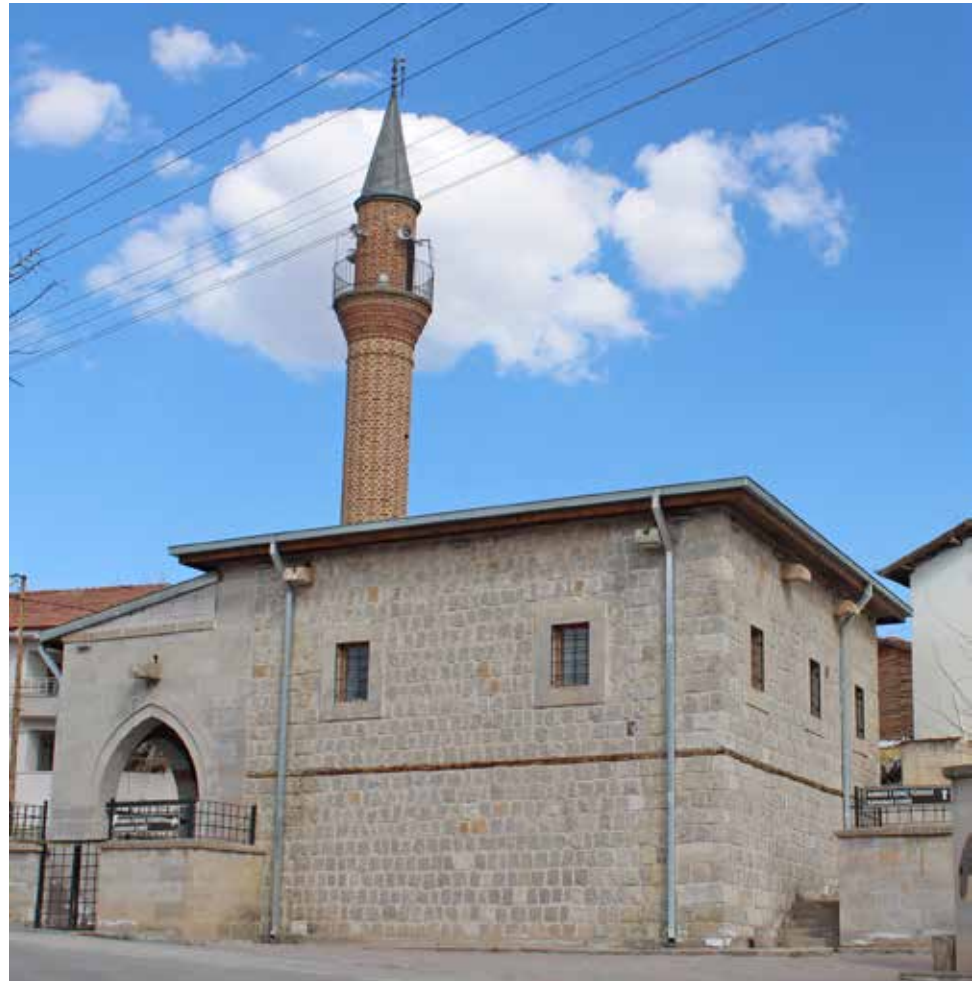
View 7.9 Karahan Mosque after the earthquake

I
Superficial / Slight Damage
Negligible damage. Some minor damages between minaret and main building.

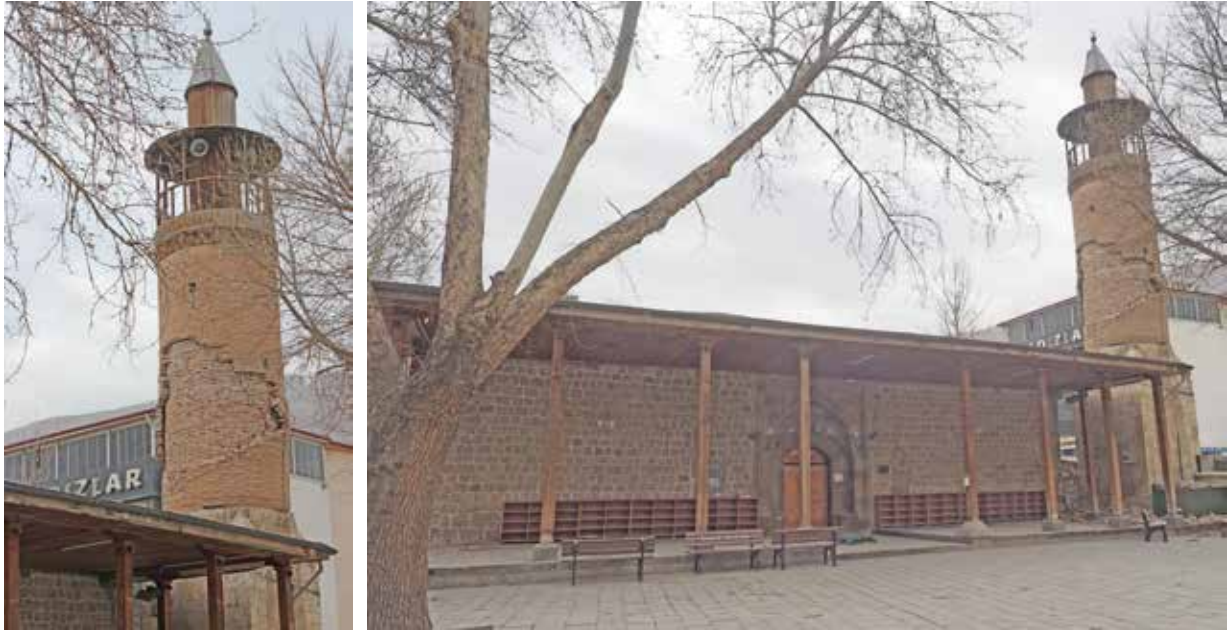
View 8.1 Elbistan Çarşı Atik (Alaüddeve) Mosque after the earthquake

III	IV
Unstable/Heavy Damage	Irreversible/ Very Heavy Damage
Moderate structural damage on main building.	Heavy structural damage on minaret. Collapsed onto roof of the main building.

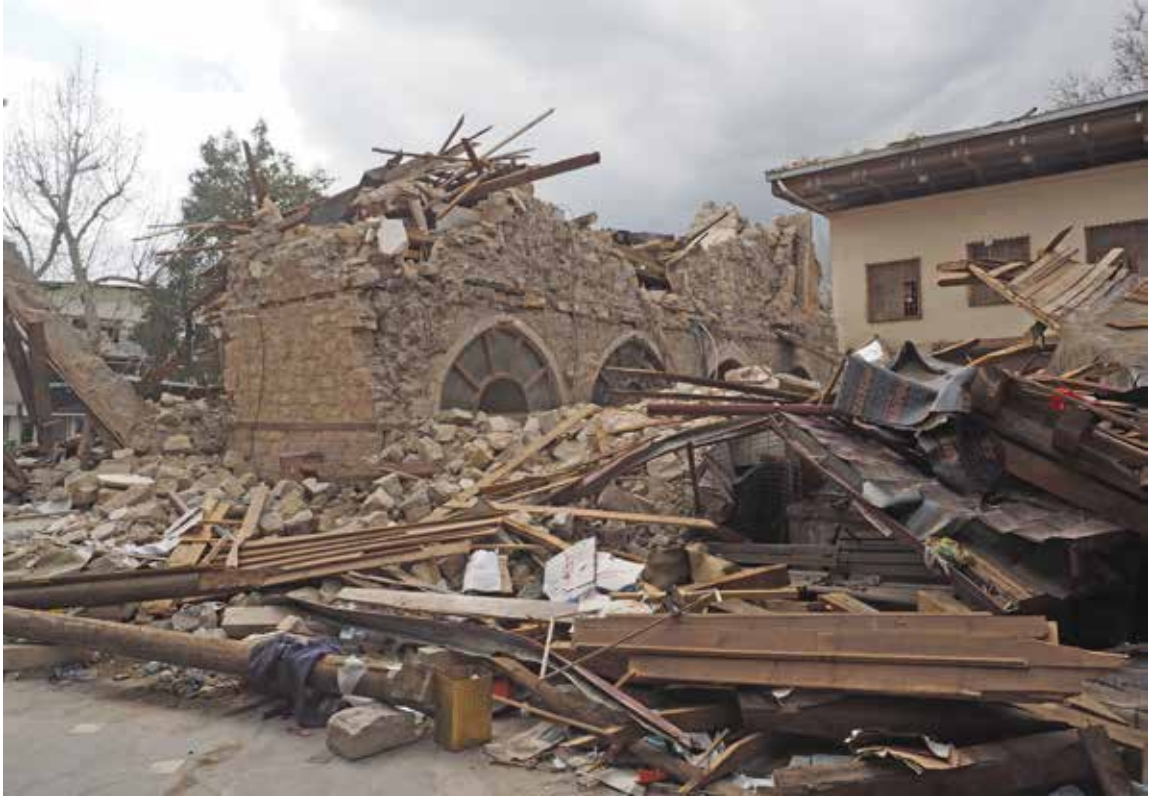
View 8.10 Saraçane Mosque after the earthquake

V
Total Collaps / Destruction
The mosque totally damaged. The plot and the building's stones became rubble.

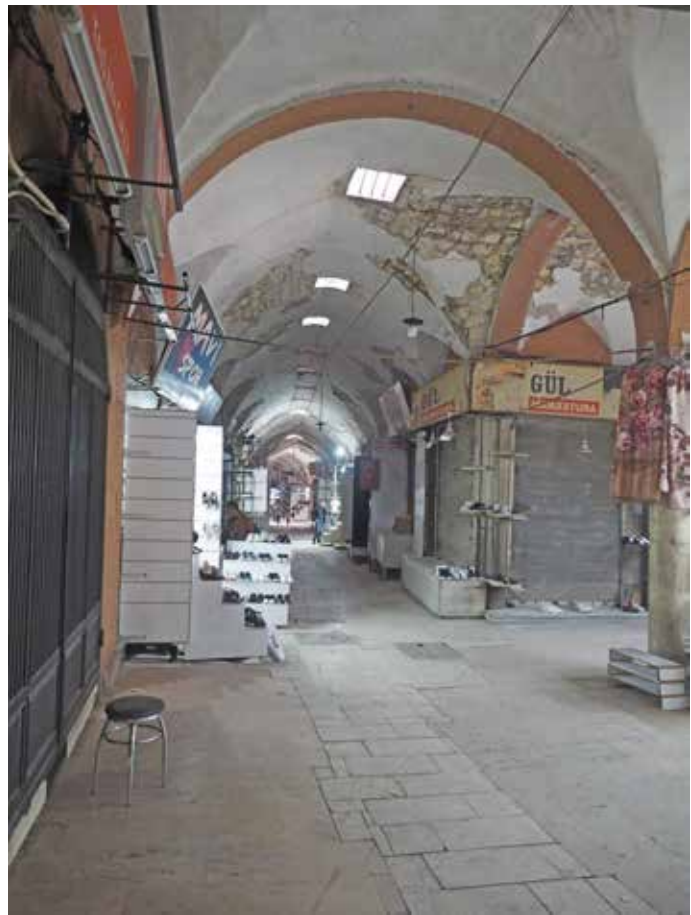
View 8.13 Covered Bazaar after the earthquake

II
Stable / Moderate Damage
Local structural and non-structural damages.

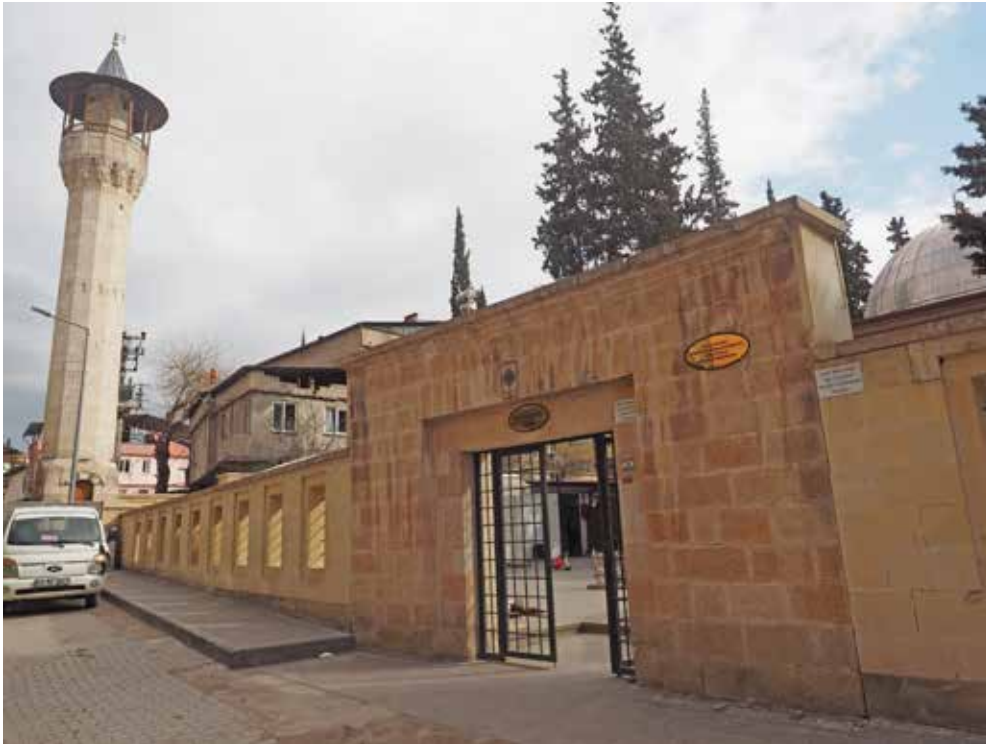
View 8.23 İsa Divanli Mosque after the earthquake

III
Unstable / Heavy Damage
Moderate structural or heavy non-structural damage on minaret.

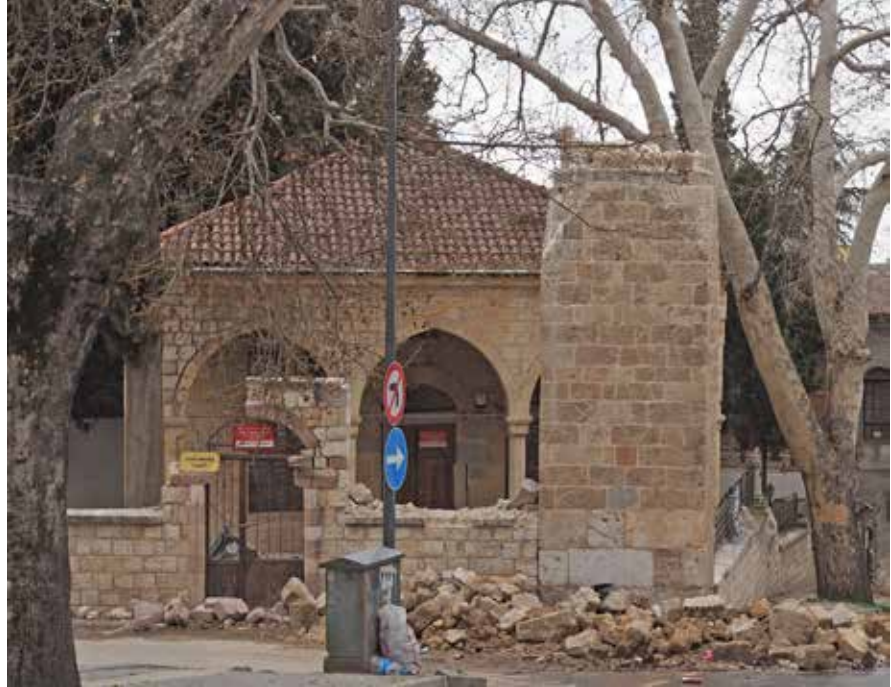
View 8.27 Çukuroba Mosque after the earthquake

III	IV
Unstable / Heavy Damage	Irreversible /Very Heavy Damage
Moderate structural or heavy non-structural damage on main building.	Heavy structural damage on minaret. Collapsed onto the courtyard.

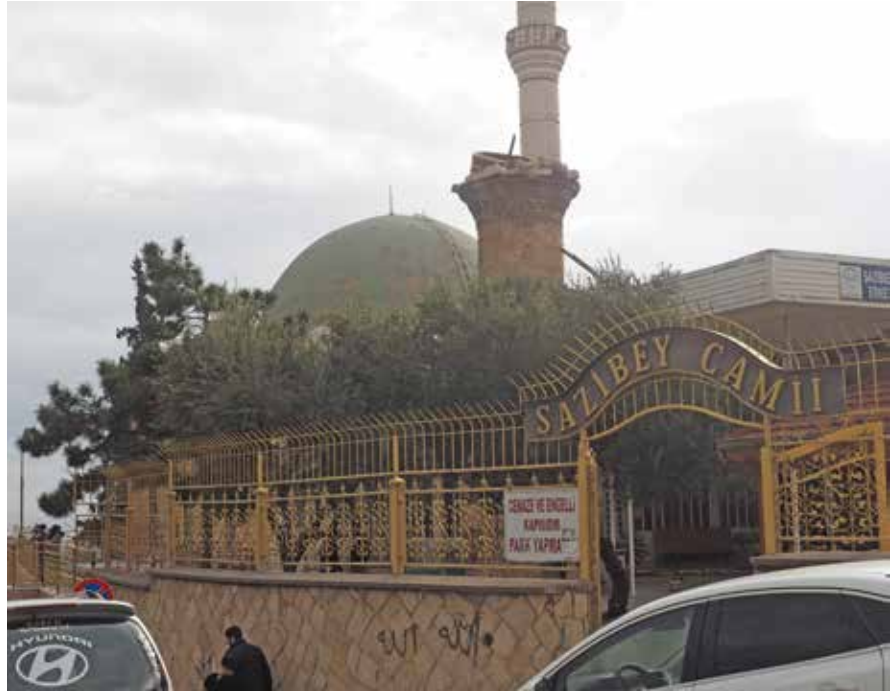
View 8.28 Şazi Bey Mosque after the earthquake

III
Unstable / Heavy Damage
Moderate structural or heavy non-structural damage on minaret.
