REPORT

ON THE DAMAGE CAUSED BY
THE FEBRUARY 2023 KAHRAMANMARAŞ EARTHQUAKE
ON ISLAMIC CULTURAL HERITAGE IN TÜRKİYE

Prepared by

Alidost Ertuğrul
Taha Zahid Özdemir
Hussein Al Ragabi

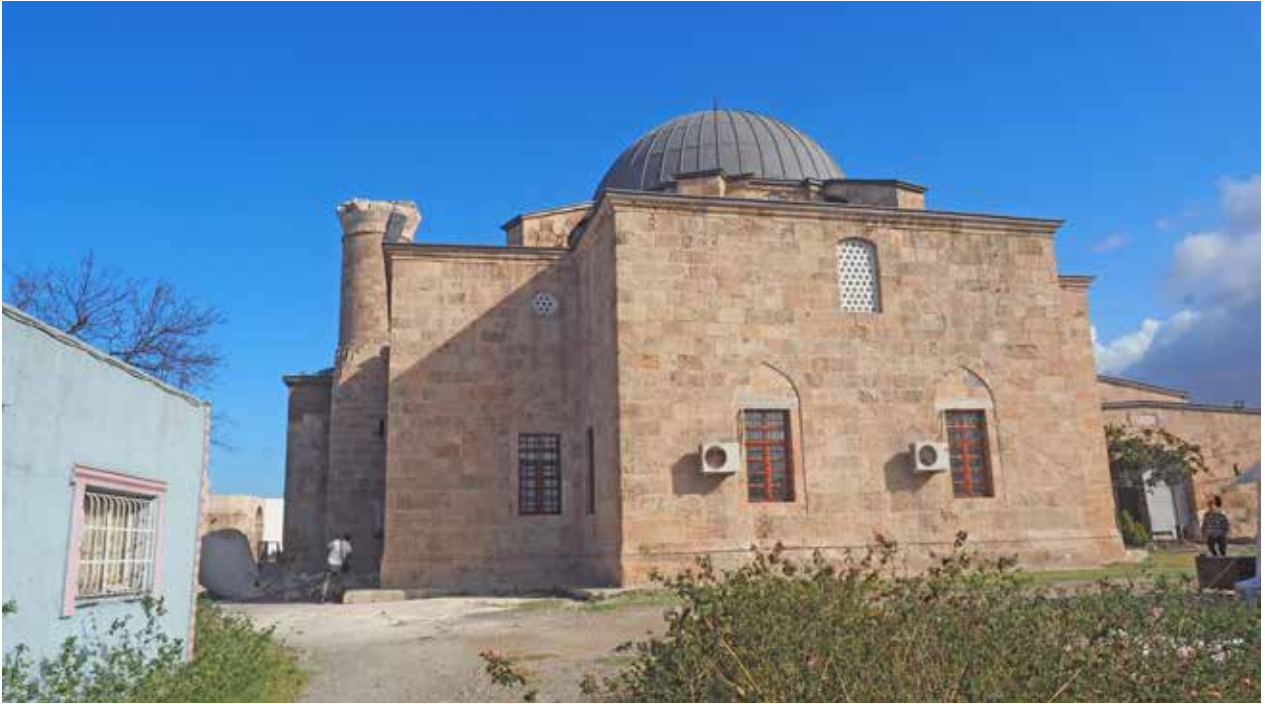
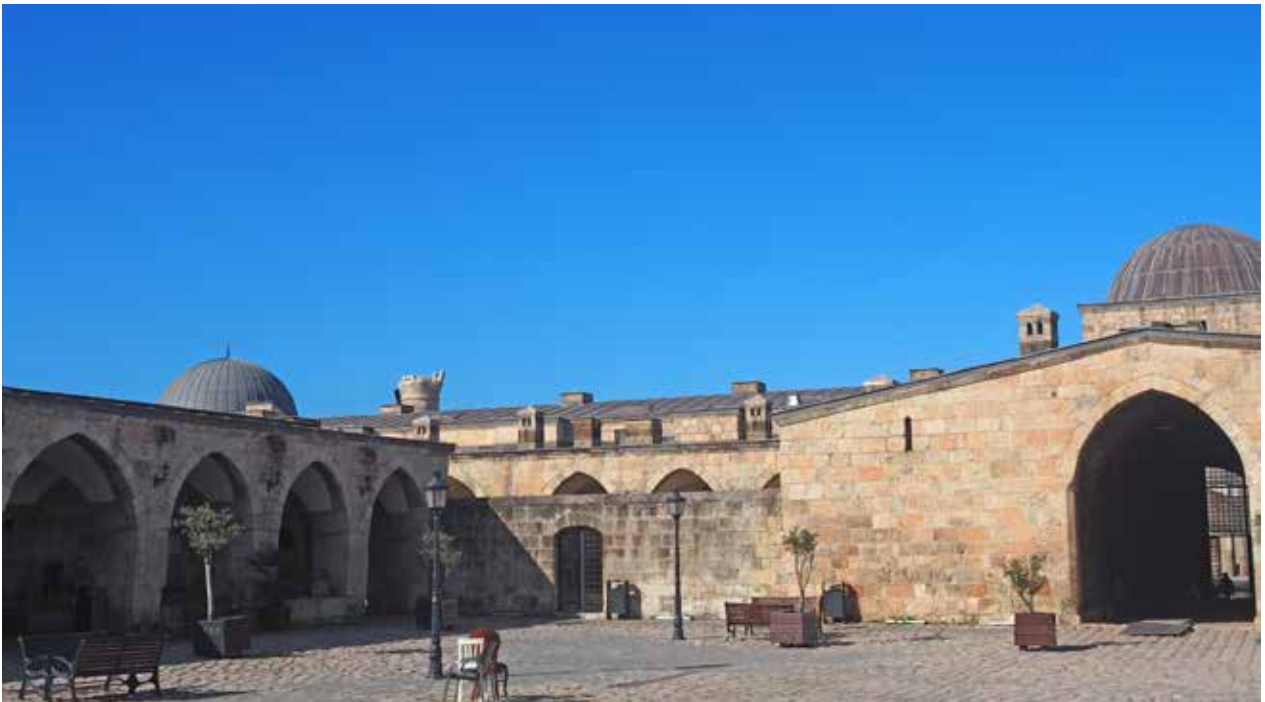
View 1.2 Payas Sokullu Mehmet Paşa Complex after the earthquake

From an overall standpoint, the complex did not experience any severe damage in the earthquake. Partial damage is observed in two structures of the complex. The Arasta building's roof vaults have plaster cracks. Its other damaged section is the minaret. It is understood that the conical top of the minaret had been renewed during recent restorations; the new concrete top, which was not made in conformity with the original building technique of the mosque, could not withstand the shocks and fell down. Partial damage occurred in the upper section of its balcony and around the minaret. The broken piece did not cause any noticeable damage to the main building because it fell on the area between the mosque and the fort.

I	II
Superficial/Slight Damage	Stable/ Moderate Damage
Negligible structural damage on main building.	Local structural damage on minaret.

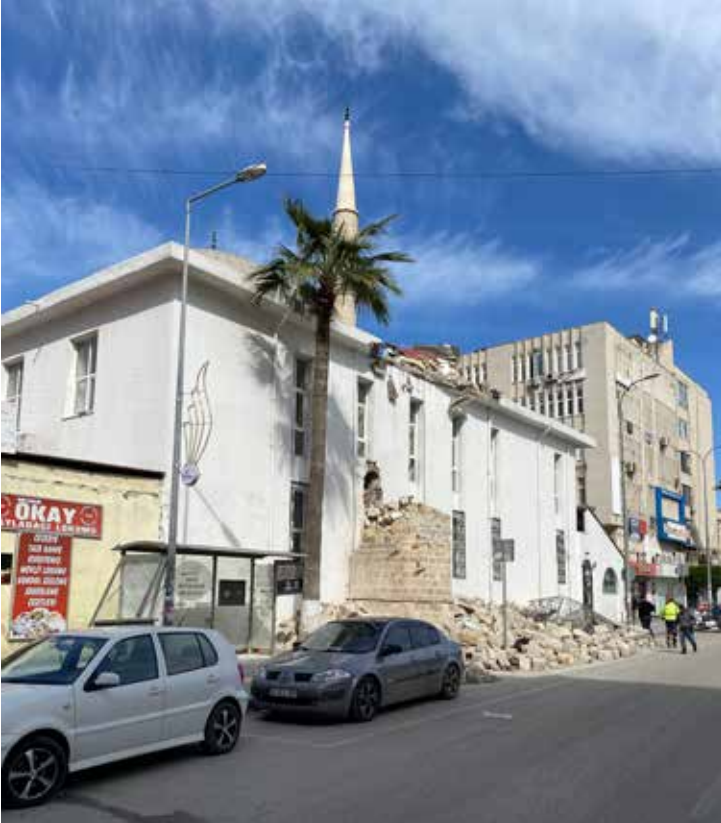
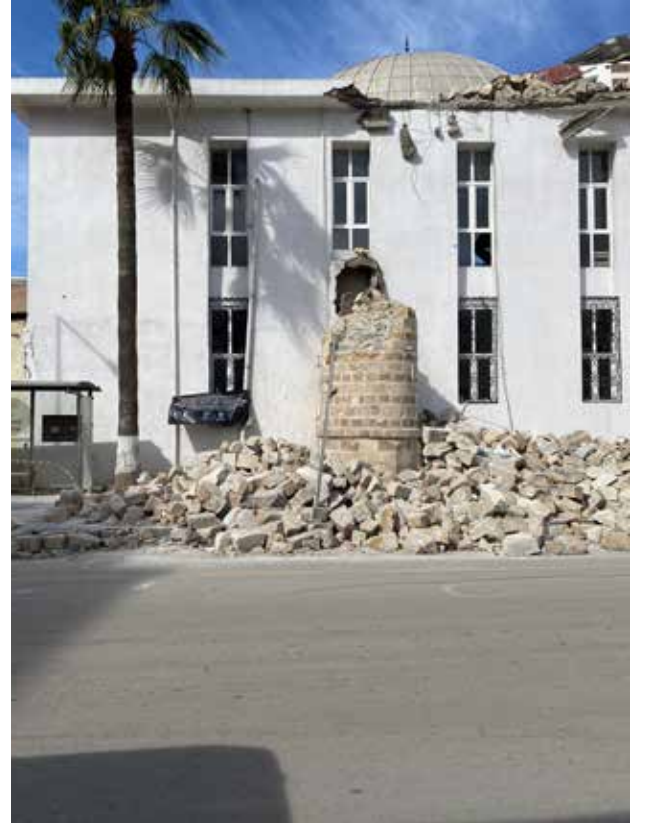
View 1.5 İskenderun Kaptan Mehmet Paşa Mosque after the earthquake

The mosque originally built by Kaptan Mehmet Paşa in 1864 consisted of a wooden prayer hall and a stone minaret. The wooden part was demolished and replaced by a reinforced concrete structure in 1974. The minaret, built with alternating stone and brick blocks from foot to top and with one balcony, remained extant until the earthquake. However, its body part above the pulpit level collapsed in the earthquake and also caused damage on the newer, reinforced concrete main building. As to the reinforced concrete minaret, which is a later addition, it withstood the shocks.

Total destruction

Minaret totally destroyed.

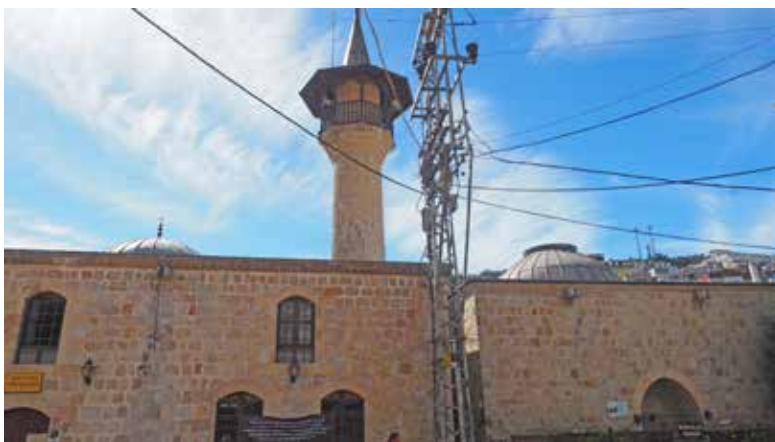
View 1.7 Belen Kanuni Sultan Süleyman Complex after the earthquake

The caravanserai appears to have survived the quake without any damage. The single-balcony minaret of the mosque displays some disintegration and carries risks. Some pieces of stone dropped off the minbar (pulpit) and the mihrab (prayer niche); the wall plasters have cracks and falling pieces. The public bath could not be visited, but people said that some sections of it had collapsed.

Superficial / Slight Damage

Negligible structural damage on main building.

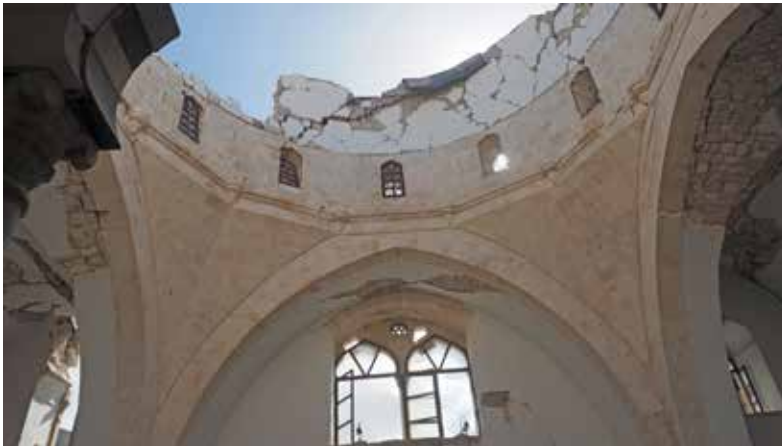
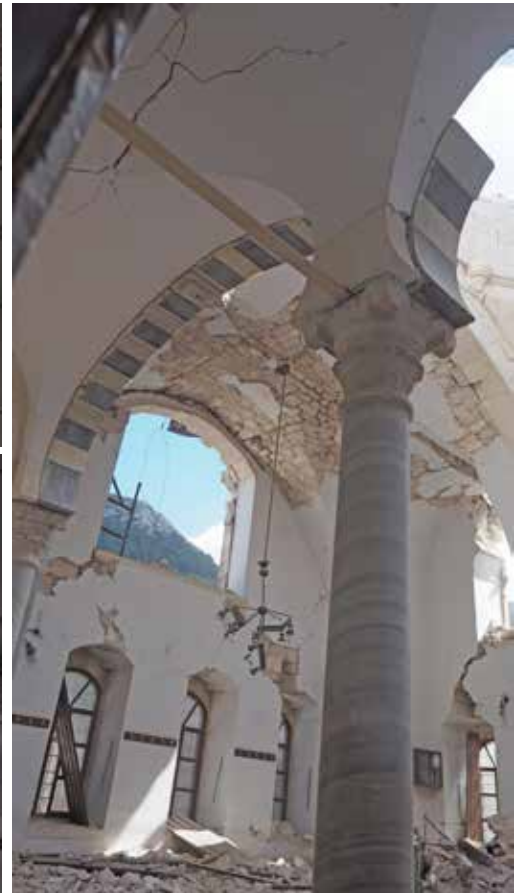
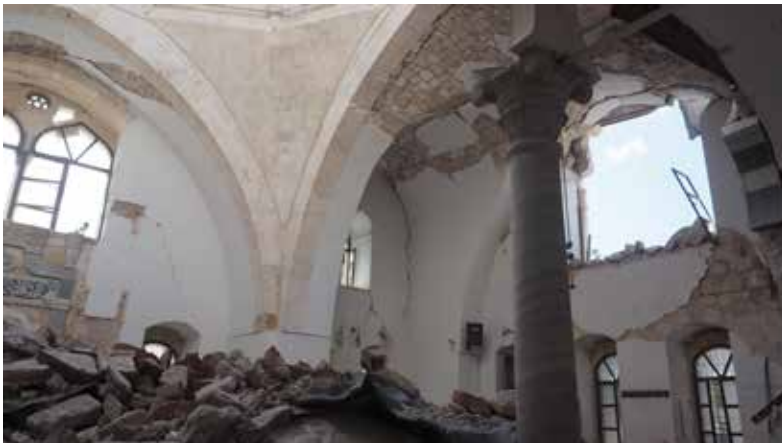
View 1.12 Şeyh Ali Mosque after the earthquake

Heavy structural damage and very heavy non-structural damage. Main dome and some of the bearing walls collapsed.

The destruction caused by the 6 February 2023 earthquake is heavy. Its dome collapsed totally; what remains is broken pieces of the southern segment of the dome base. The upper part of the minaret above the level of the mosque roof broke into pieces, so did the upper middle part of the eastern wall of the building. There are cracks on all facades of the mosque and some stones fell off. The entrance arcade and its top covering are destroyed. Relating to the medrese building that faces the mosque, some sections of its front facade collapsed.

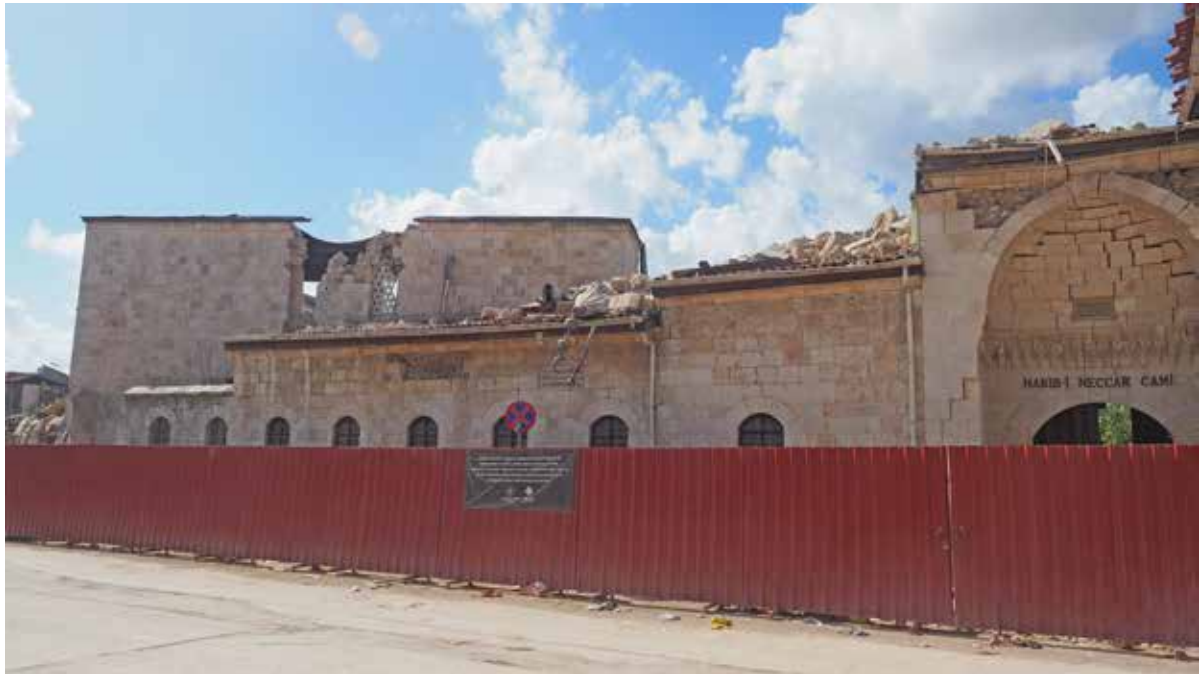
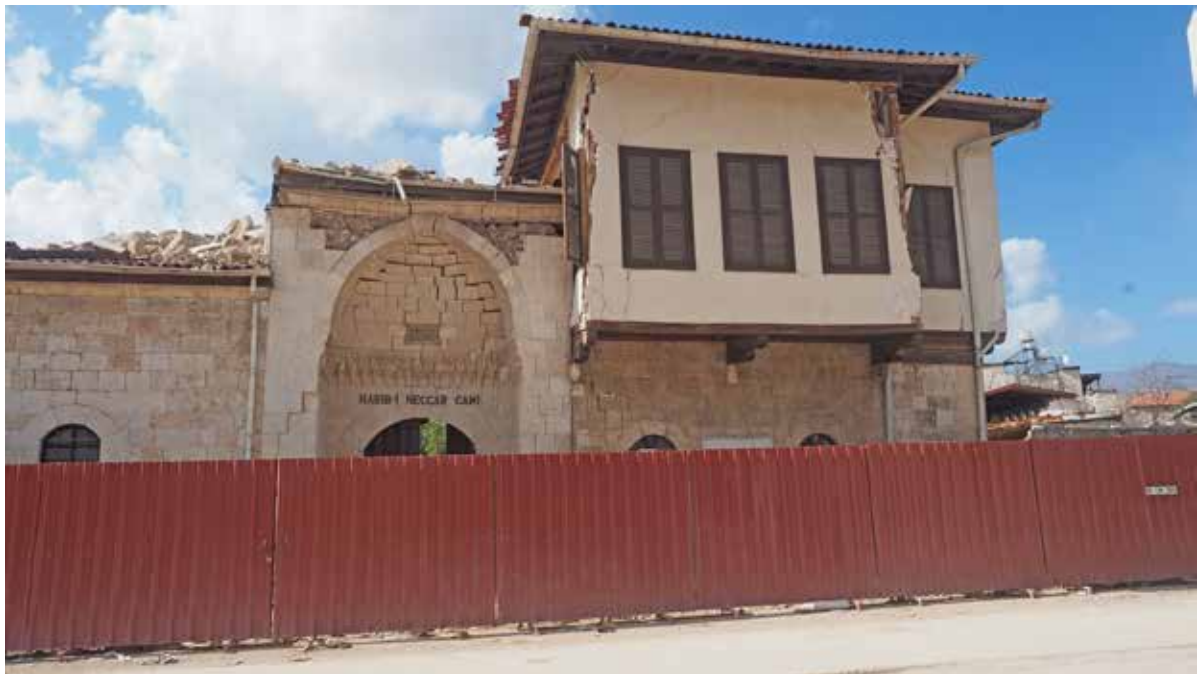
It appears to be one of the most heavily damaged monuments. The central dome of the prayer area of the mosque collapsed. Total collapsing of the minaret located nearby the entrance gate caused destruction to the courtyard gate and its surroundings. The arcades on the northern side entrance were destroyed due to the collapse of the mosque dome and roof. All of the facades have deep fractures and some of their stones fell off.

View 1.17 Habib-i Neccar Mosque after the earthquake

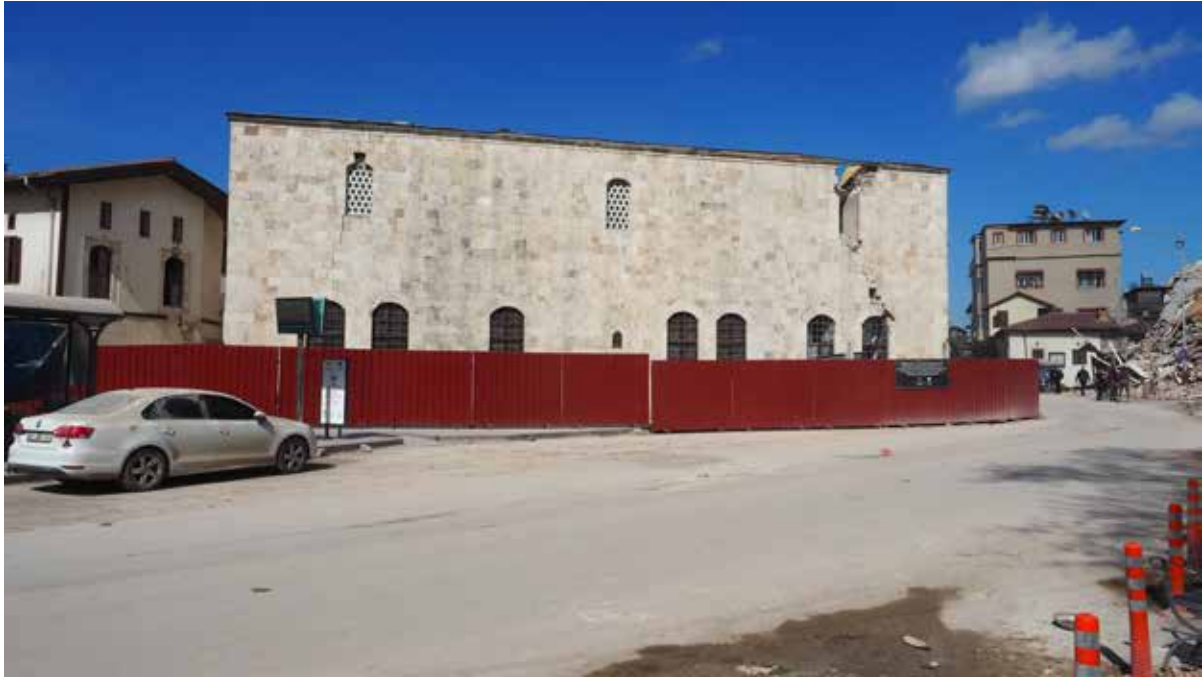
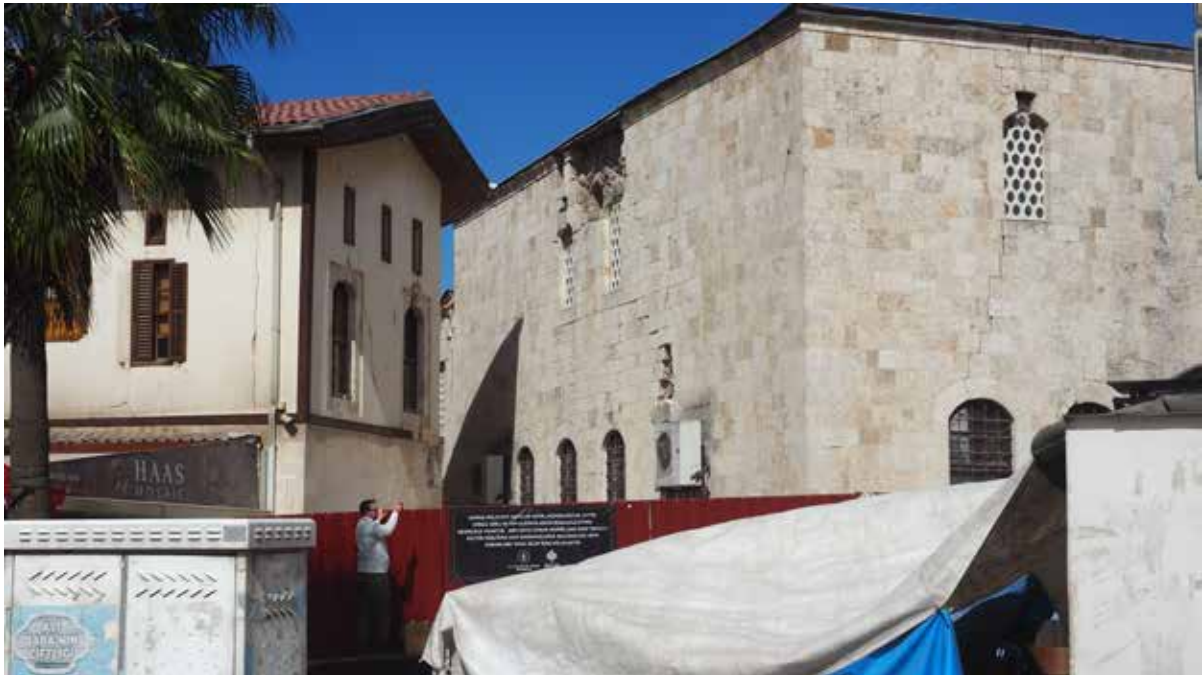
Heavy structural damage and very heavy non-structural damage. Main dome and some of the bearing walls collapsed.

View 1.18 Habib-i Neccar Mosque after the earthquake

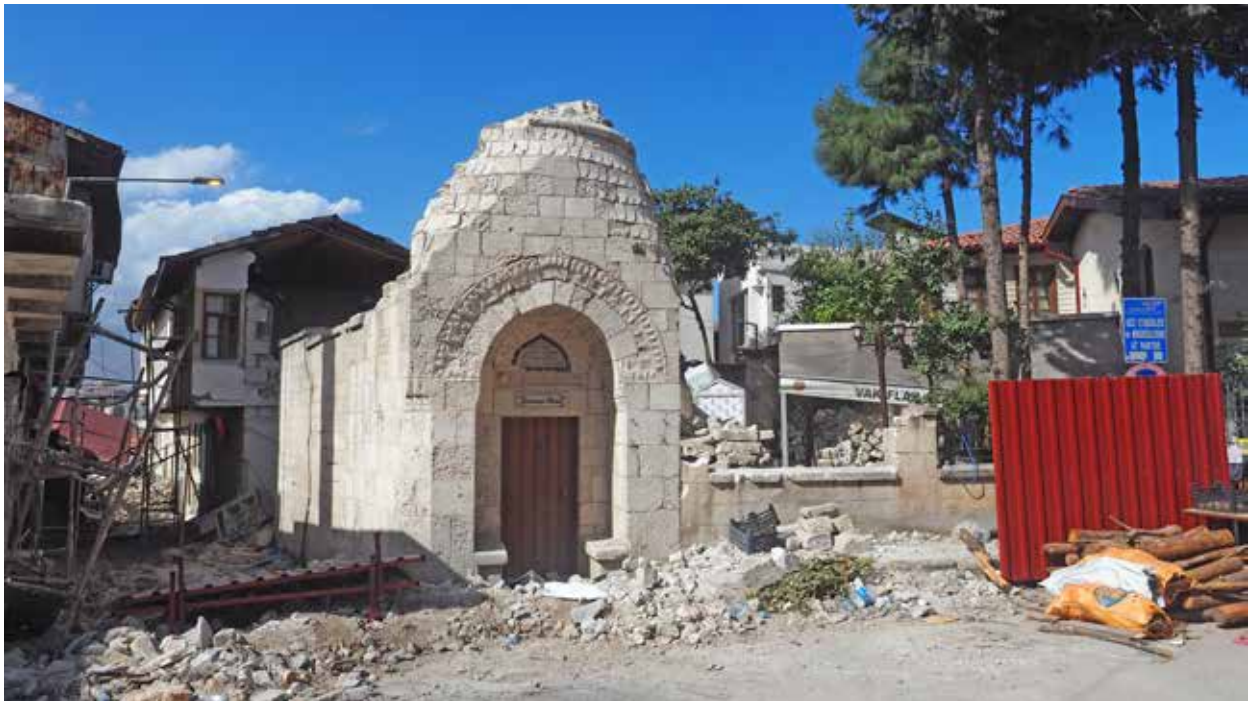
The mosque was severely destroyed in the 2023 earthquakes. The part of the minaret above its base collapsed; falling pieces hit the surrounding structures. There are dislocations in the load-bearing walls and the interior vaults of the mosque which is also a threat to its roof. Piece of stone were detached and fell from the fractures of the stone vaults in the central part of the mosque.

III	IV
Unstable/Heavy Damage	Irreversible/ Very Heavy Damage
Moderate structural or heavy non structural damage. Roof and main walls damaged, risk of collapse.	Heavy structural damage on minaret. Collapsed till the base. Many features of the minaret were erased.

View 1.20 Sarimiye Mosque after the earthquake

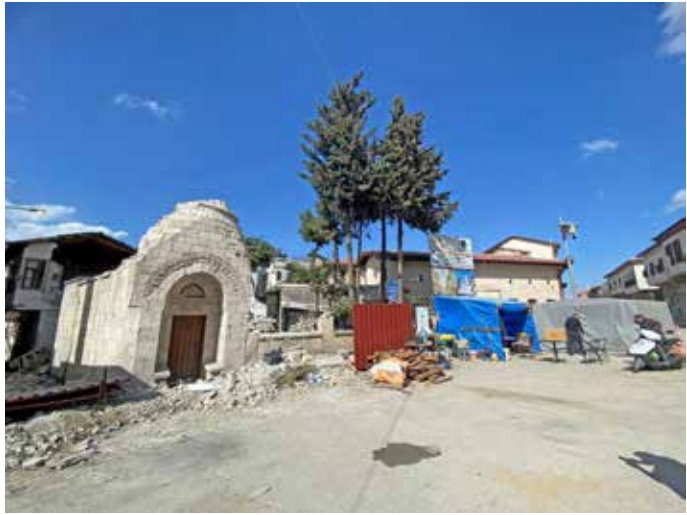
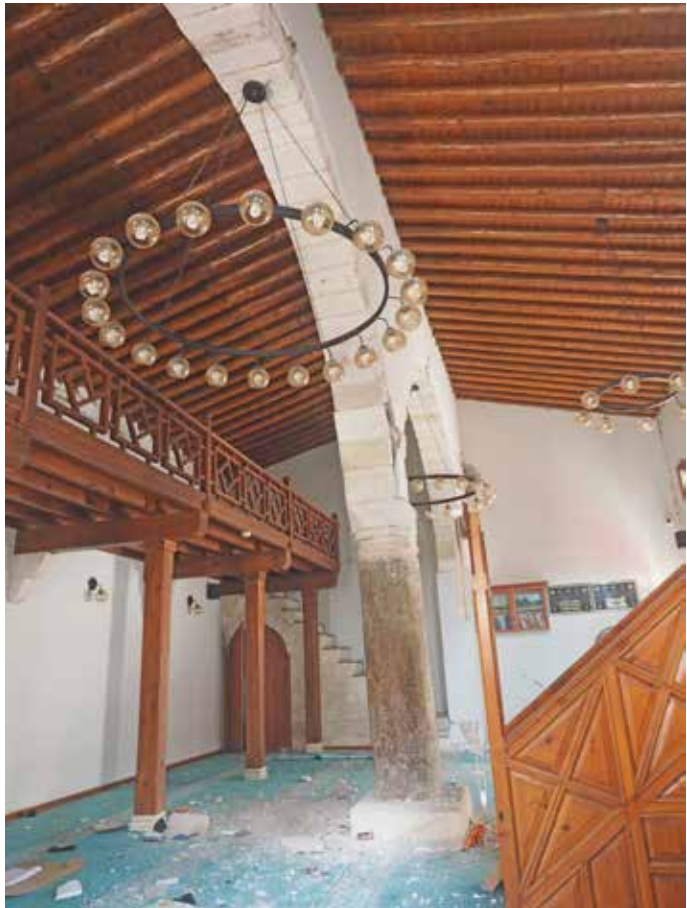
View 1.21 Sarimiye Mosque after the earthquake

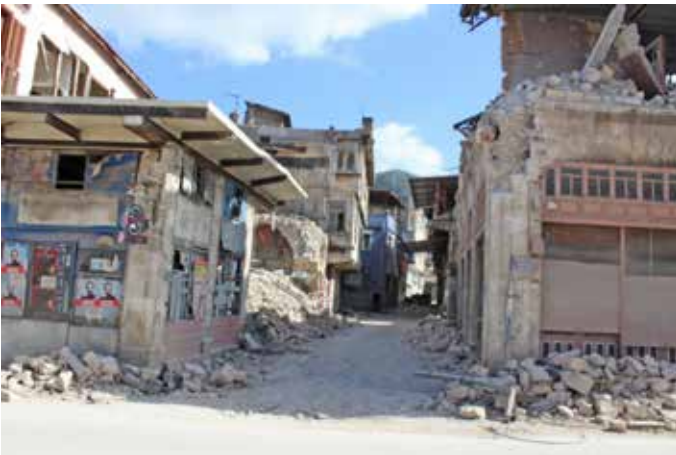
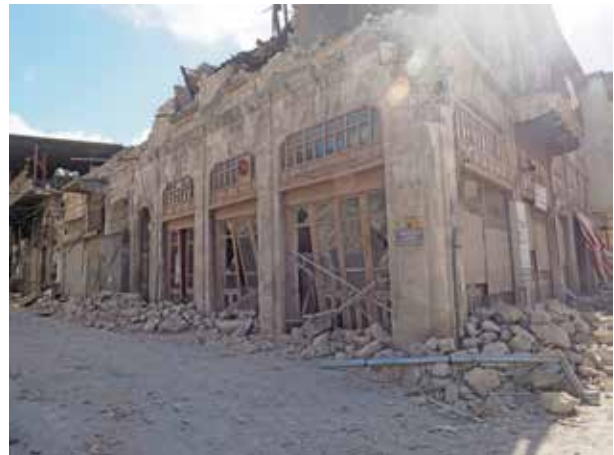
The coffeehouse was heavily damaged during the February 2023 earthquake. Its roof collapsed; a large part of its facade, the side wall of its upper floor, its wooden door and entrance were damaged; a partial collapse is seen in the corner of the ground floor and stones falling off from the building are scattered around the street.

III
Unstable / Heavy Damage
Moderate structural or heavy non-structural damage. Roof and main facade were damaged.

View 1.22 The historical Affan Coffeehouse after the earthquake

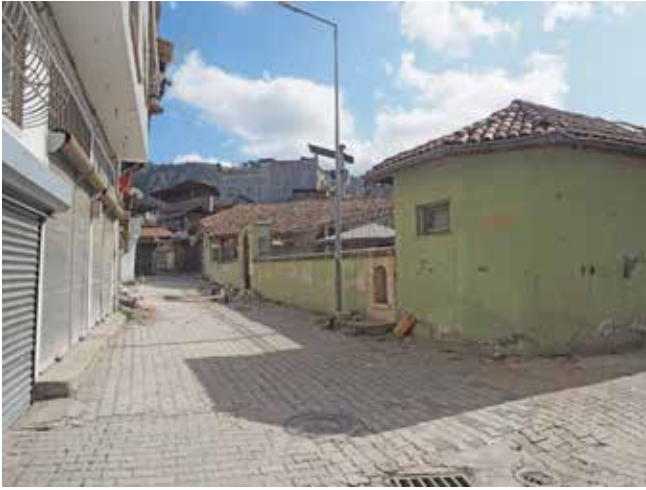
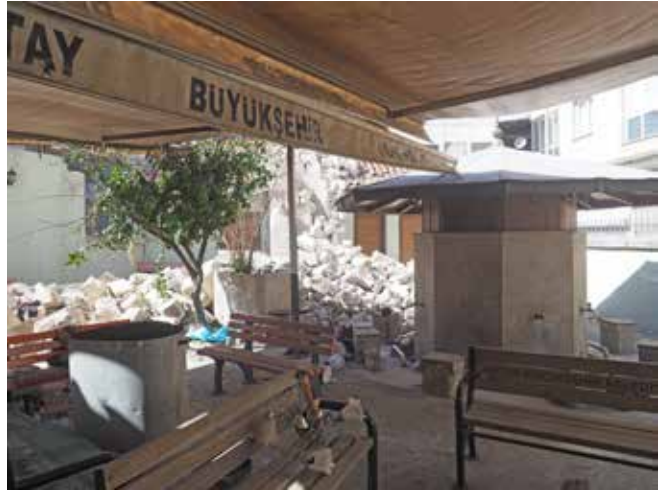
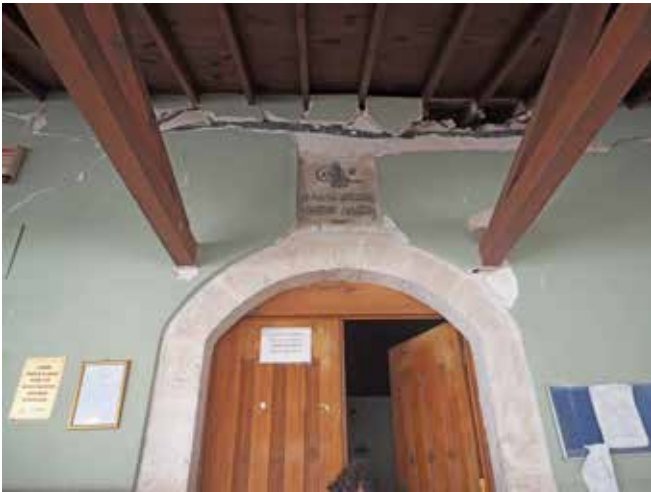
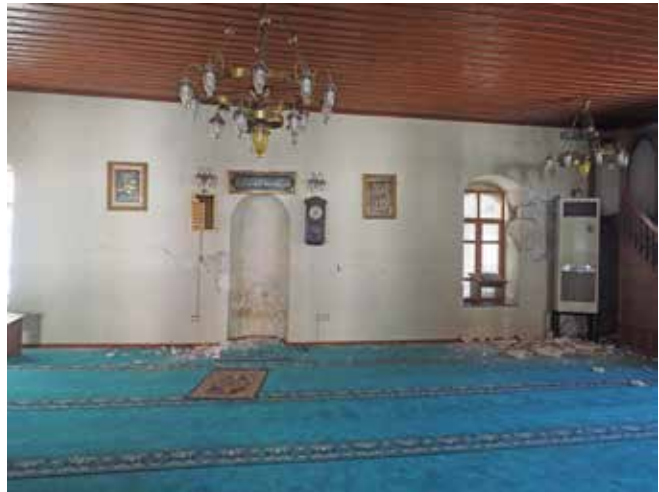
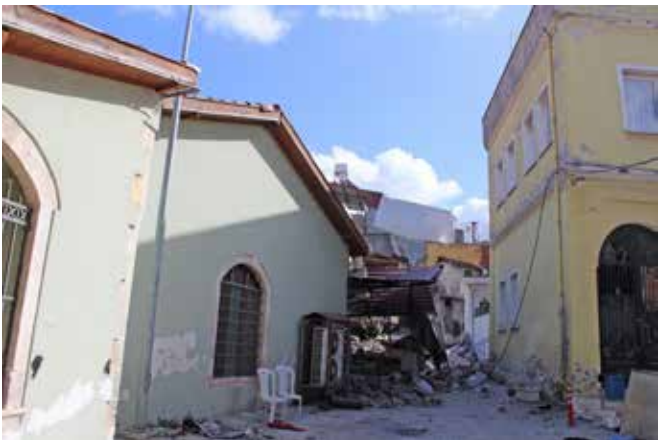
The mosque seems to have suffered partial damage in the quake. The minaret fell off to the garden. There are cracks in the plasters of the main entrance facade and also at other places. The mihrab wall is fractured and the plastering on the walls is flaking off.

III	IV
Unstable/Heavy Damage	Irreversible/Very Heavy Damage
Moderate structural or heavy non-structural damage.	Heavy structural damage on minaret. Collapsed onto the roof of the mosque.

View 1.23 Ertuğrul Affan Mosque after the earthquake

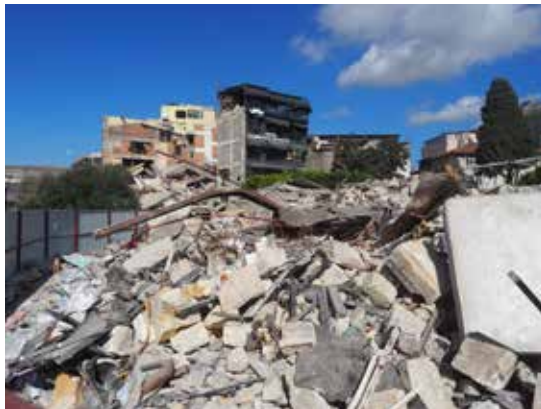
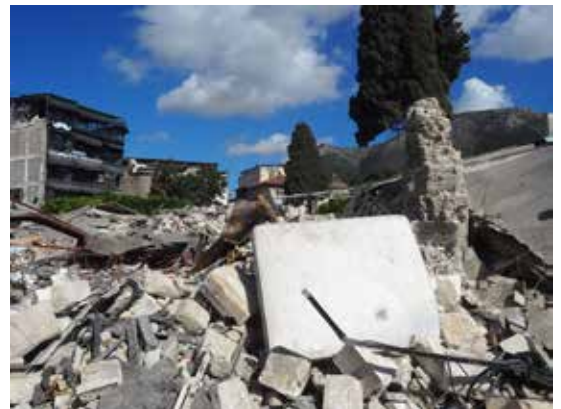
V
Total Collaps / Destruction
Totally destroyed. The plot and the building's stones turned into rubble.

View 1.24 Ulu Mosque after the earthquake

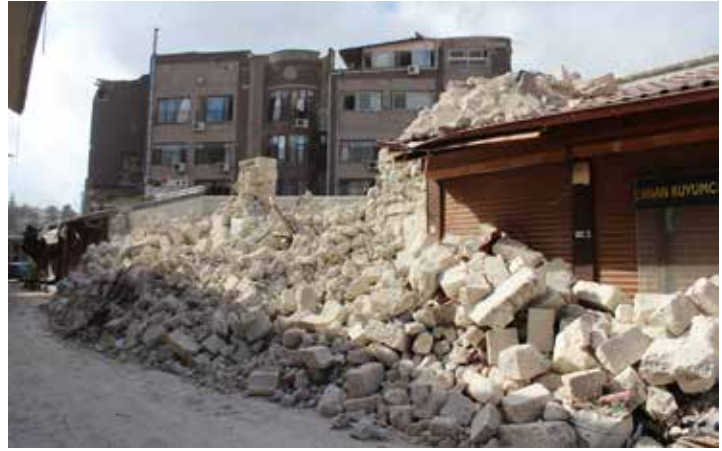
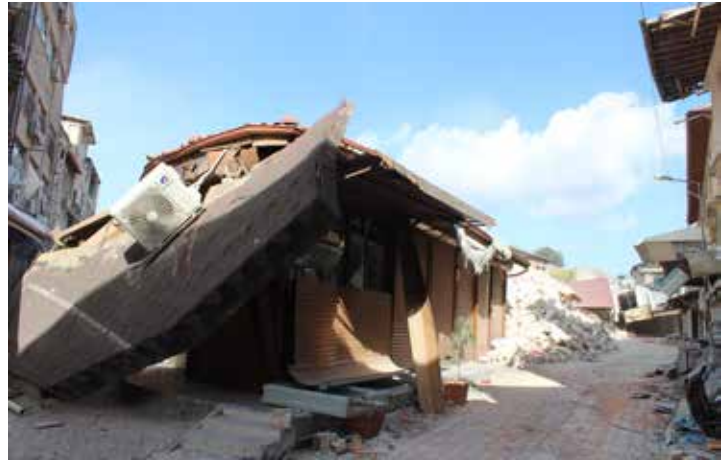
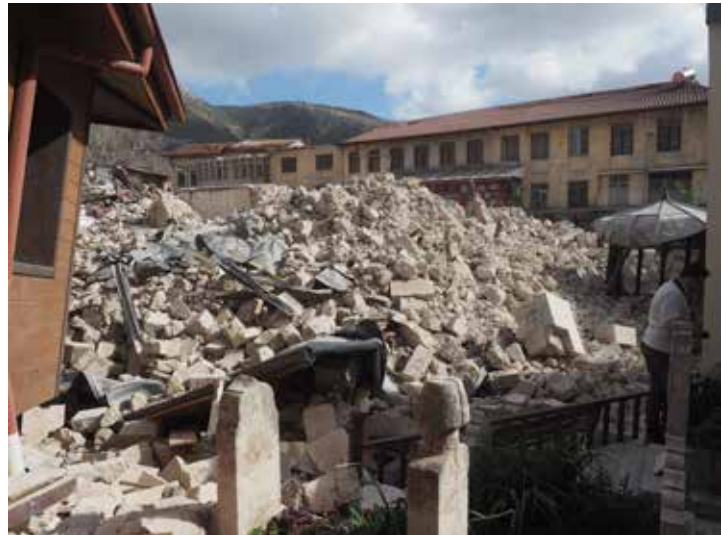
V
Total Collaps / Destruction
Totally destroyed. The plot and the building's stones turned into rubble.

View 1.26 İhsaniye Mosque after the earthquake

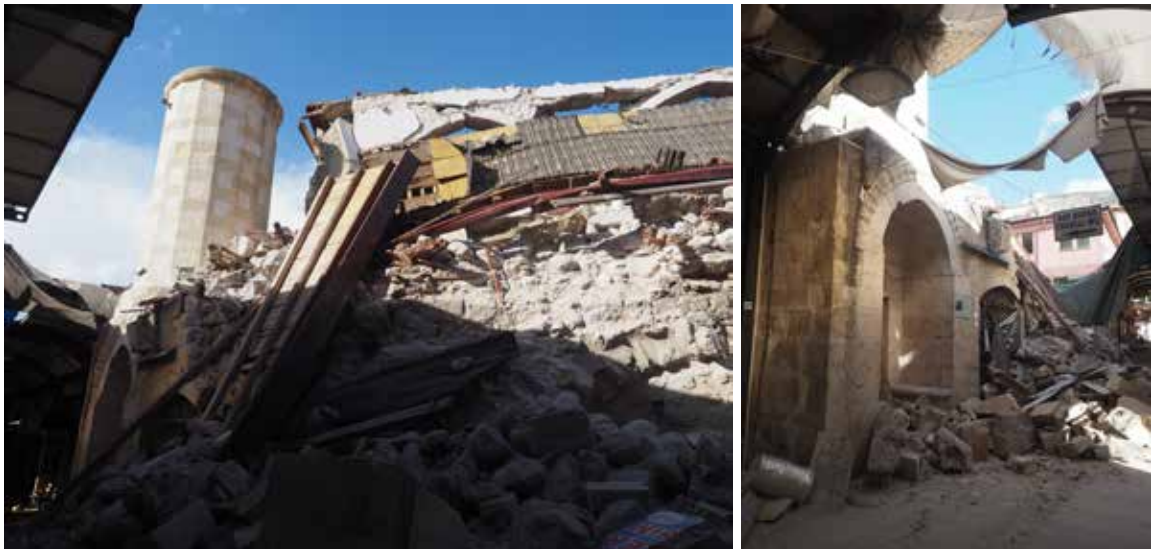
III	IV
Unstable/Heavy Damage	Irreversible/Very Heavy Damage
Moderate structural or heavy non-structural damage.	Heavy structural damage on minaret. Collapsed onto the roof of the mosque.

View 1.28 Mahremiye Mosque after the earthquake

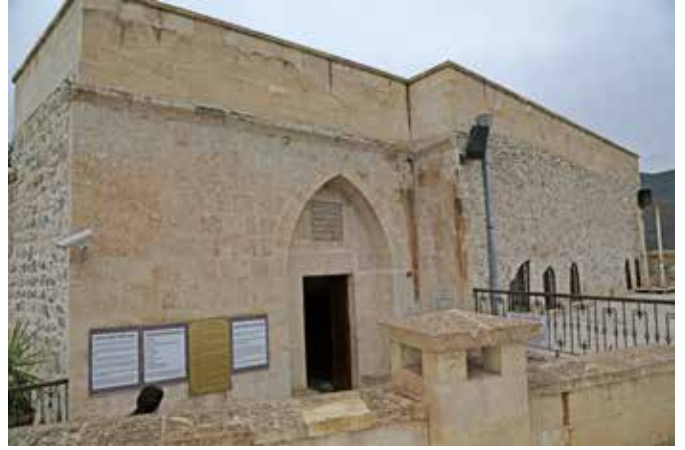
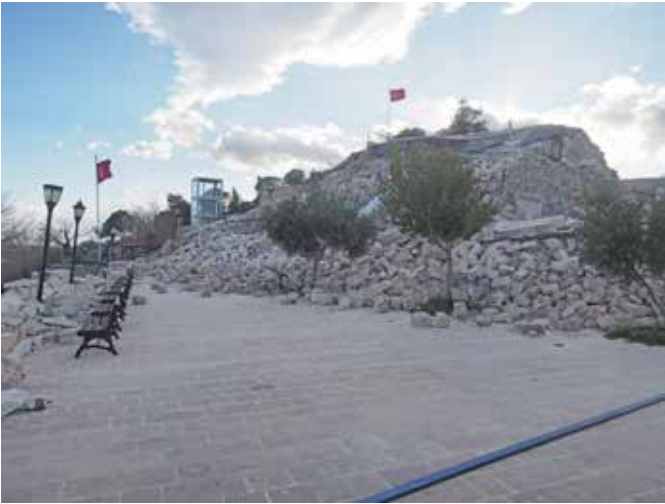
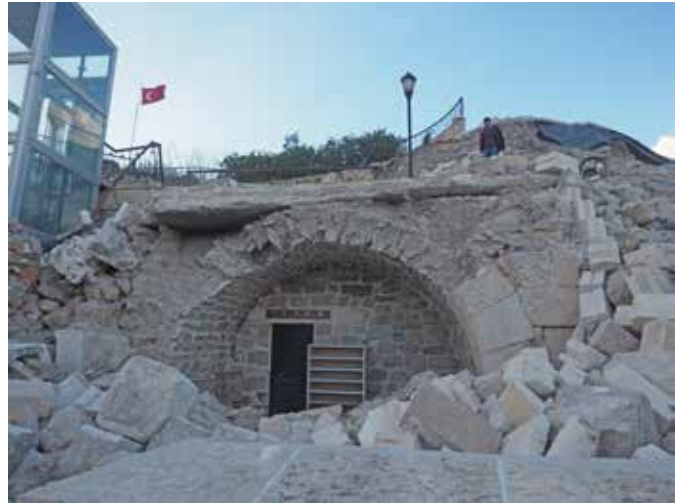
View 1.32 Bayezid-i Bistami Mausoleum after the earthquake

The foundations of the slopy road leading to the site of the mausoleum collapsed during the February 2023 quakes, splitting the roads and severely damaging the structures at the ground level of the mausoleum. The latter's walls were broken by the shakings. However, the coffins inside the mausoleum were safe, protected by their vaulted ceiling that was not damaged.

IV
Irreversible / Very Heavy Damage
Heavy structural damage and very heavy non-structural damage.

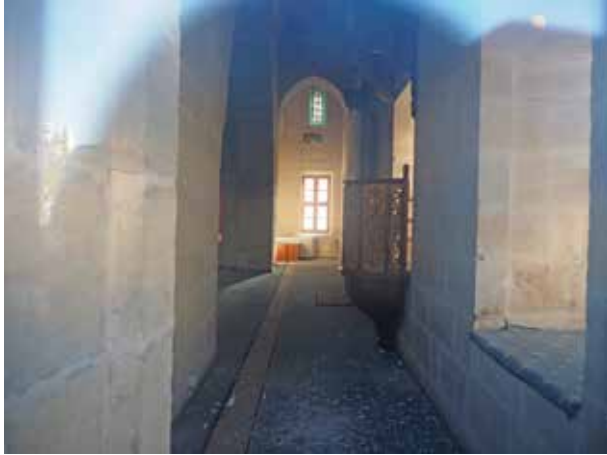
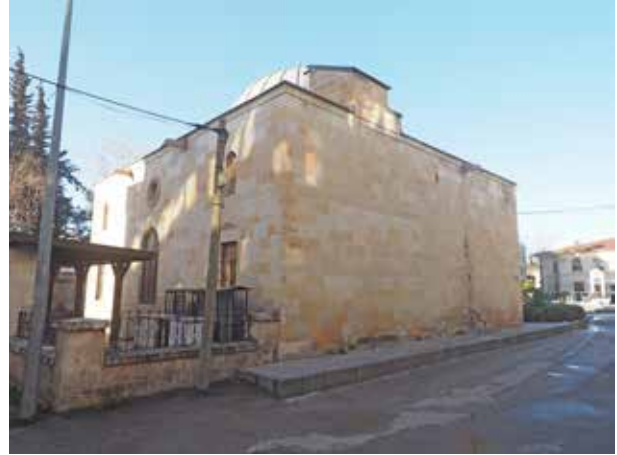
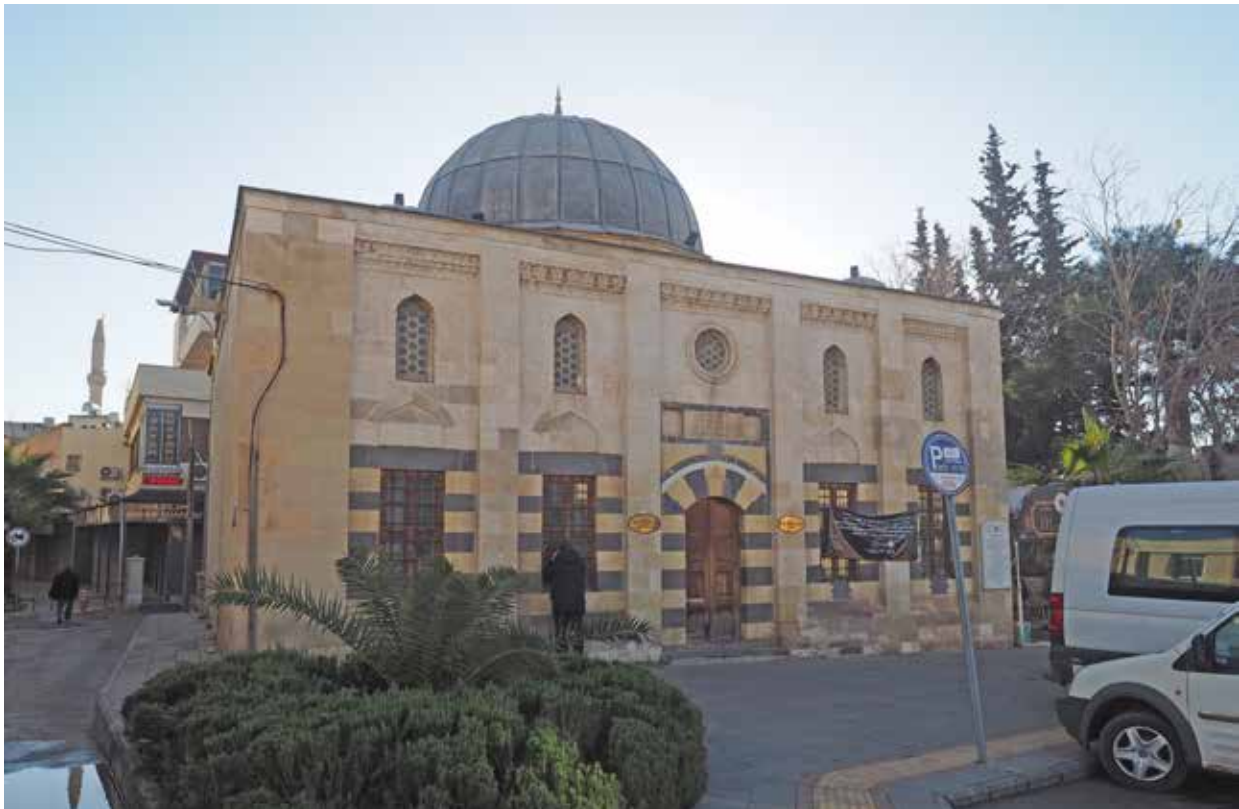
View 2.1 Mevlvihane Mosque after the earthquake

The earthquake provoked cracks in the inside wall plasters and parts of them fell off. No fractures or damages were seen on outside surfaces.

I
Superficial / Slight Damage
Negligible damage. Some of the features such as plaster fell down and minor cracks.

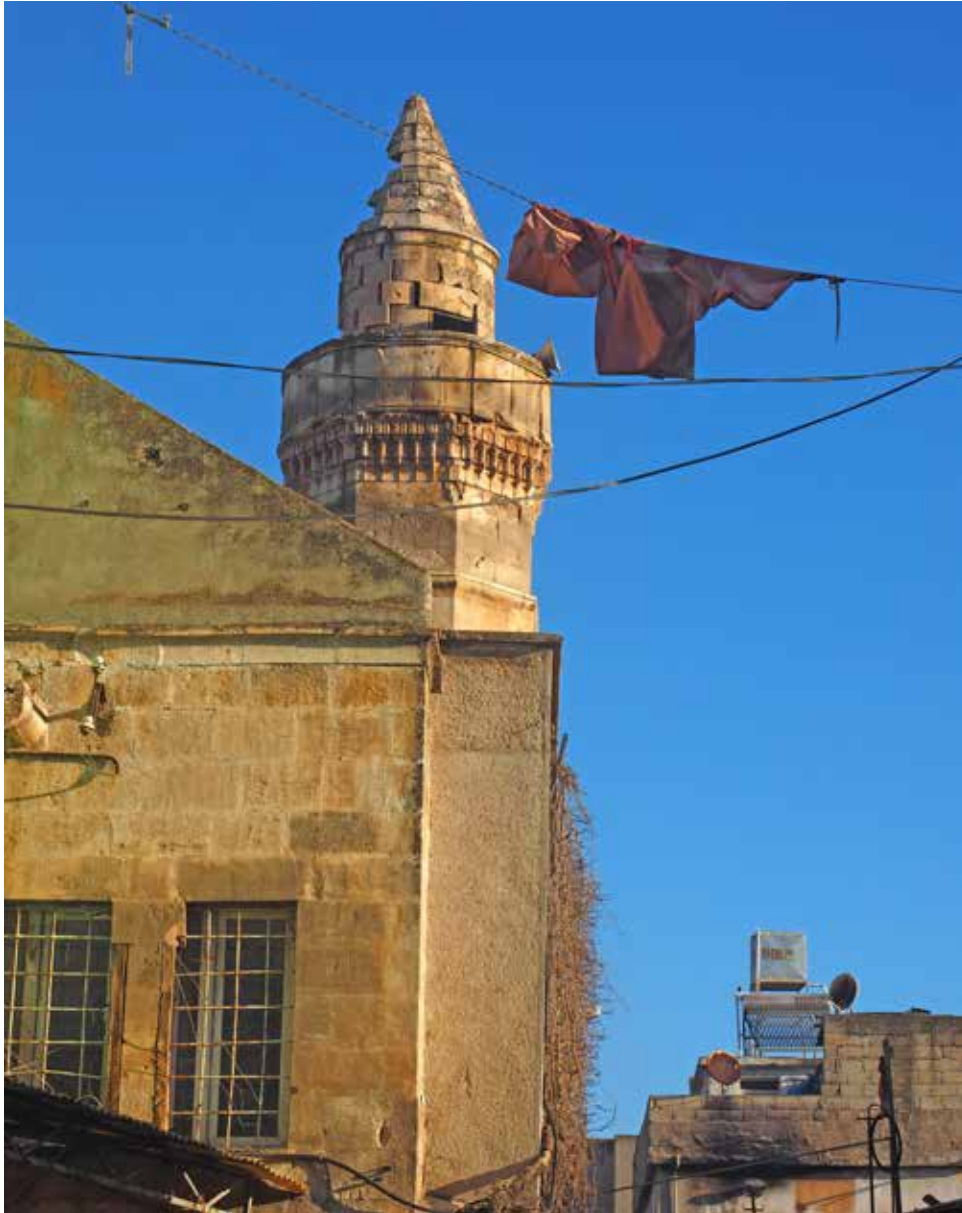
View 2.2 Şihlar Mosque after the earthquake

In the last earthquake, the section of the minaret above its balcony was damaged. A segment of its alem (finial ornament) made of stone has collapsed and needs to be repaired. No information is available about the interior space since it could not be visited.

III
Unstable / Heavy Damage
Moderate structural or heavy non-structural damage on minaret.

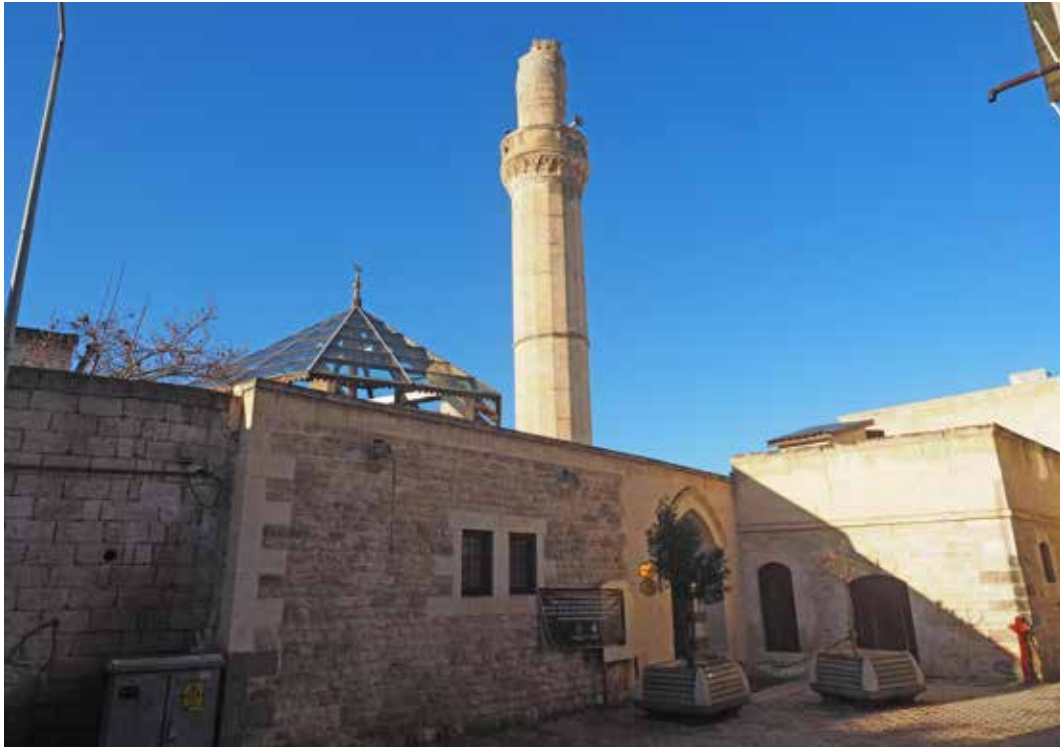
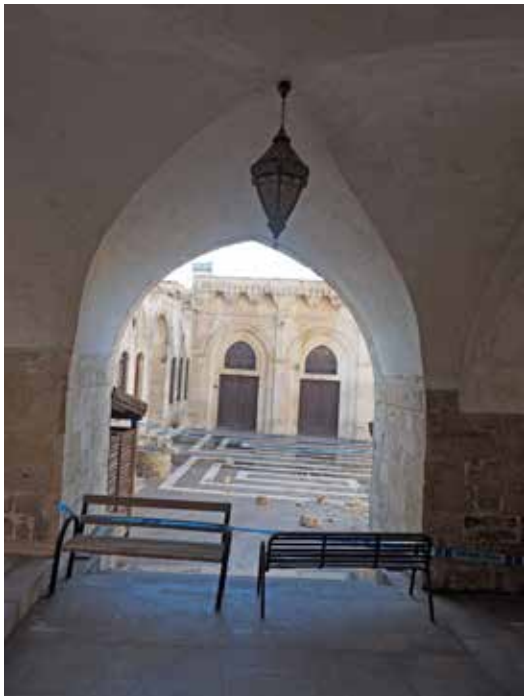
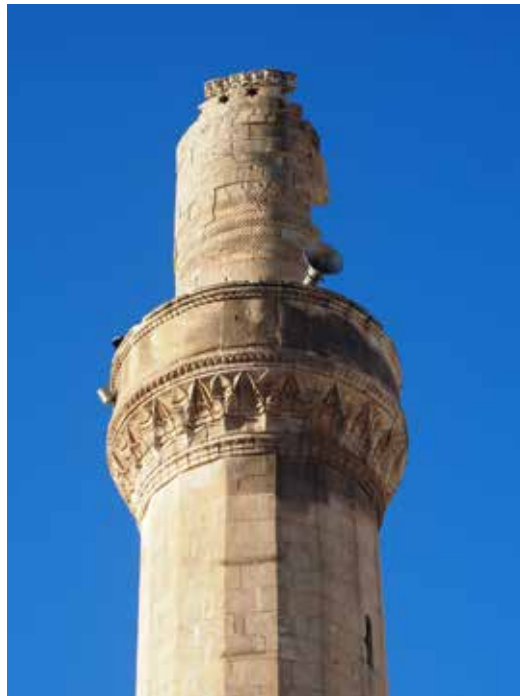
View 2.3 Ulu Mosque after the earthquake

The biggest earthquake damage is in its minaret. A substantial part of its section above the balcony up to the alem (finial piece) collapsed and fell to the courtyard, damaging some sections of the main building. One of the mosque's inscription plates mentions a similar collapse of the minaret in the 1824 earthquake and a subsequent restoration.²

III
Unstable / Heavy Damage
Moderate structural or heavy non-structural damage on minaret.

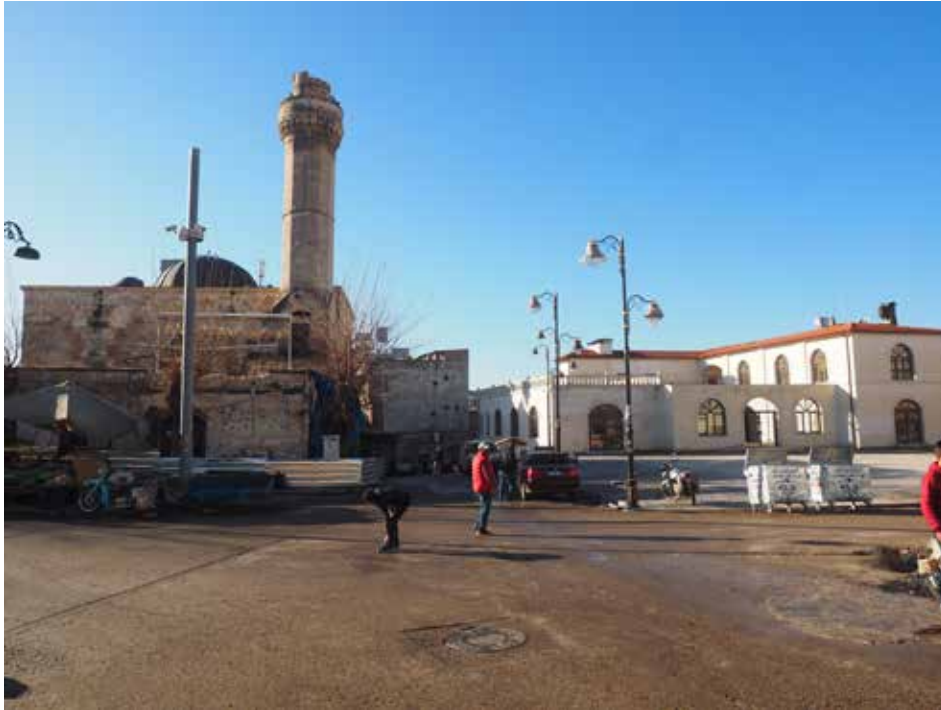
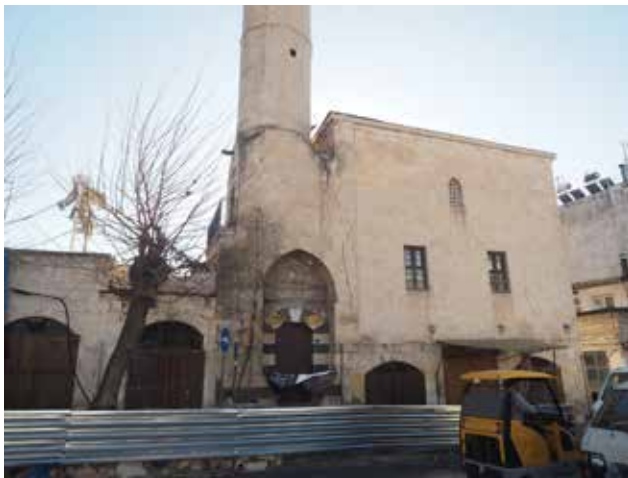
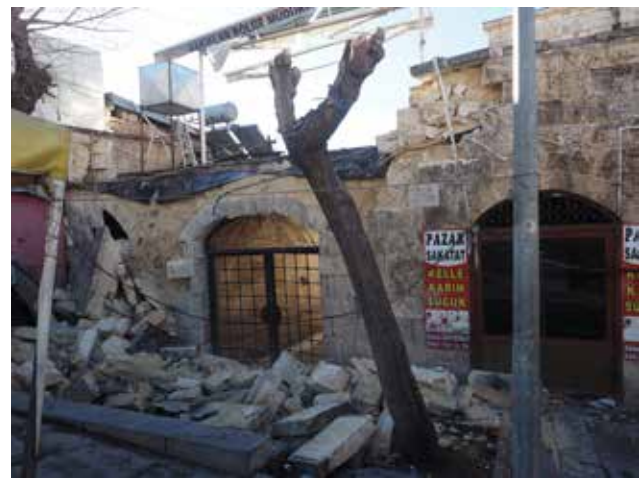
View 2.4 Muallak Mosque after the earthquake

The earthquake caused damage in the mosque. As in the many others, its minaret was damaged above its balcony up to the alem (top ornament). The wall surface renderings at the shops' entrance floor, the staircase leading to the mosque and the railings of the courtyard in the upper floor were broken under the shocks. Furthermore, cracks are visible at the vaults' junctures in the corners of the mihrab wall and the west wall.

III
Unstable / Heavy Damage
Moderate structural or heavy non-structural damage on minaret.
