REPORT

ON THE DAMAGE CAUSED BY
THE FEBRUARY 2023 KAHRAMANMARAŞ EARTHQUAKE
ON ISLAMIC CULTURAL HERITAGE IN TÜRKİYE

Prepared by

Alidost Ertuğrul
Taha Zahid Özdemir
Hussein Al Ragabi

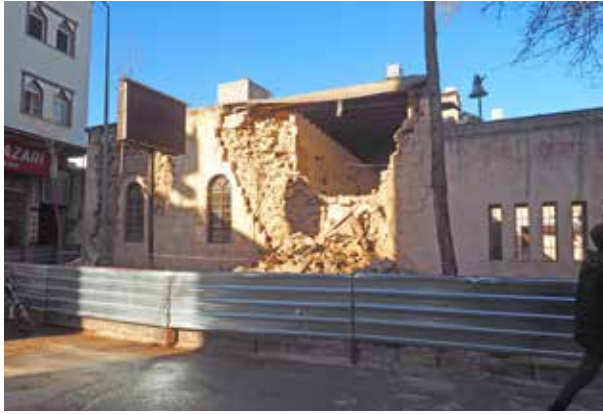
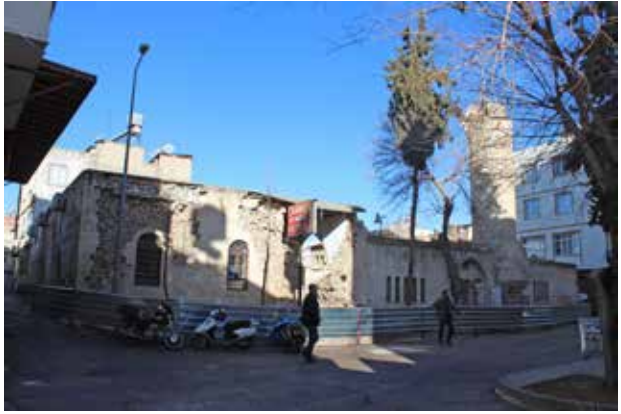
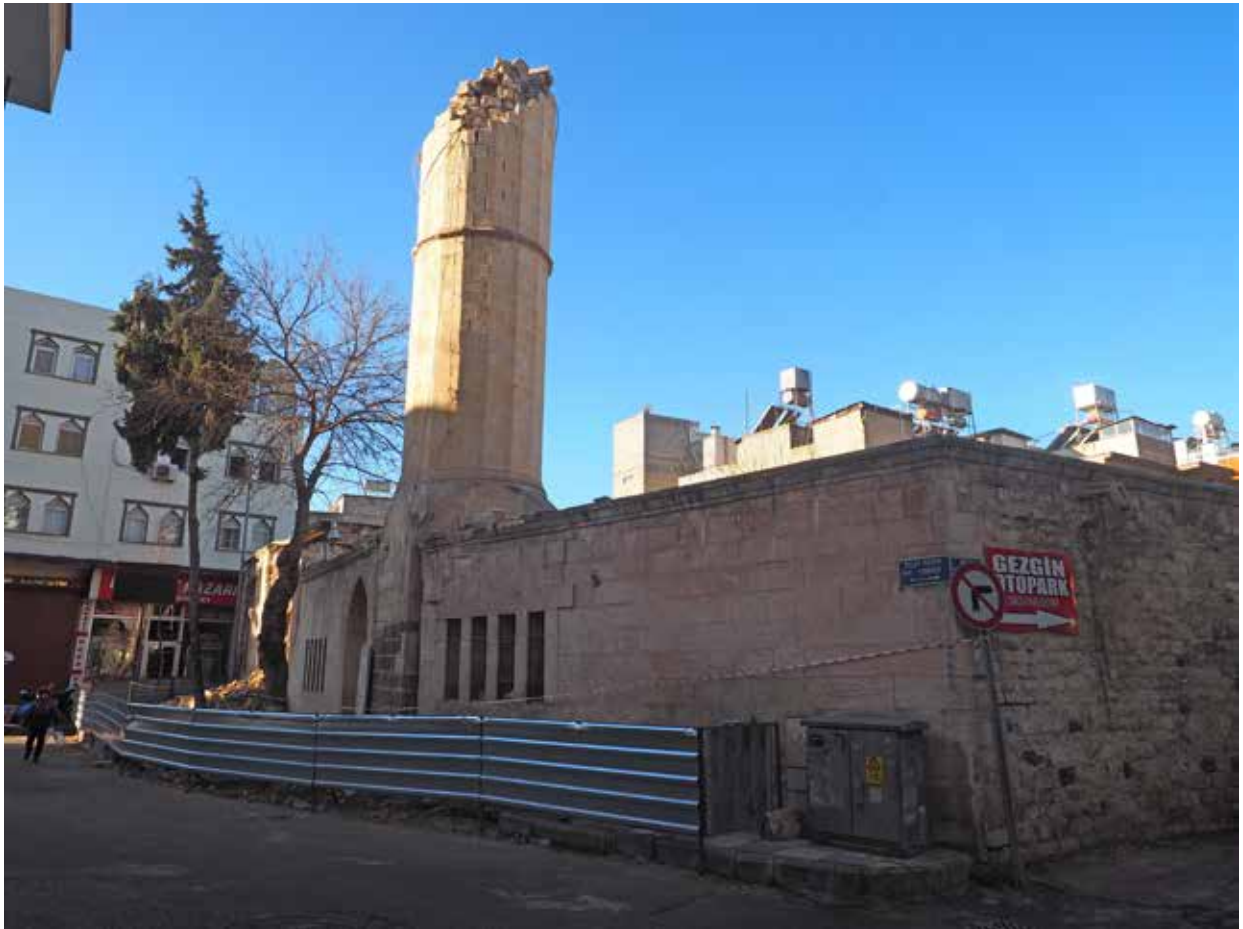
View 2.5 Tabakhane Mosque after the earthquake

Tabakhane Mosque is one of the most heavily damaged buildings visited in Kilis. The top part of its minaret collapsed, including its balcony. Its eastern, street-side wall disintegrated, some of its sections break away. All the walls carry displacements and losses of pieces due to the weight of the reinforced concrete covering which seems to have been added during one of the restorations.

III
Unstable / Heavy Damage
Moderate structural or heavy non-structural damage on minaret and main building.

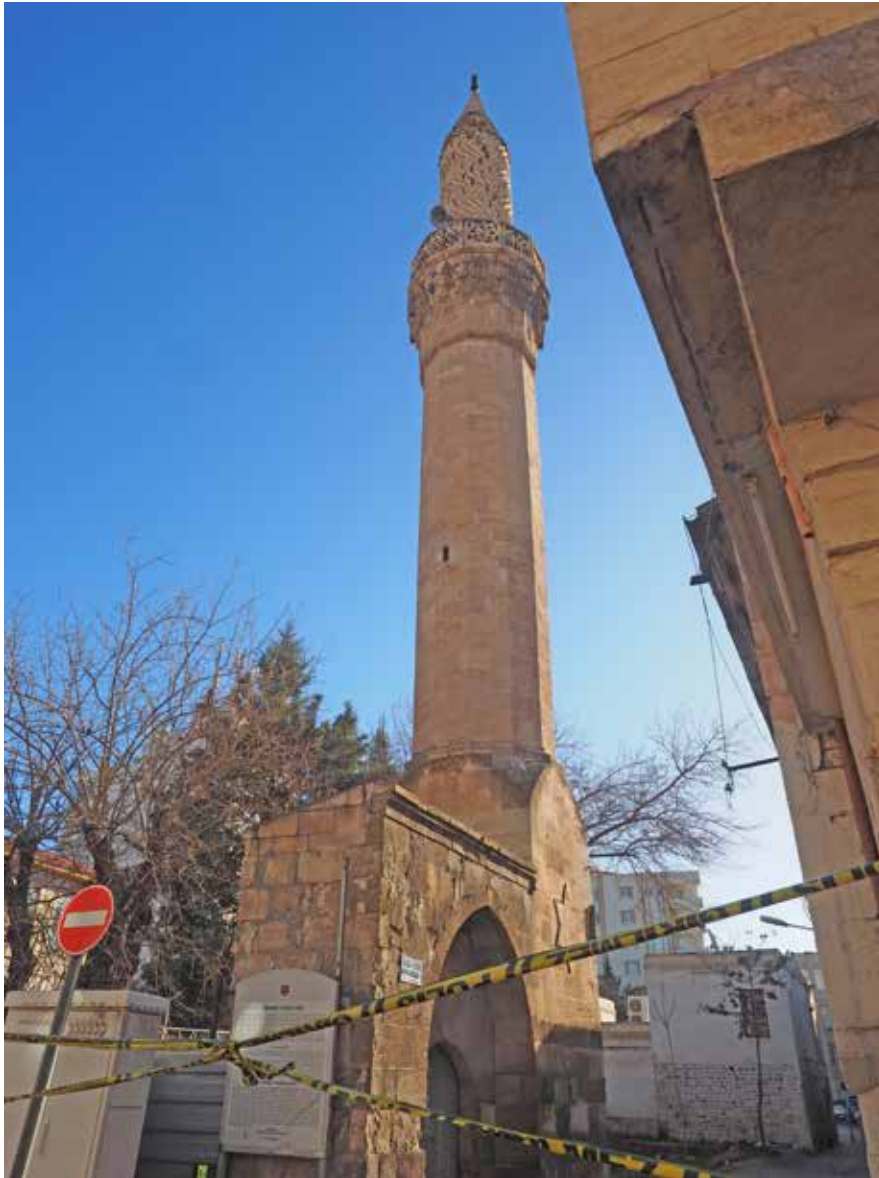
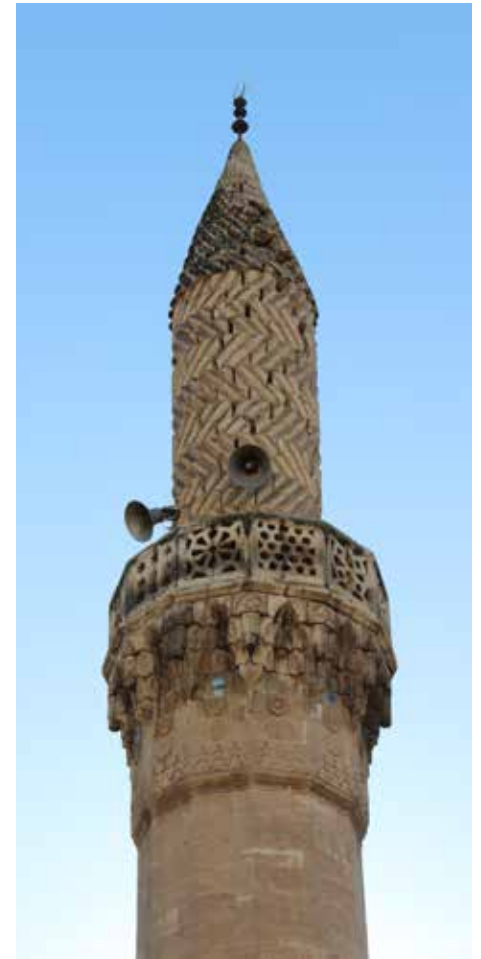
View 2.6 Öksüz Minaret after the earthquake

The earthquake caused breaks and displacements in the zigzag pattern of the stone wall texture of the minaret above its balcony and this section threatens to collapse. The railings of the balcony are also broken. The entire minaret might collapse under an eventual future shock.

III
Unstable / Heavy Damage
Moderate structural or heavy non-structural damage on minaret.

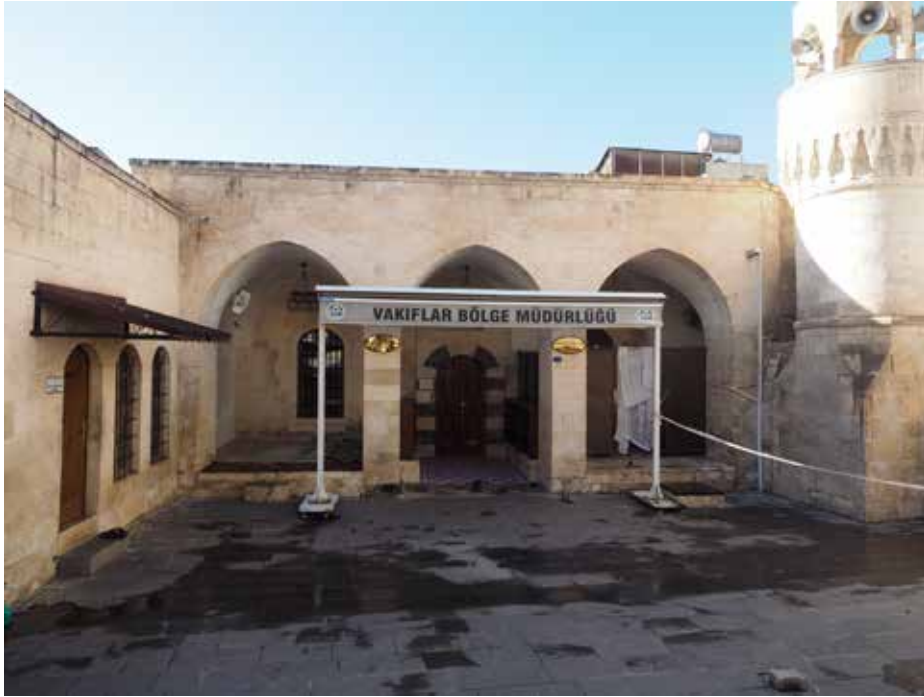
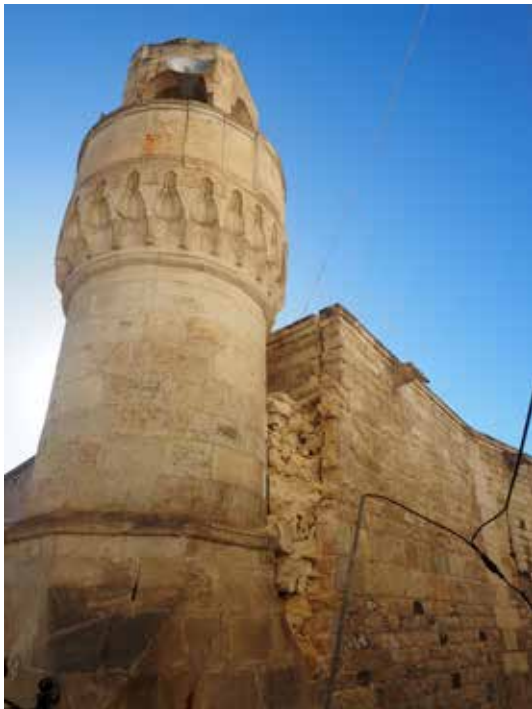
View 2.8 Hacı Derviş Mosque
after the earthquake

It was observed that the earthquake caused displacements in the stone arched structures above the minaret balcony and the alem (finial piece). Some parts of the wall between the minaret and the last comers' prayer area were broken. The wall between this area and the western wall has also disintegrated and this whole section threatens to collapse.

II
Stable / Moderate Damage
Local structural and non-structural damages but could be considered as generally stable. Damage on the minaret and outer domes.

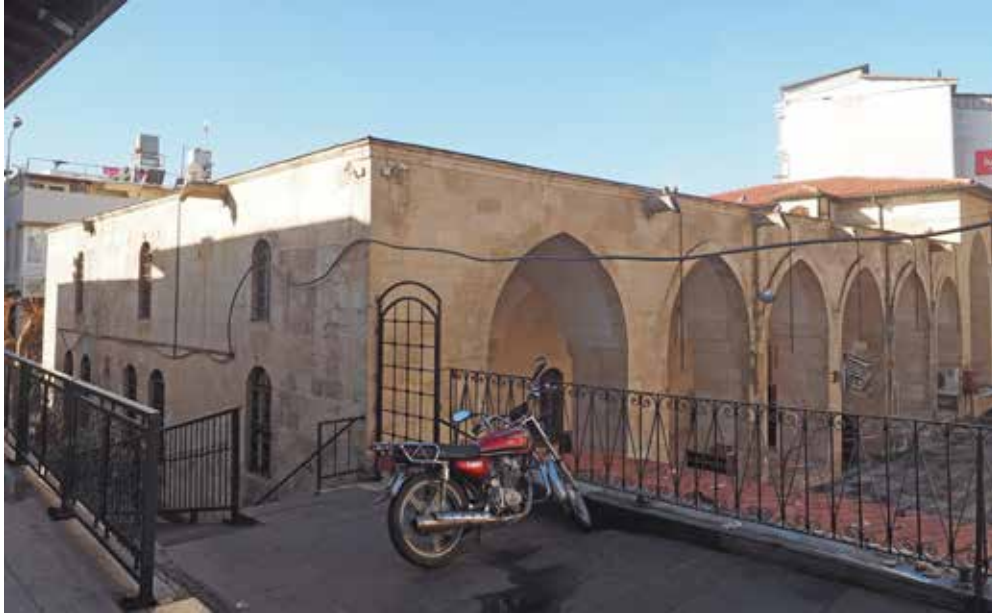
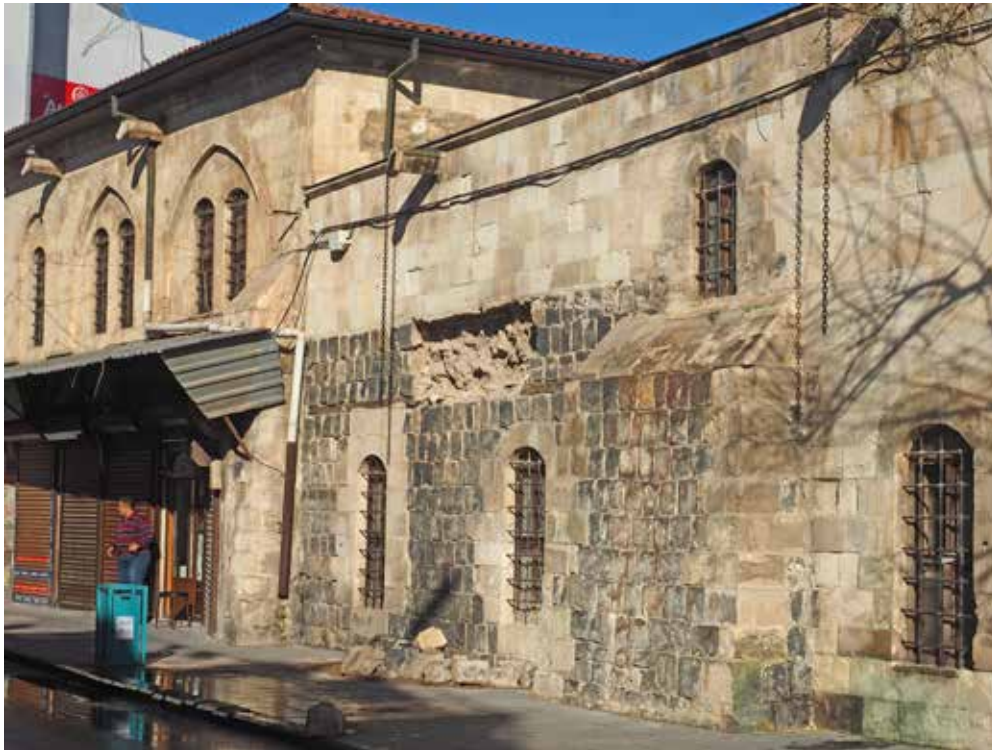
View 2.9 Kara Kadı Mosque after the earthquake

Karakadı Mosque is one of the buildings most severely affected by the earthquake. As entry to the building was not possible, observations were made from outside. The stone fabric of the mihrab wall, understood to have been restored earlier, disintegrated and scattered around the street. No damages were seen, however, in the minaret or the last comers' prayer area.

II
Stable / Moderate Damage
Local structural and non-structural damages Some of the stones have fell on the facade.

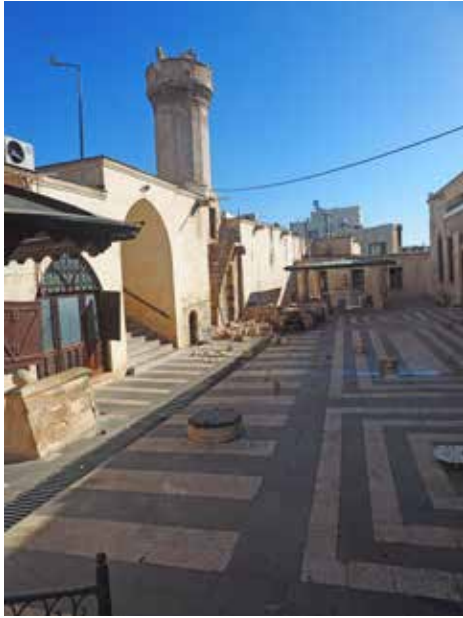
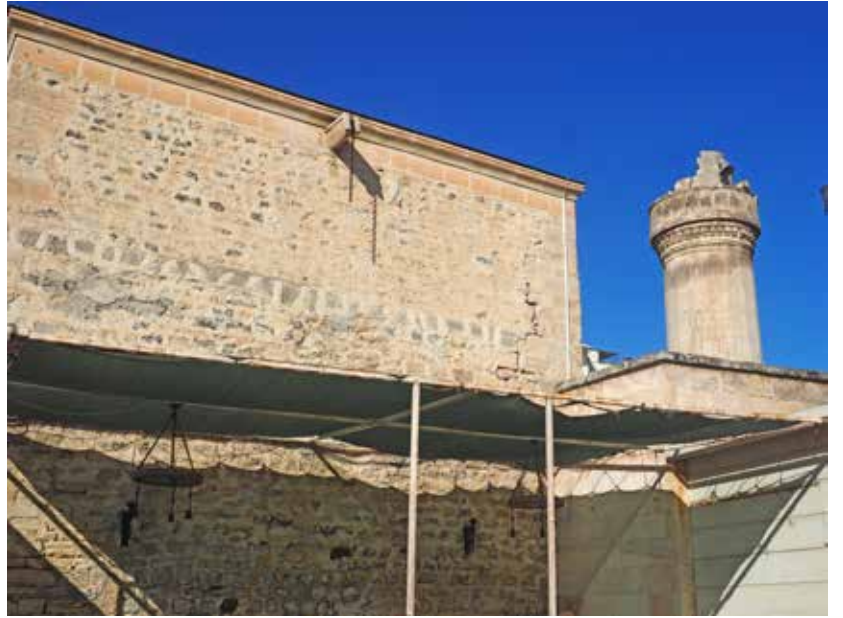
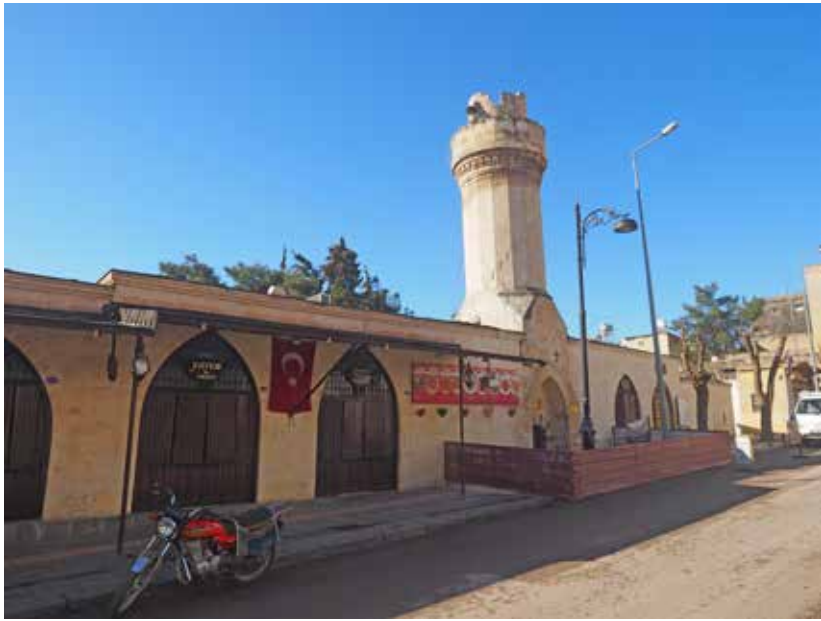
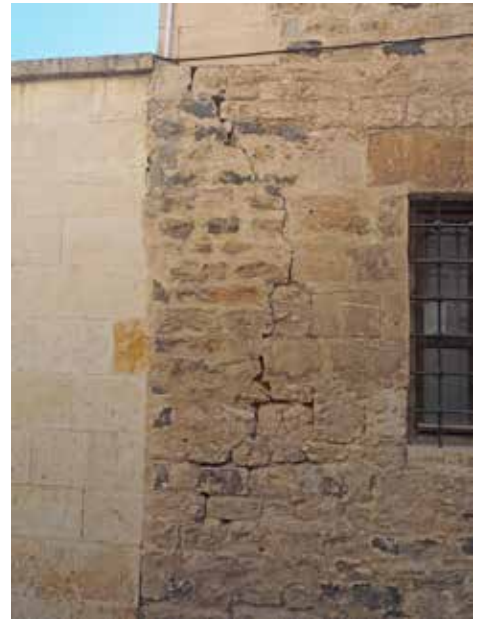
View 2.10 Cüneyne Mosque after the earthquake

The section of the minaret above its balcony broke into pieces, that are scattered around the courtyard and the pathway that leads to the courtyard entrance. There are cracks in the bottom course of the minaret. A deep split occurred in the southeast corner of the prayer hall across the courtyard entrance. No damage is observed in the shops on each side of the courtyard entrance.

III	IV
Unstable/Heavy Damage	Irreversible/Very Heavy Damage
Moderate structural or heavy non-structural damage on main building.	Heavy structural damage on minaret. Collapsed onto entrance courtyard.

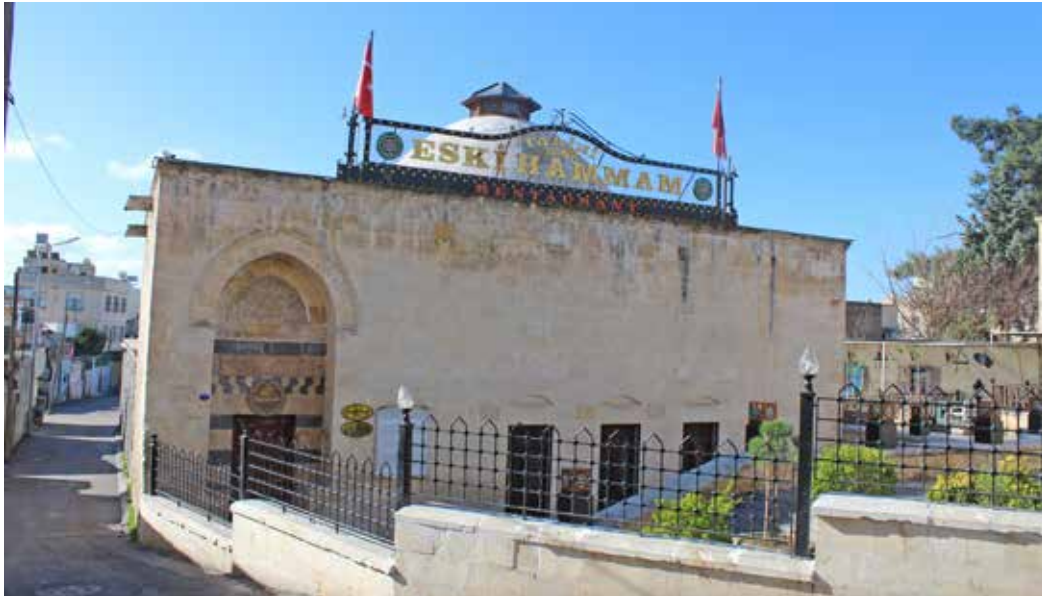
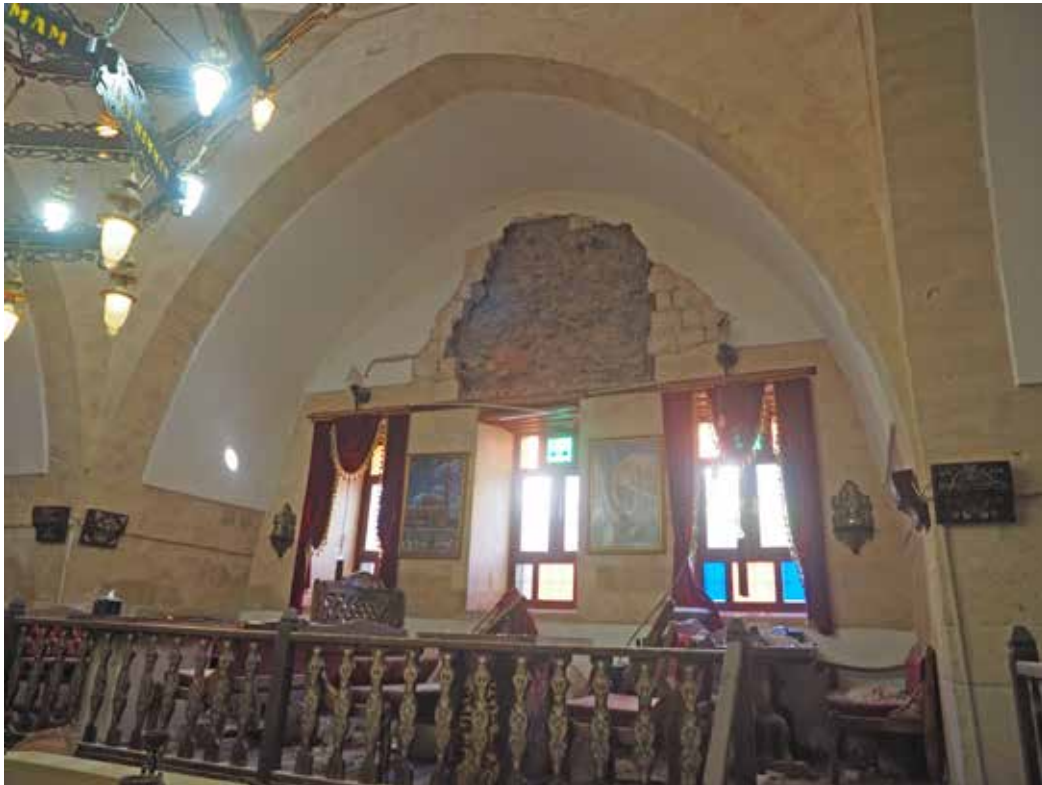
View 2.11 Eski Hamam after the earthquake

The survey of the building showed that the interior wall of the dressing place disintegrated at its core and its pieces fell on the inside floor. No other damage was apparent.

II
Stable / Moderate Damage
Local structural and non-structural damages Stones fell from inside walls.

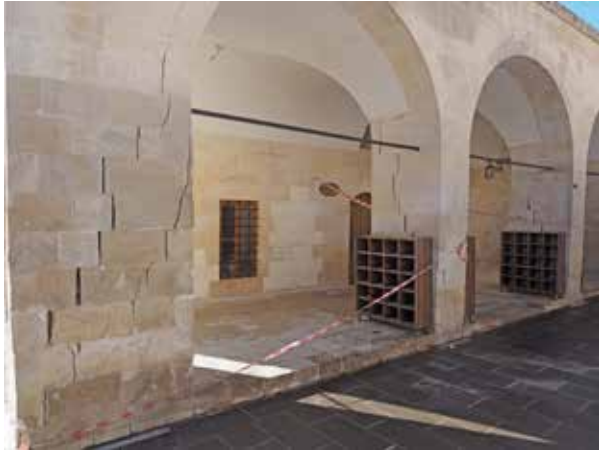
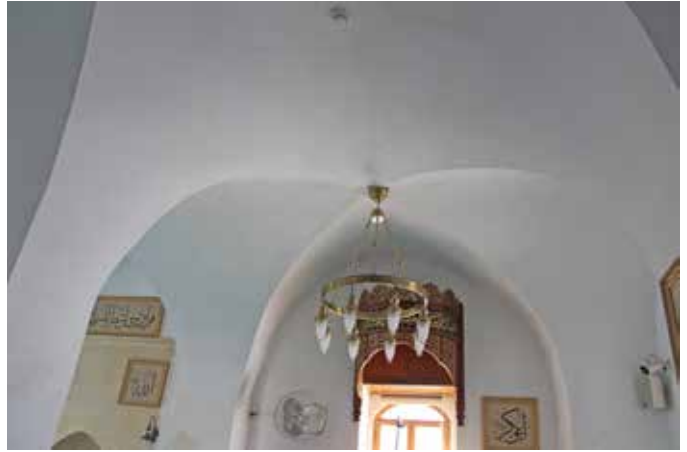
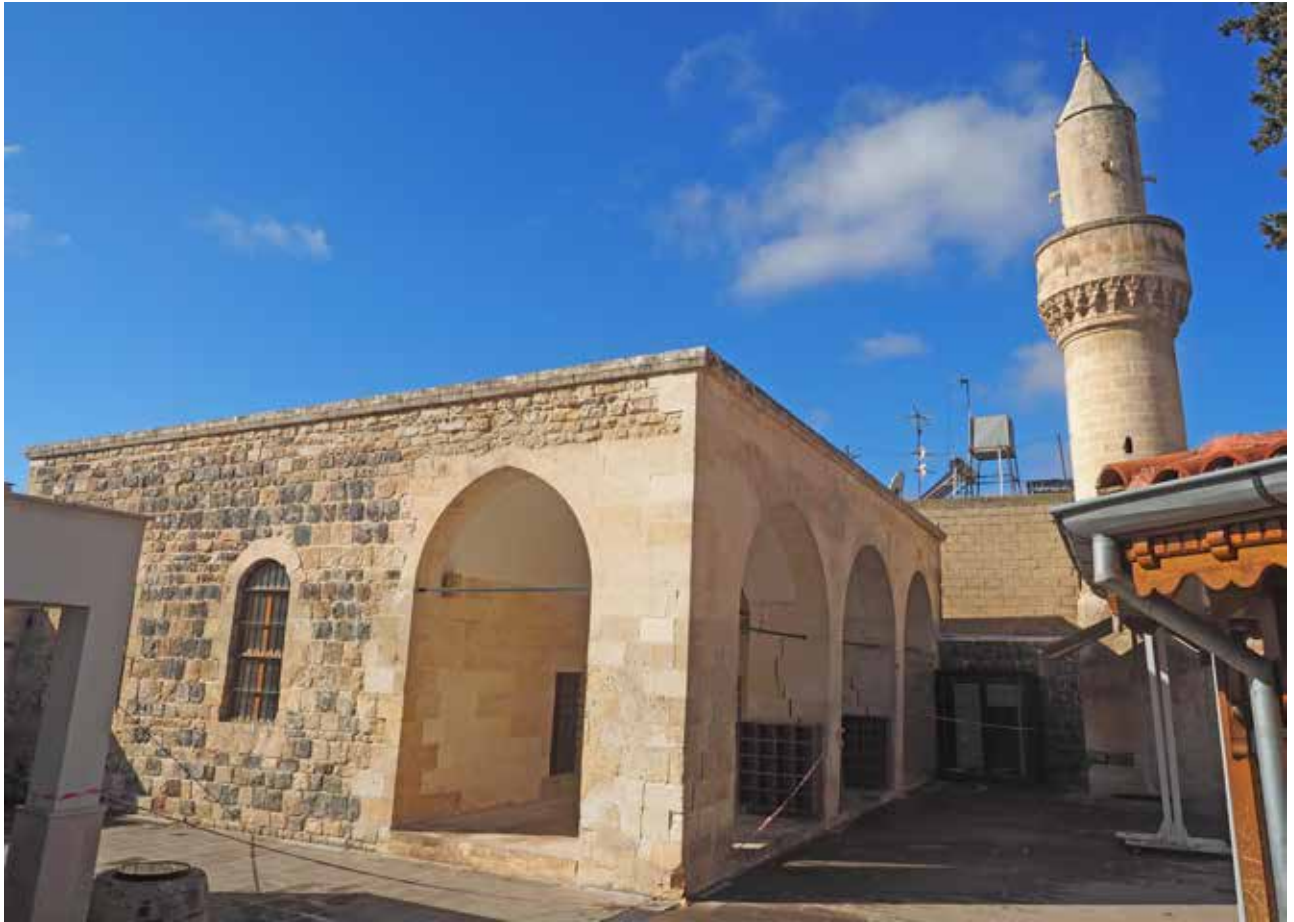
View 2.12 Pirlioğlu Mosque after the earthquake

Shakings during the earthquake distorted the piers that carry the roof, particularly in the last comers' area, causing cracks and breaks in their stone textures. As a result, the top vaults were fractured. The vault in front of the mihrab wall has a plaster crack; its depth has to be measured. Seen from outside, the minaret survived the earthquake. Unrelated to the earthquake, the mosque's interior wall plasters and paints are swollen due to humidity caused by the rising level of water at its foundations. Ground-level drainage is needed to control this problem.

II
Stable / Moderate Damage
Local structural and non-structural damages.

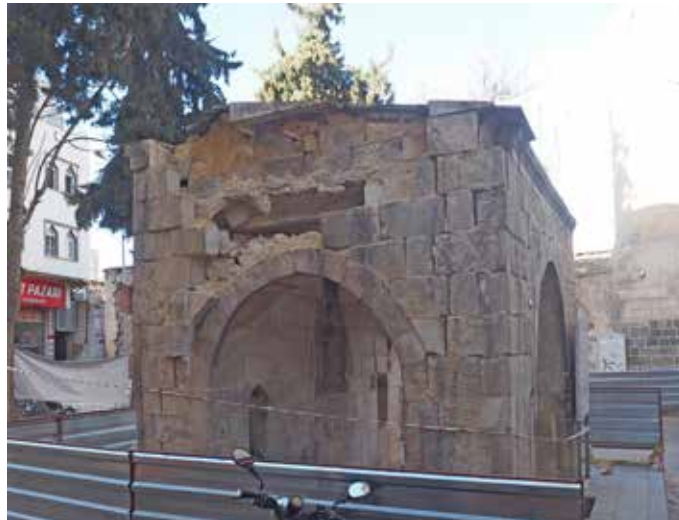
View 2.13 Salih Ağa Fountain after the earthquake

III
Unstable / Heavy Damage
Moderate structural or heavy non-structural damage on main building.

Salih Ağa Fountain's southern and western, infilled and cladded walls have collapsed in the earthquake. The lack of binding mortar between the sheathing sone structures and the inside fillings might have contributed to the destruction

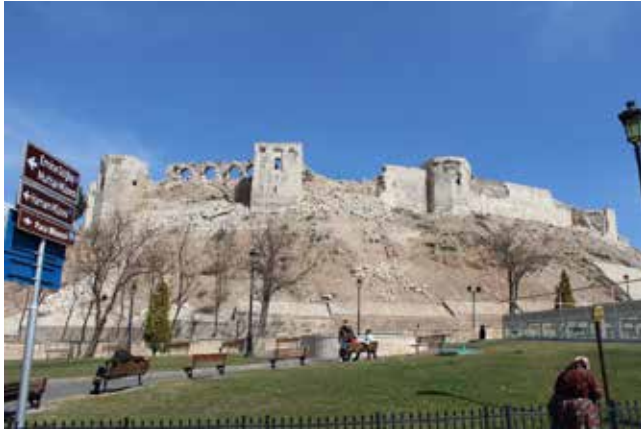
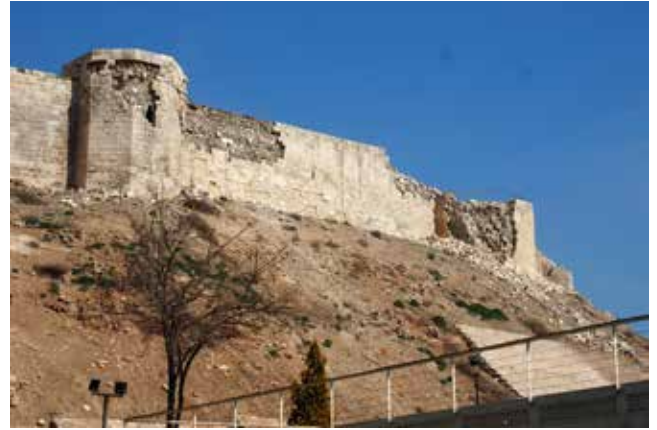
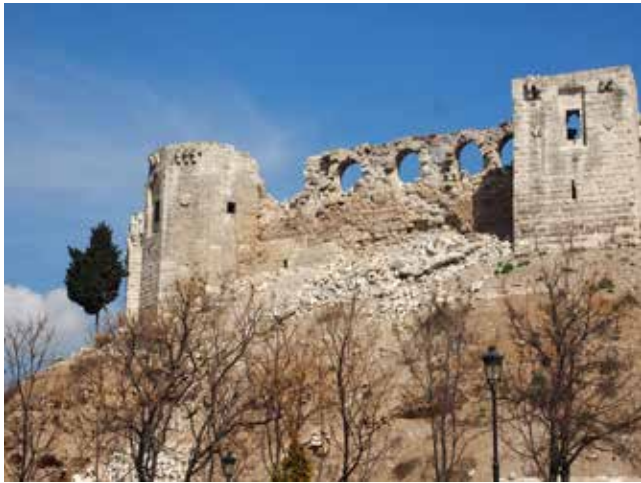
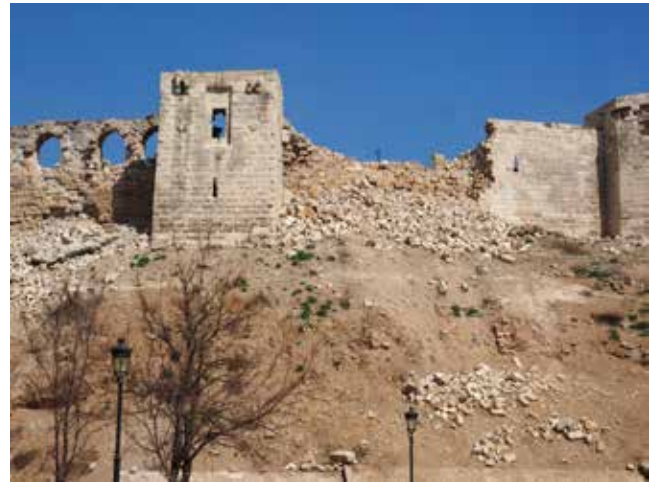
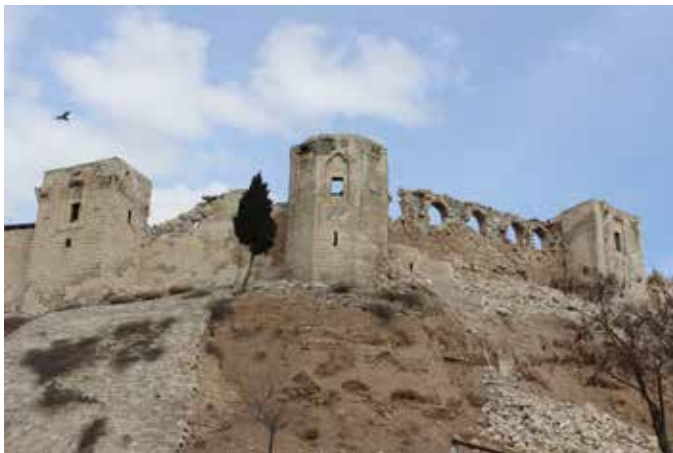
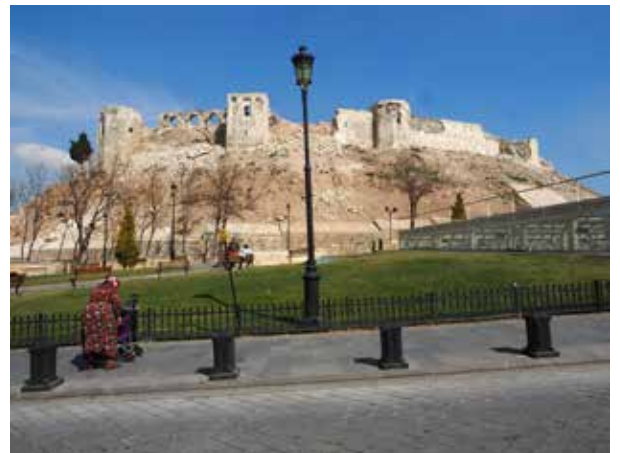
View 3.3 Gaziantep Citadel after the earthquake

III
Unstable / Heavy Damage
Moderate structural or heavy non-structural damage on main building.

During the examination of the historical Gaziantep Citadel, it was seen that the walls, the exterior walls in particular, had disintegrated due to structural deterioration of the wall cores and/or failure of later restorations to bind outer surface renderings with the cores. Stones broke off the citadel's walls, leaving large cavities. The citadel's load-bearing support walls also have cracks.

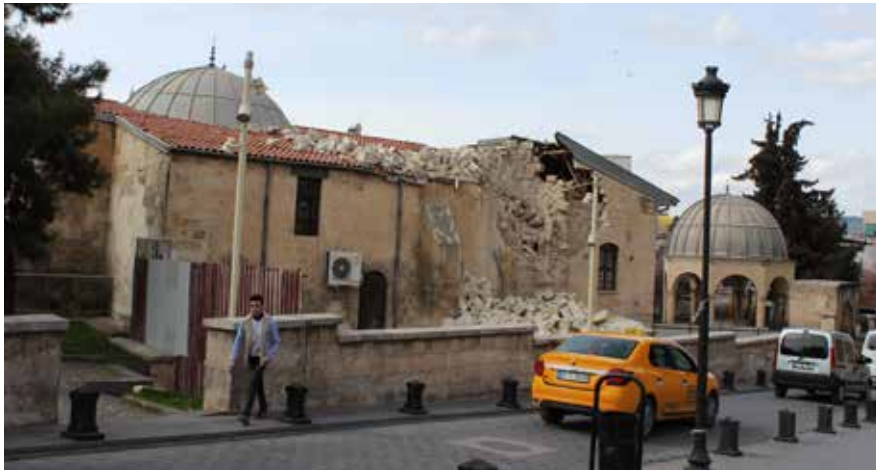
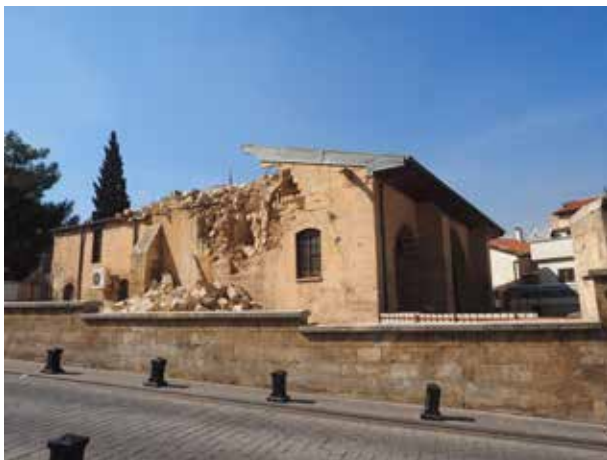
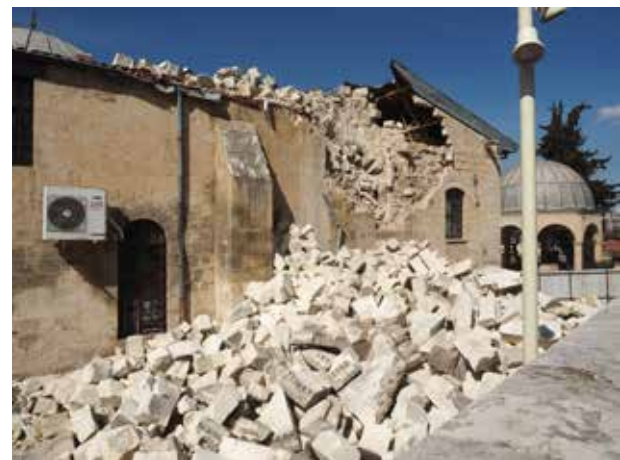
View 3.5 Şirvani Mosque after the earthquake

Minarets are historical mosques' parts most vulnerable to earthquakes. Şirvani Mosque's minaret rebuilt in 1947 was destroyed in the earthquake down to the level of the prayer hall wall. In its collapse, the minaret fell onto the mosque's roof covered with curved tiles and to the ground. This caused partial damages in the roof and the main walls. No observations could be gathered inside since the building could not be entered.

III	IV
Unstable/Heavy Damage	Irreversible/Very Heavy Damage
Moderate structural damage on main building.	Heavy structural damage on minaret. Collapsed onto roof of the main building.

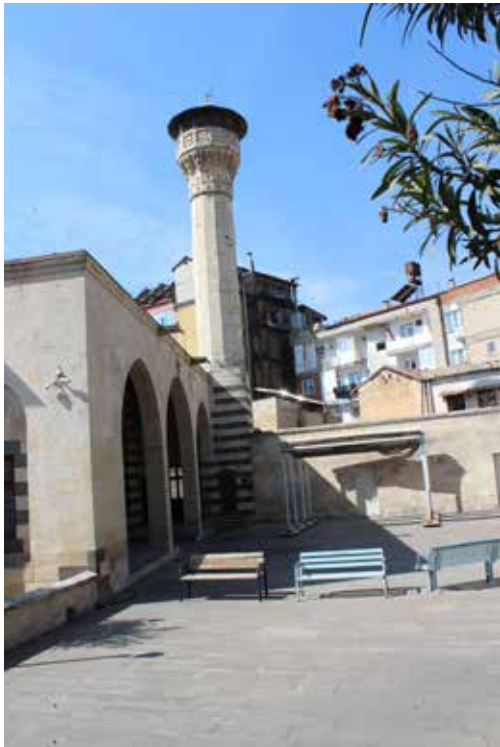
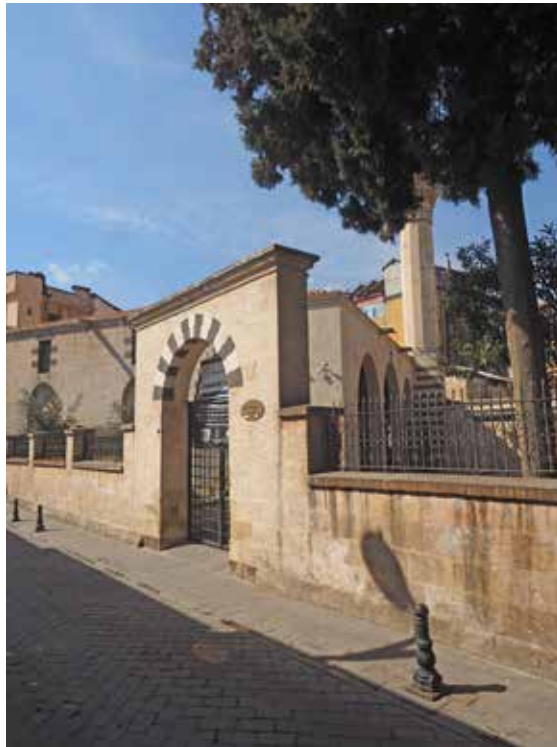
View 3.7 Handanbey Mosque after the earthquake

Handanbey Mosque was lightly damaged in the earthquake. The most apparent damage is in its minaret, which has fractures and threatens to crumble.

II
Stable / Moderate Damage
Although there are local and non-local damages in the main structure, the minaret risks to collapse.

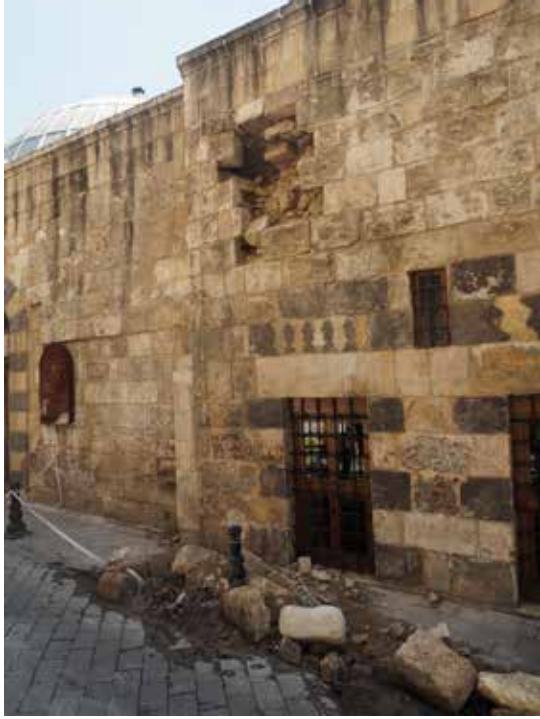
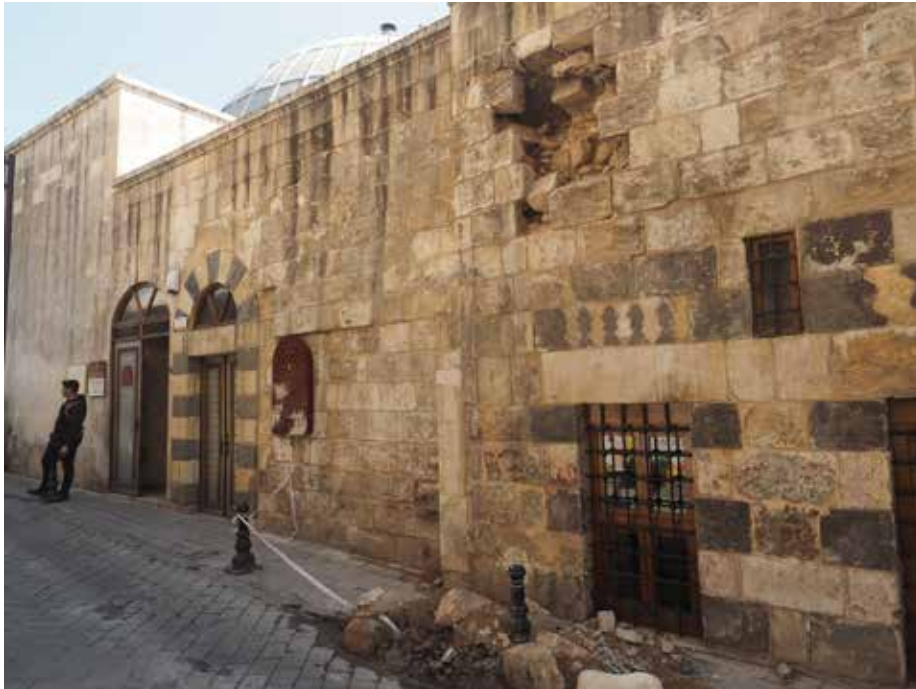
View 3.8 Lala Mustafa Paşa Bath after the earthquake

During the earthquake, the wall of its dressing place broke into parts and its stones fell out. The collapse must be due to the deterioration of the mortar bindings between the outside surface and the inner core of the wall.

II
Stable / Moderate Damage
Local structural and non-structural damages.

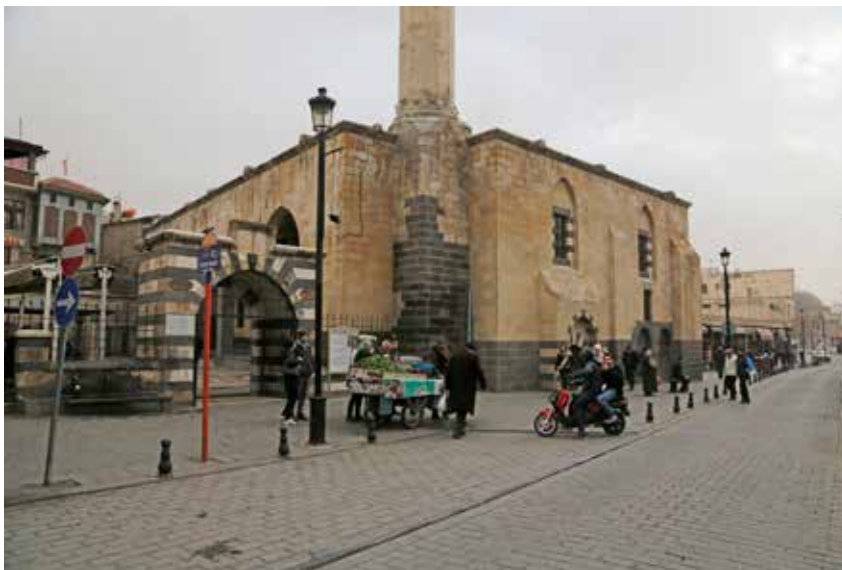
View 3.10 Tahtani Mosque after the earthquake

Its minaret and its internal wall plastering have fractures. It can be considered as lightly damaged.

I
Superficial / Slight Damage
Negligible damage. Some of the features such as plaster fell down; minor cracks.

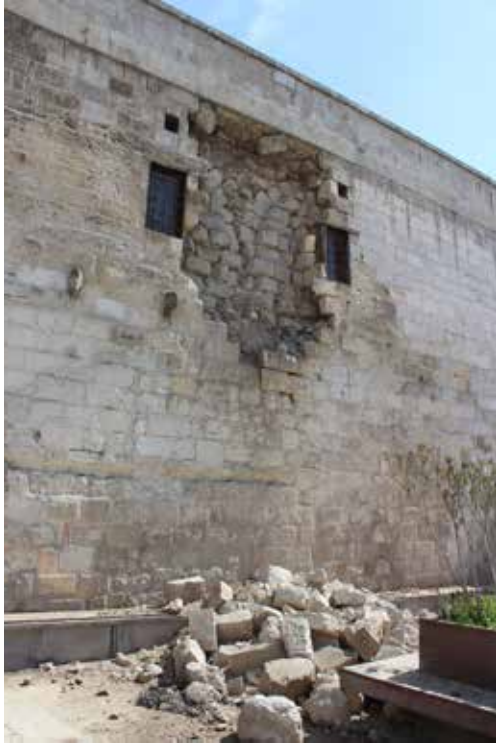
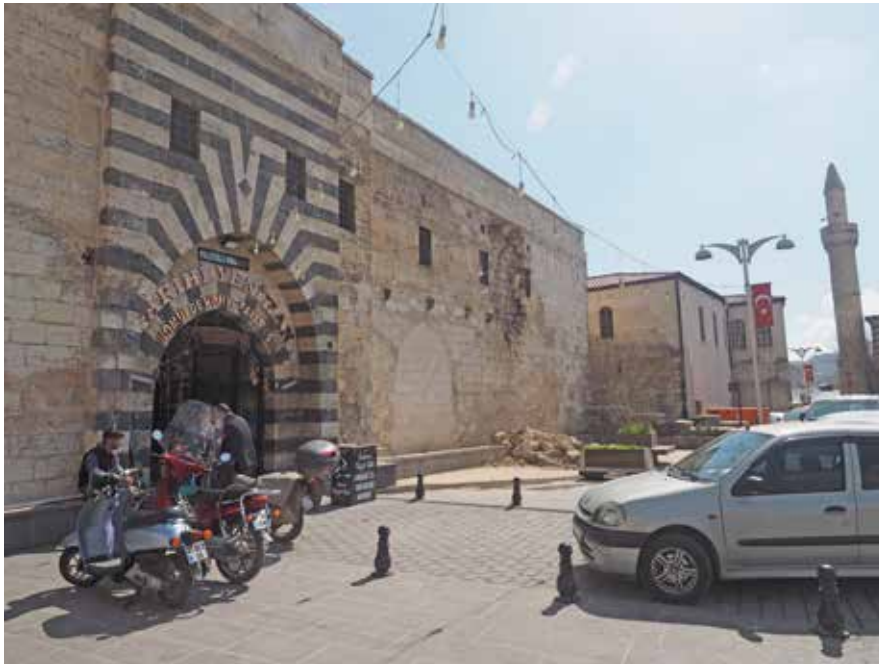
View 3.11 Yenihan after the earthquake

There was no noticeable damage inside the mosque. However, seen from outside, the outer wall of the entrance facade broke off at the second floor due to the separation of the inner and outer wall structures, and part of the outer layering fell out to the street. This disintegration must have been caused by the deterioration of binding materials. Though no serious problem appears at first sight, a statics analysis would be needed to measure the effects of the earthquake.

II
Stable / Moderate Damage
Local structural and non-structural damages.

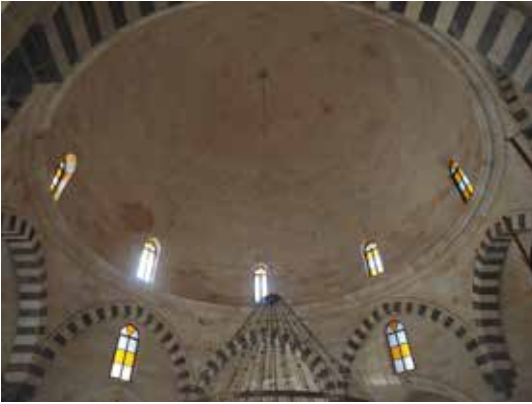
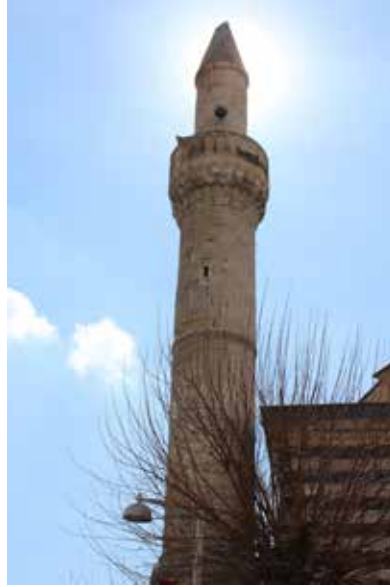
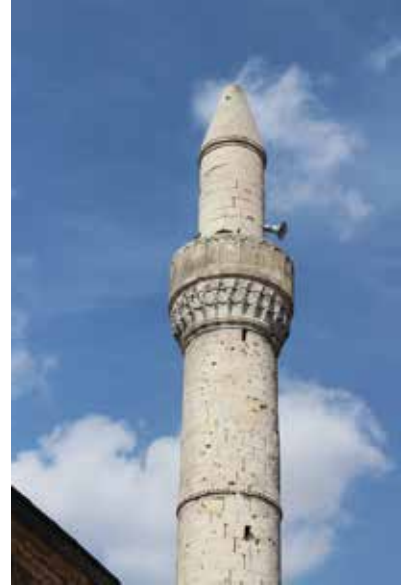
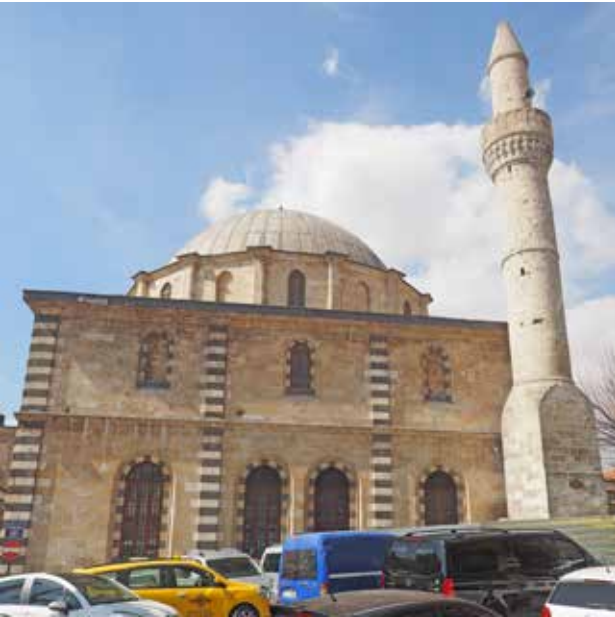
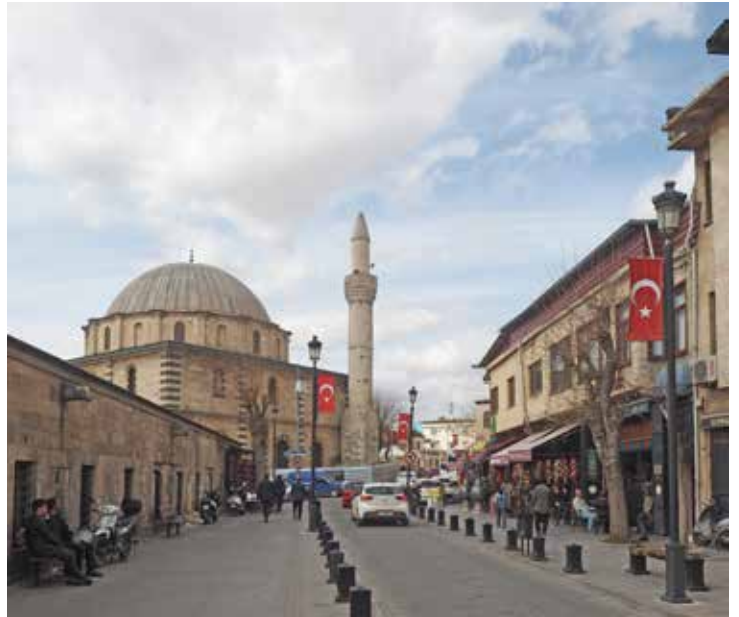
View 3.13 Alaüddevle Mosque after the earthquake

It is one of the largely damaged important monuments in the Gaziantep city center. The minaret threatens to collapse due to the disintegration of its stone structure; it has to be entirely undone and rebuilt. Its stone dome has cracks which have to be examined by experts to determine the most appropriate reinforcement methods.

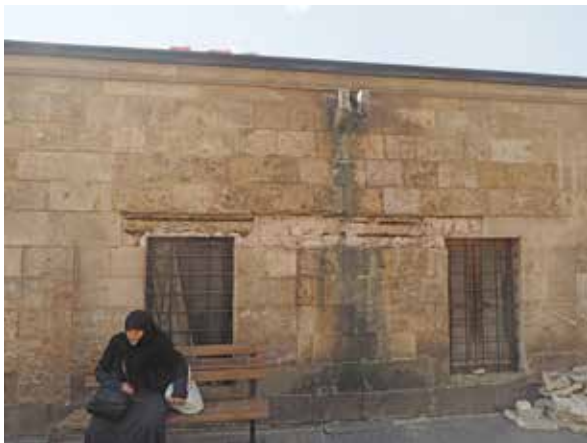
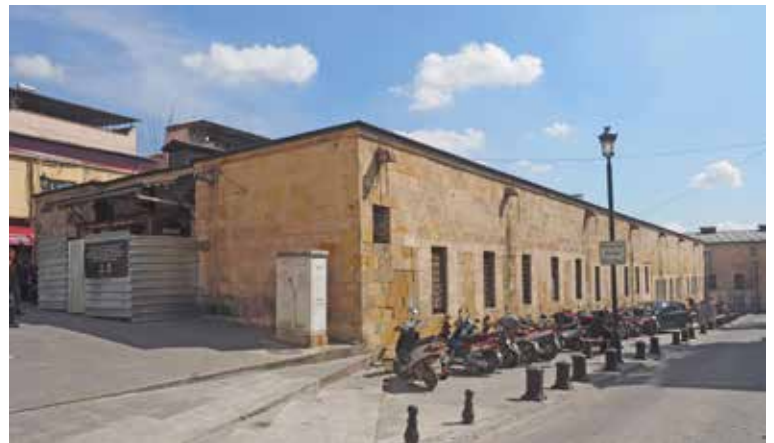
View 3.15 Zincirli Bedesten after the earthquake

Zincirli Bedesten could not be visited, preventing any evaluation of its interior state. It was observed from outside that stone beams had fallen off the outer walls since they were not embedded but fastened as surface coverings.

I
Superficial / Slight Damage
Negligible damage. Some of the features such as plaster fell down; minor cracks.

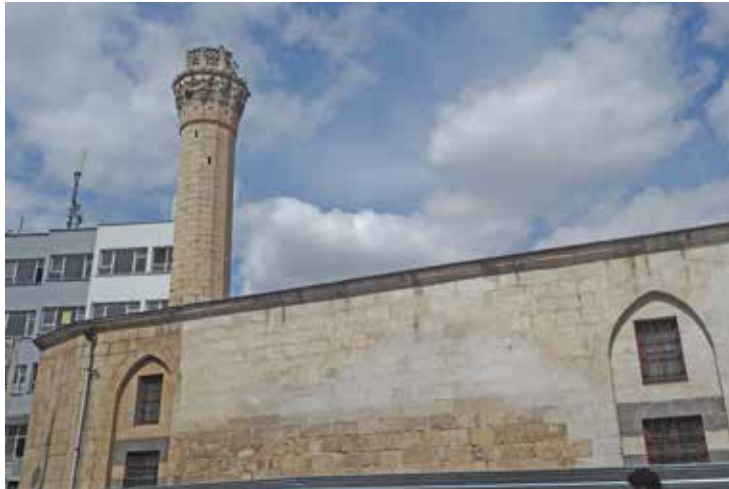
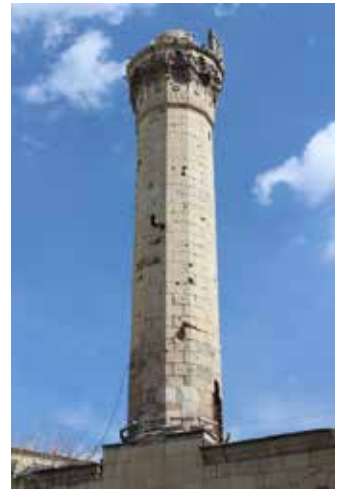
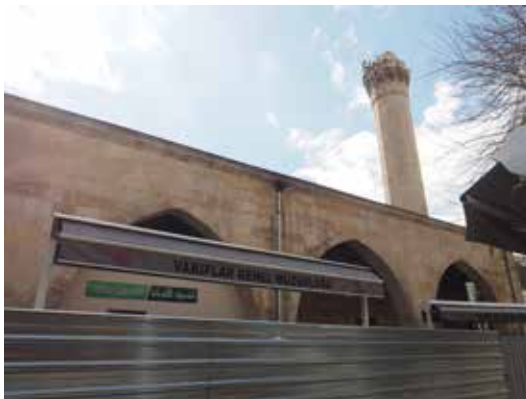
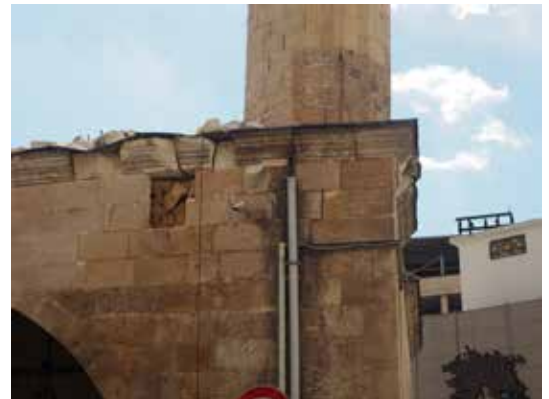
View 3.17 Karagöz Mosque after the earthquake

The minaret, which was renovated at the beginning of the 20th century, lost its part above the balcony level. The remaining bottom part is also threatened by destruction due to the visible disintegration of its stone structures. Pieces falling off the balcony hit and damaged the mosque roof; stones detached from the minaret walls fractured the outer walls of the last comers' area on the entrance side. It was heard there were cracks also inside the mosque, which could not be visited.

III	IV
Unstable/Heavy Damage	Irreversible/Very Heavy Damage
Moderate structural damage on main building.	Heavy structural damage on minaret. Collapsed onto roof of the main building.
