REPORT

ON THE DAMAGE CAUSED BY
THE FEBRUARY 2023 KAHRAMANMARAŞ EARTHQUAKE
ON ISLAMIC CULTURAL HERITAGE IN TÜRKİYE

Prepared by

Alidost Ertuğrul
Taha Zahid Özdemir
Hussein Al Ragabi

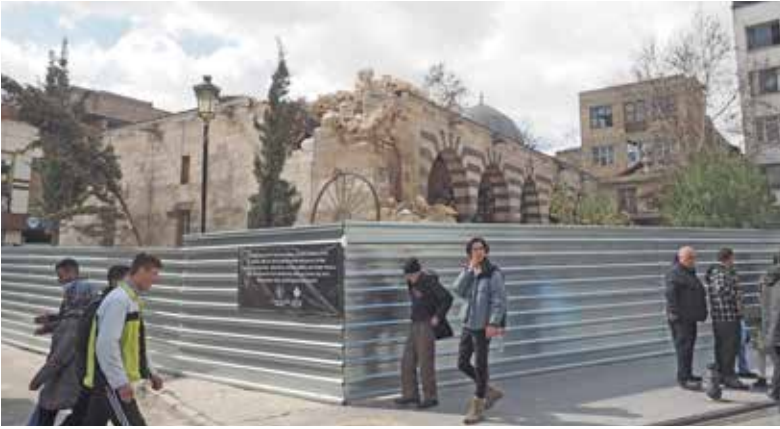
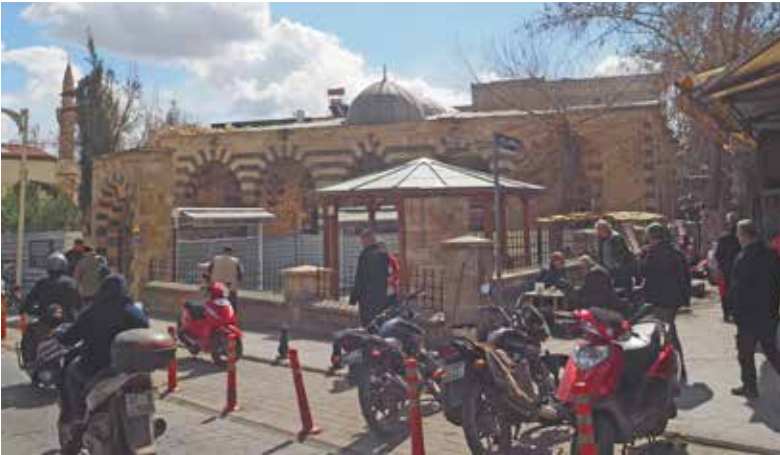
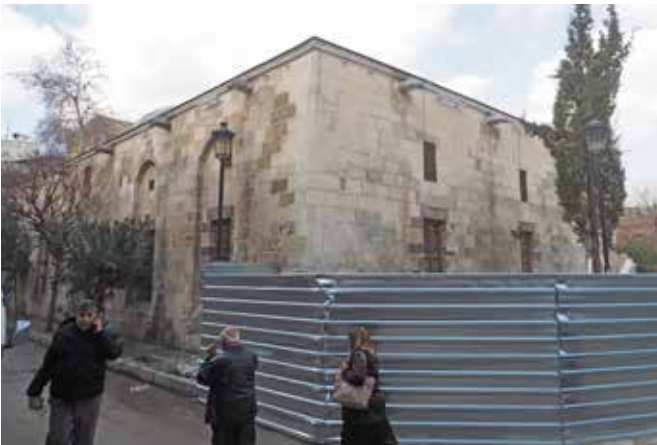
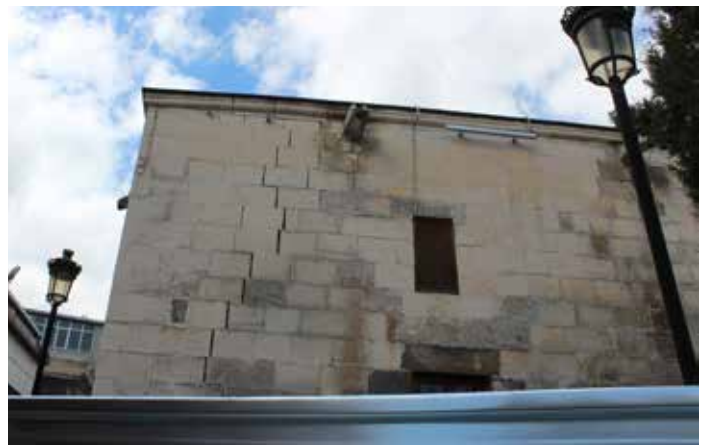
View 3.19 Karatarla Mosque after the earthquake

Karatarla Mosque's minaret collapsed from its top down to pulpit level, falling towards the roof of the last comers' prayer place. The falling stones damaged the said section, along with the minaret's surroundings, the top covering of the mosque and its western corner. The shocks also caused cracks and breaks occurred in the walls of the mihrab and along the western wall.

III	IV
Unstable/Heavy Damage	Irreversible/Very Heavy Damage
Moderate structural damage on main building.	Heavy structural damage on minaret. Collapsed onto roof of the main building.

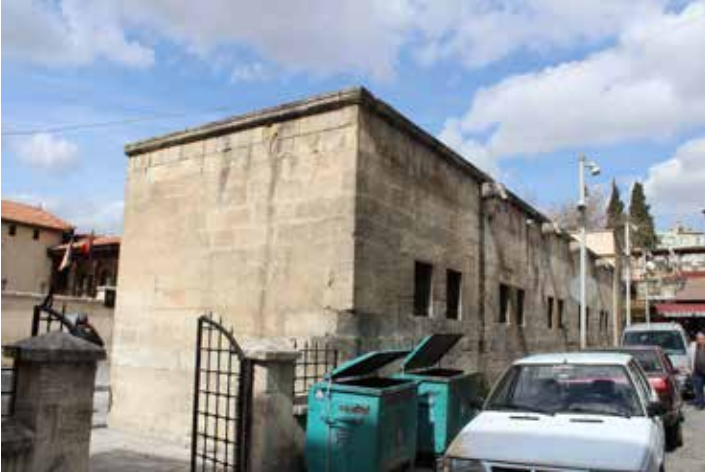
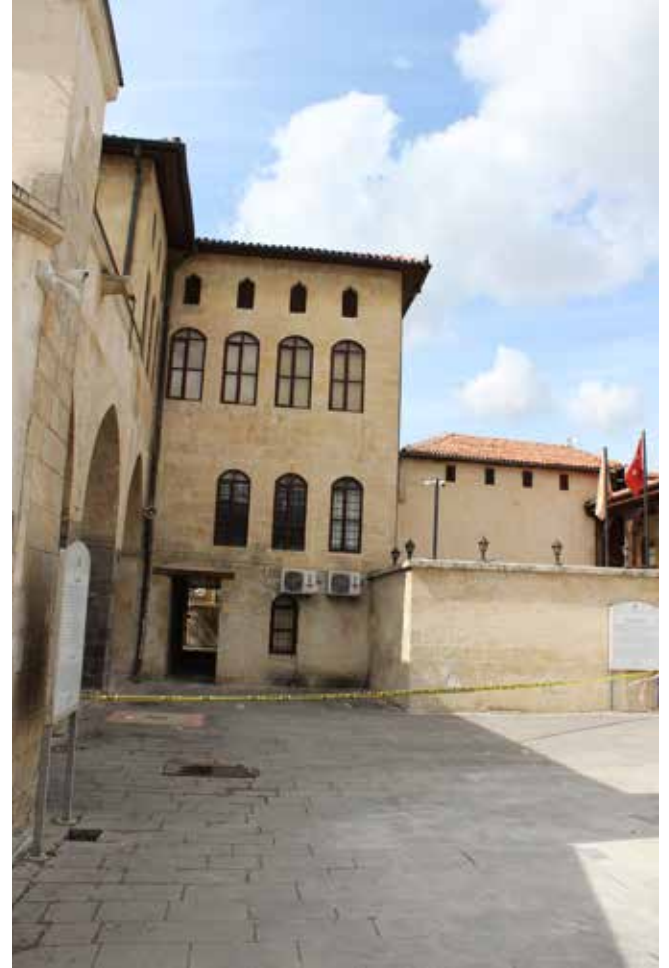
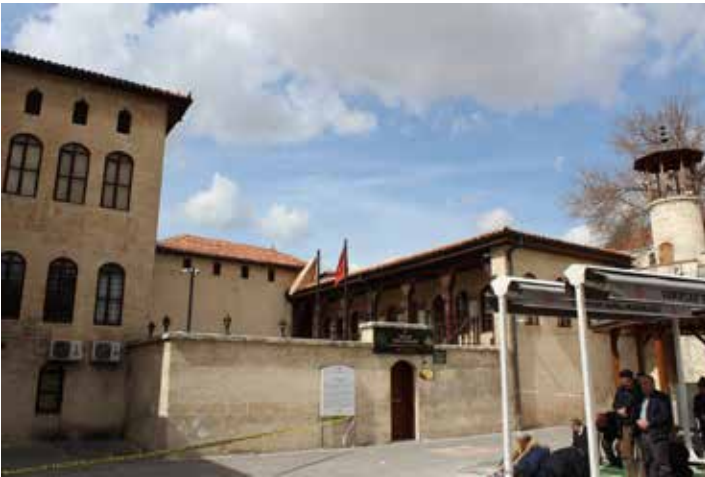
View 3.20 Gaziantep Mevlevihanesi after the earthquake

The Waqf Museum section has cracks and breaks in its walls. The degree of the damage can be described as medium.

II
Stable / Moderate Damage
Local structural and non-structural damages.

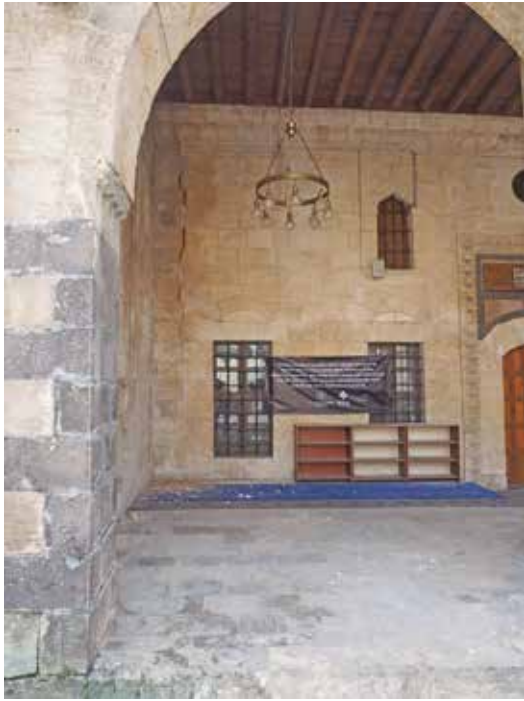
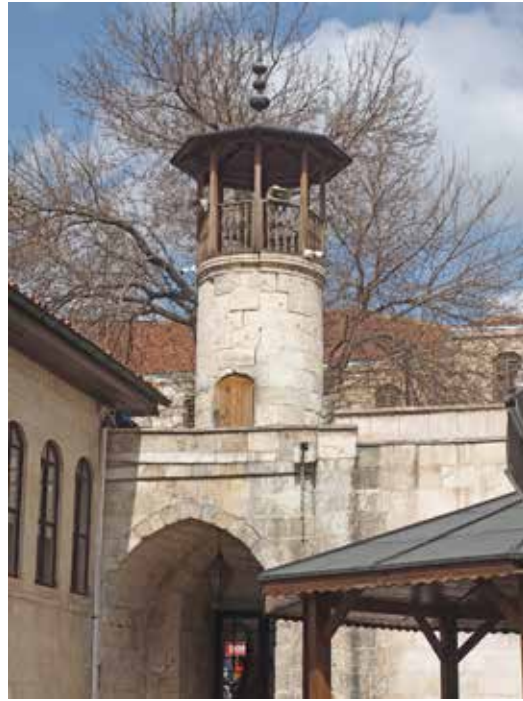
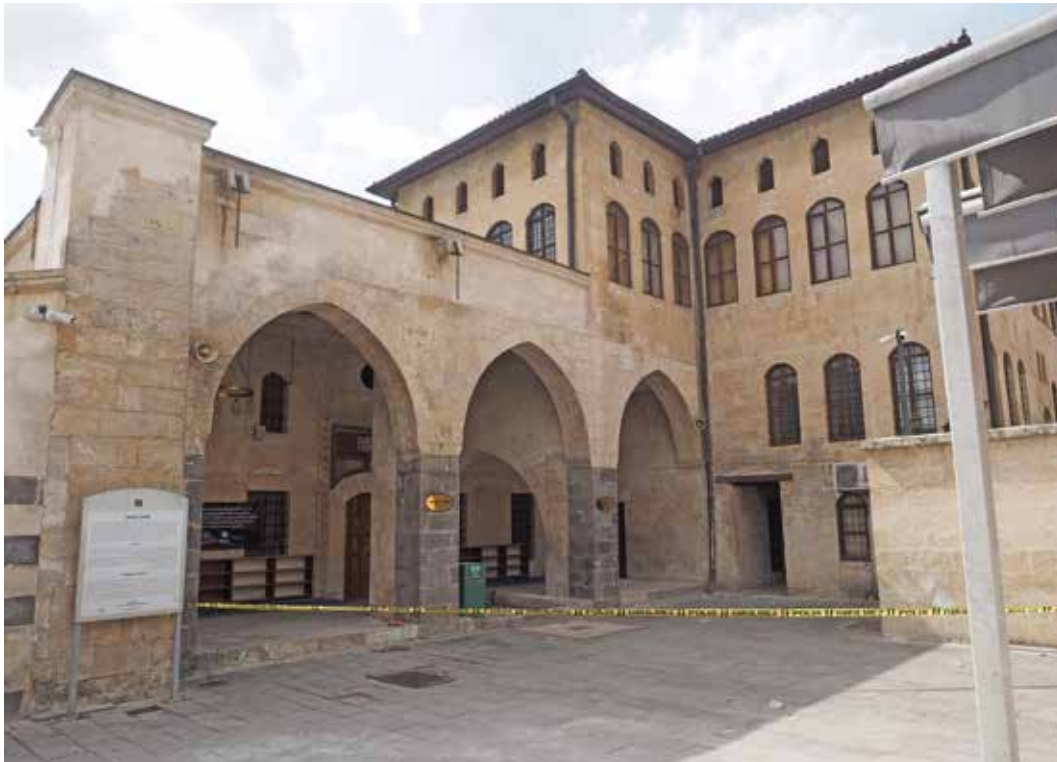
View 3.21 Tekke Mosque after the earthquake

The sema hall section which is used as the Tekke Mosque has a minaret that stands on the wall of its courtyard. It is destabilized due to displacement of its stones and threatens to collapse. There are cracks on the walls of the last comers' prayer area. A thorough examination must be made to assess the required interventions.

II
Stable / Moderate Damage
Local structural and non-structural damages.

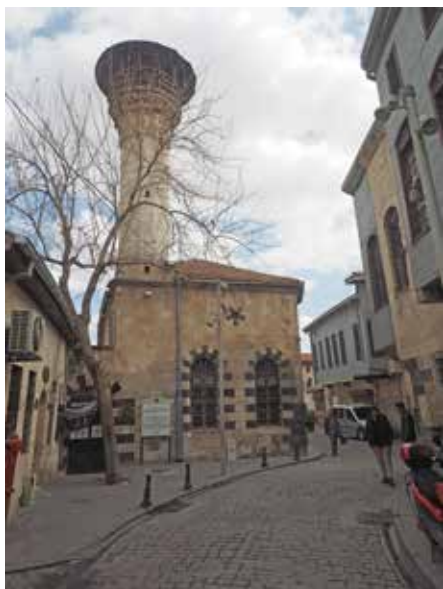
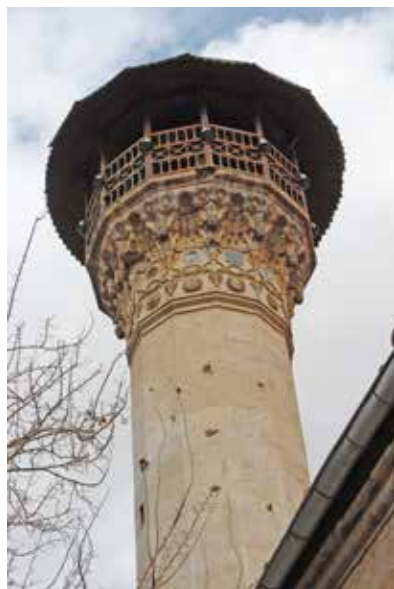
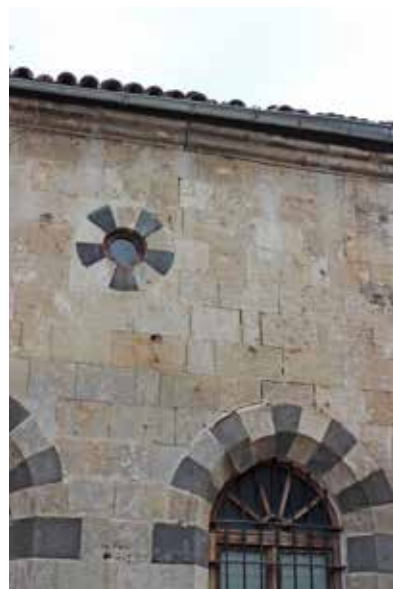
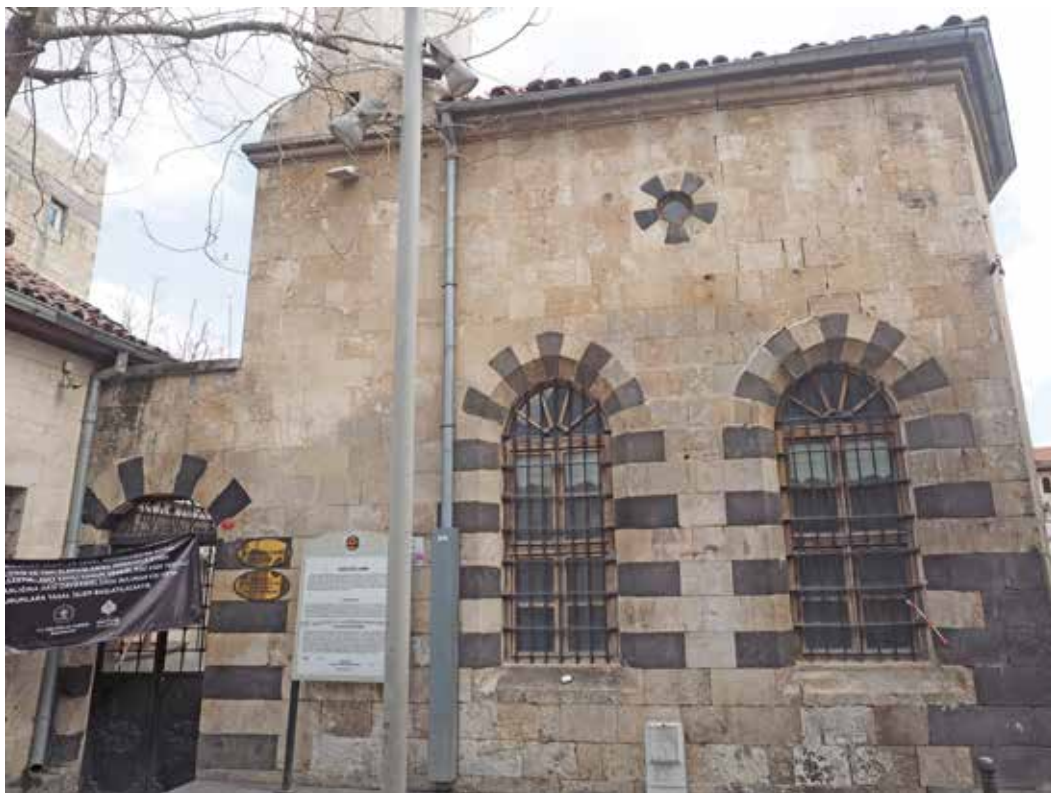
View 3.22 Kozluca Mosque after the earthquake

Unlike others, its minaret was not affected by the seism. The stone wall that carries the mihrab has a crack over its window, which can be described as a light damage. It was not possible for the team to see the interior of the mosque.

I
Superficial / Slight Damage
Negligible damage. Some minor cracks.

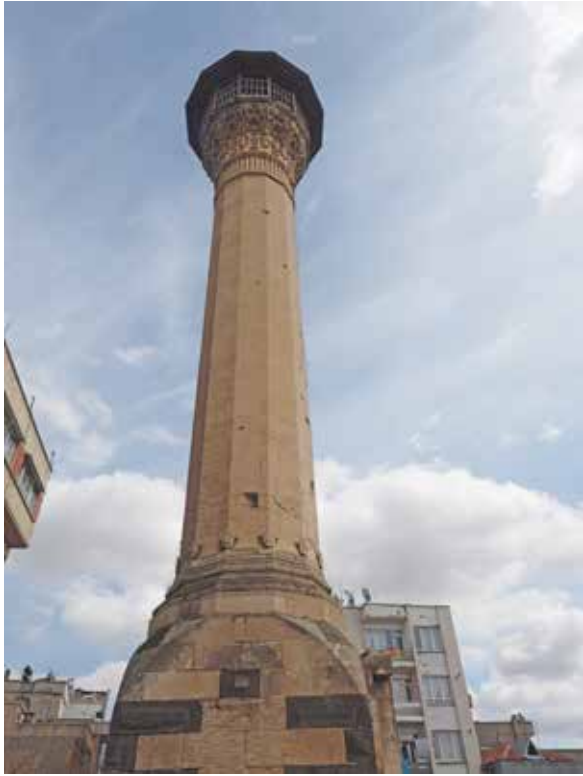
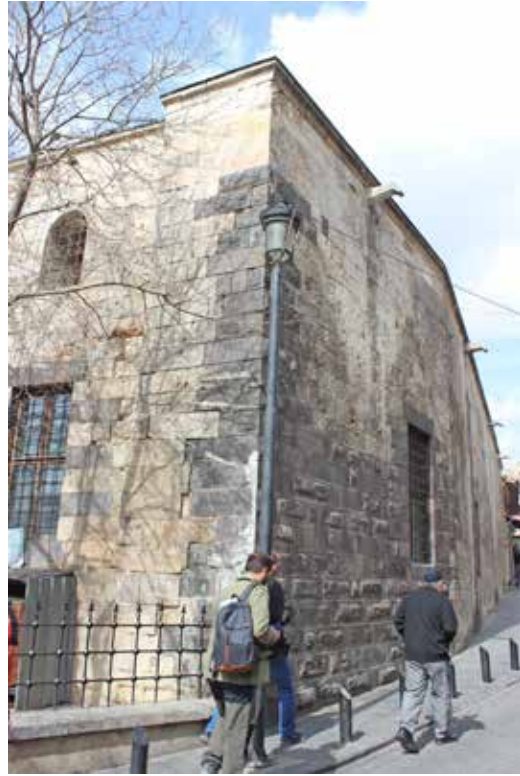
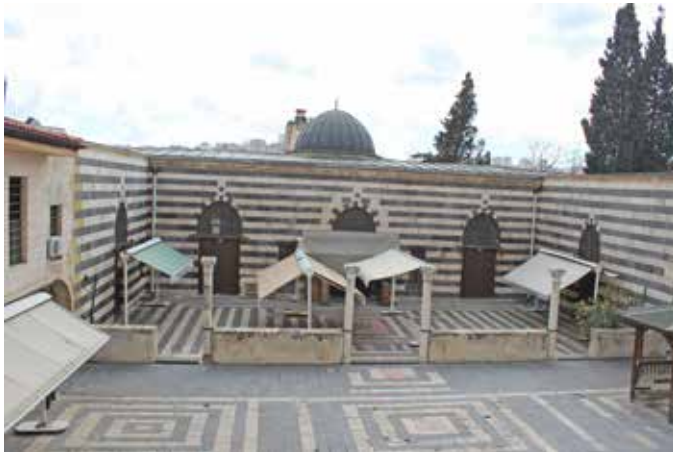
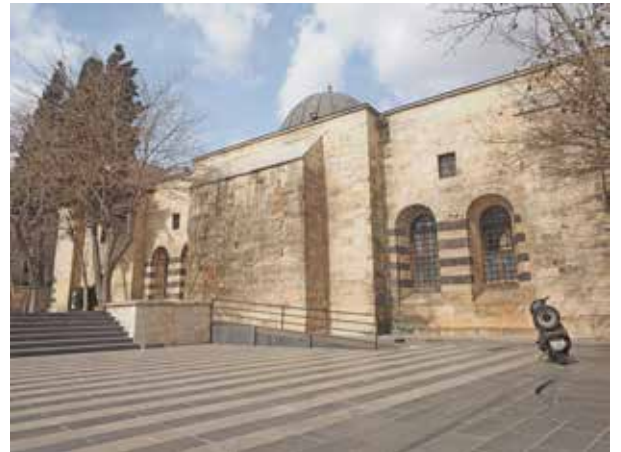
View 3.23 Boyacı Mosque after the earthquake

It was seen that the mihrab wall has a small crack and that the minaret, which is separate from the main building, has swayed slightly and its stone structure has slight cracks.

1
Superficial / Slight Damage
Negligible damage. Some minor cracks.

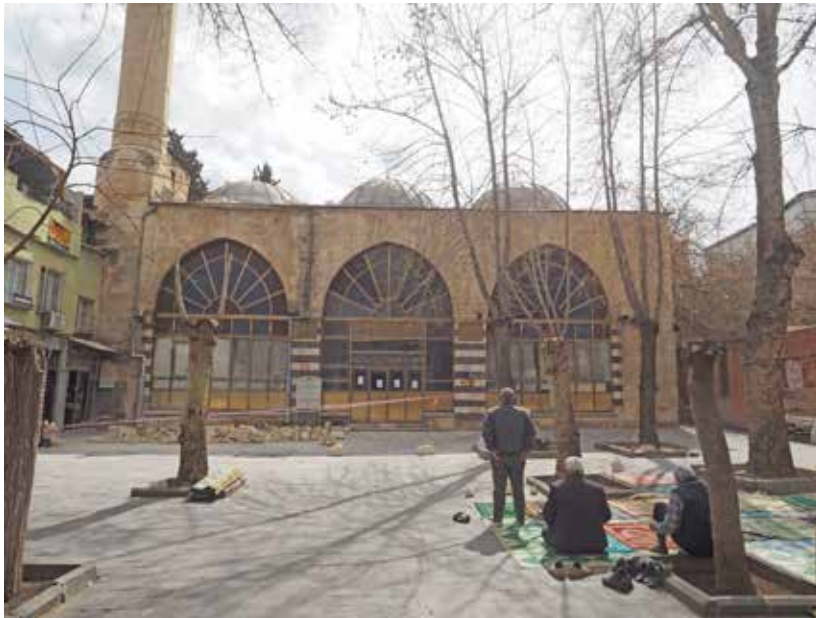
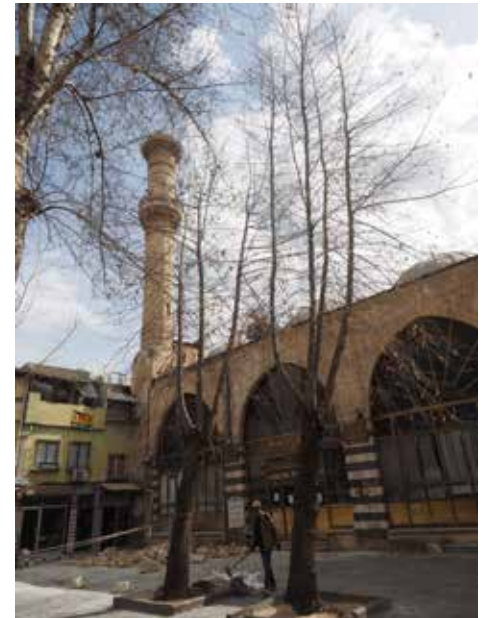
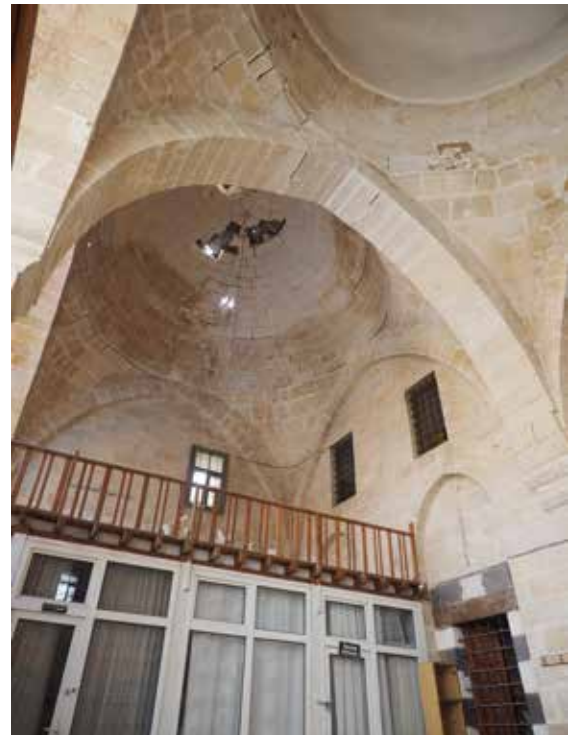
View 3.24 Hüseyin Paşa Mosque after the earthquake (2018)

II
Stable / Moderate Damage
Local structural and non-structural damages.

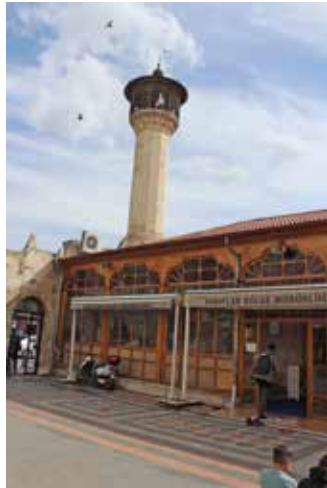
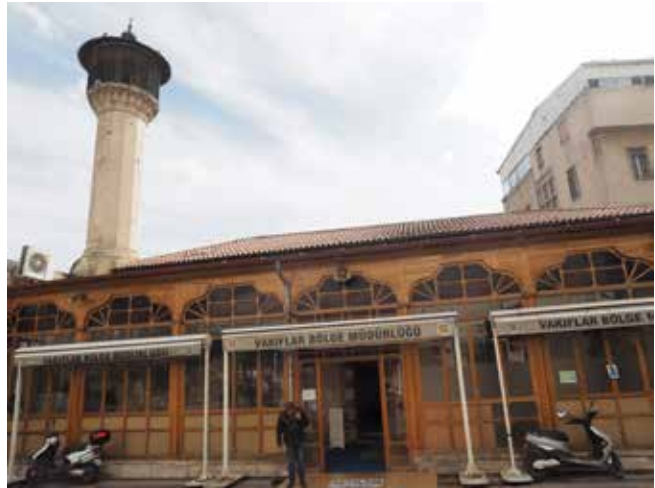
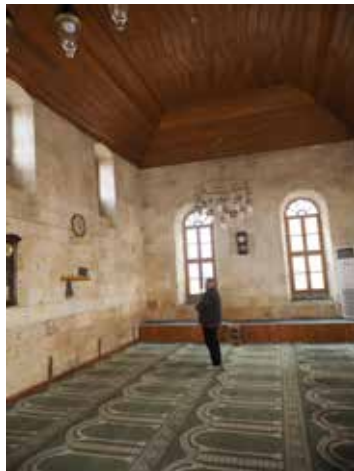
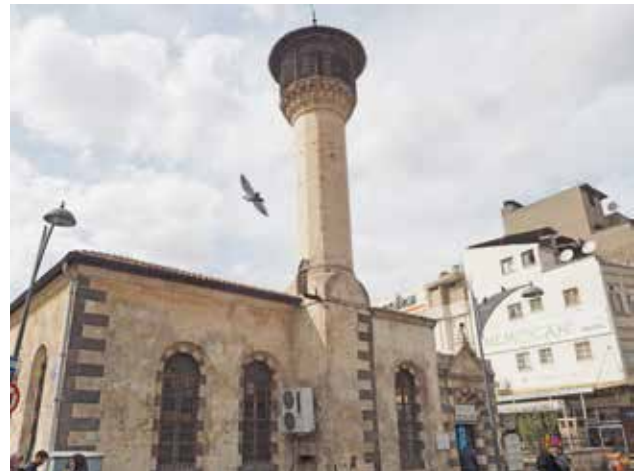
View 3.27 Hacı Veli Mosque after the earthquake

It was slightly damaged during the February 2023 earthquake, with detachments/fractures at the corners of the last comers’ hall.

I
Superficial / Slight Damage
Negligible damage. Some minor cracks.

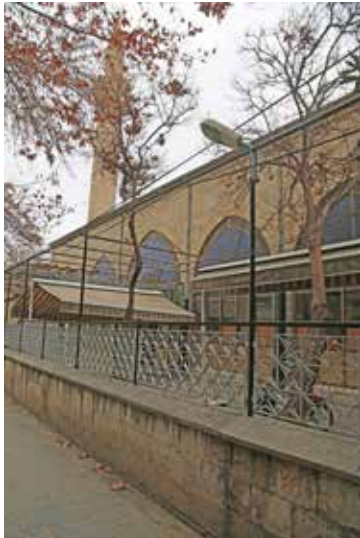
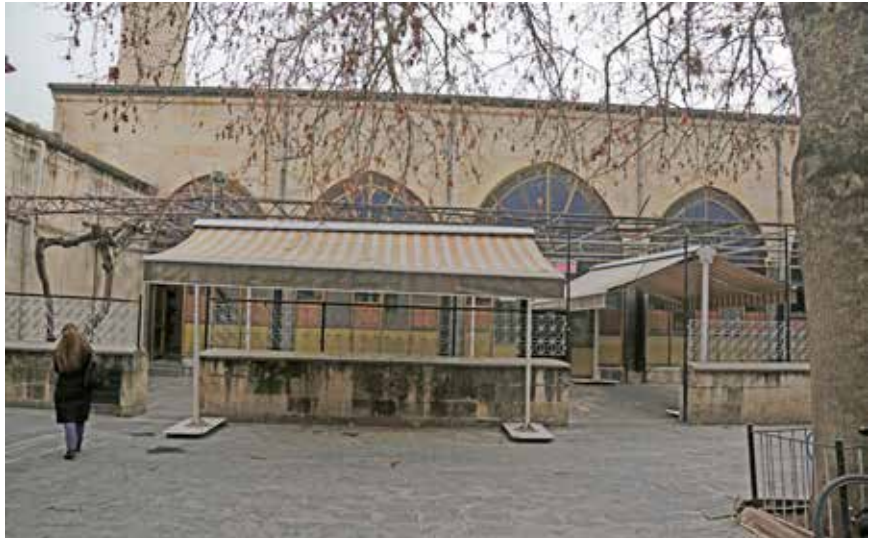
View 3.29 Hacı Veli Mosque after the earthquake

The mosque can be considered as lightly damaged, with only small-scale cracks and dislocations in its minaret.

I
Superficial / Slight Damage
Negligible damage. Some minor cracks.

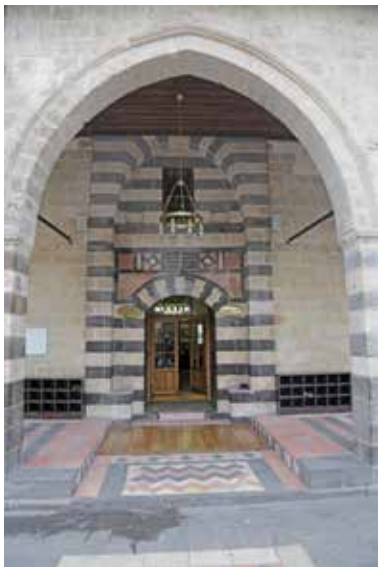
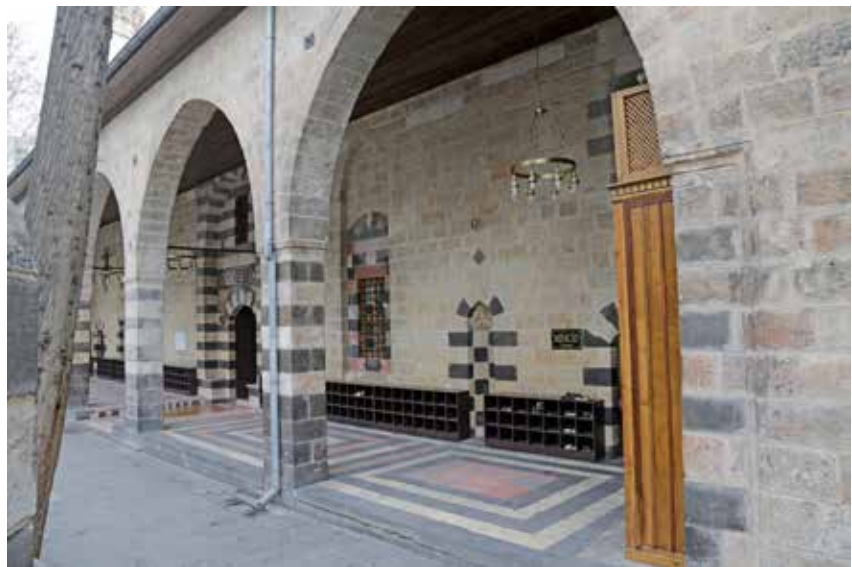
View 3.31 Alaybey Mosque after the earthquake

The ground shakings caused cracks in the walls of Alaybey Mosque, with stones falling and plasters peeling off. Stones fell from above the entrance gate, as well as from the interior walls and ceilings. The *alem* (finial piece) of the minaret fell off, the stone spire partly broke down. Some of the outside walls swayed under the effect of shakings.

II
Stable / Moderate Damage
Local structural and non-structural damages.

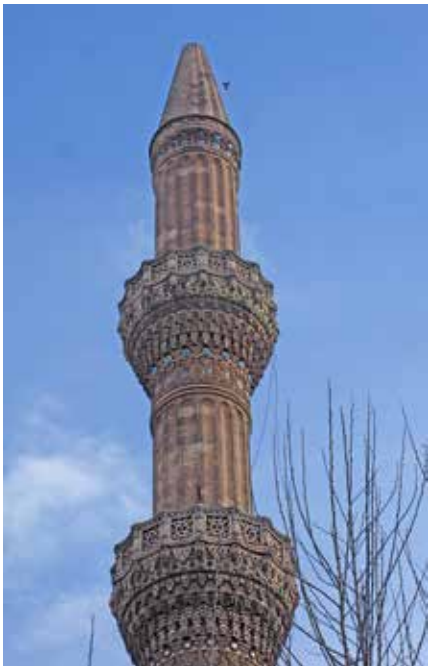
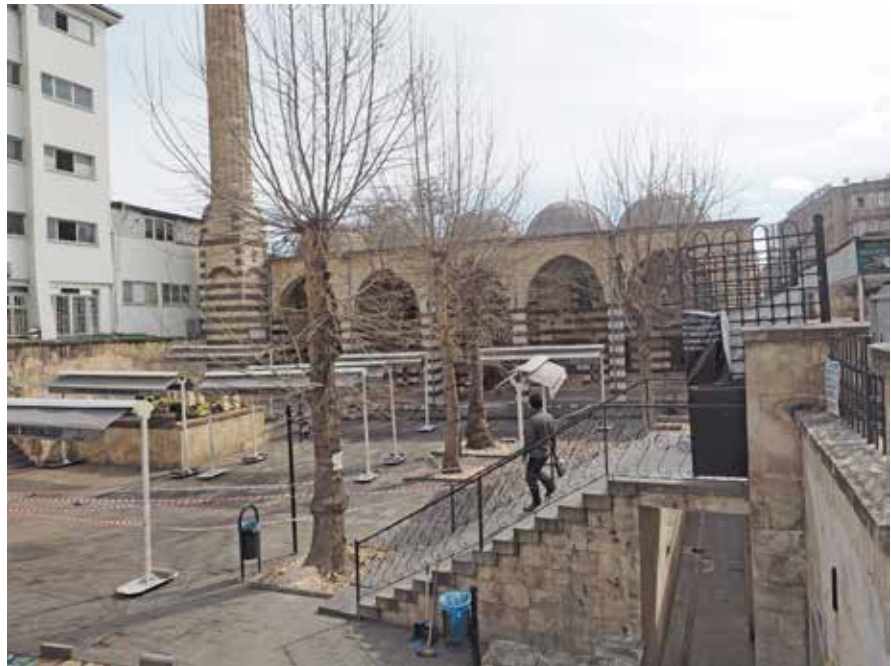
View 3.32 Nuri Mehmet Paşa Mosque after the earthquake

Small-scale damages occurred in the mosque in the earthquake. The alem (finial piece) of the minaret, and some pieces from its stone spire, fell down.

II
Stable / Moderate Damage
Local structural and non-structural damages.

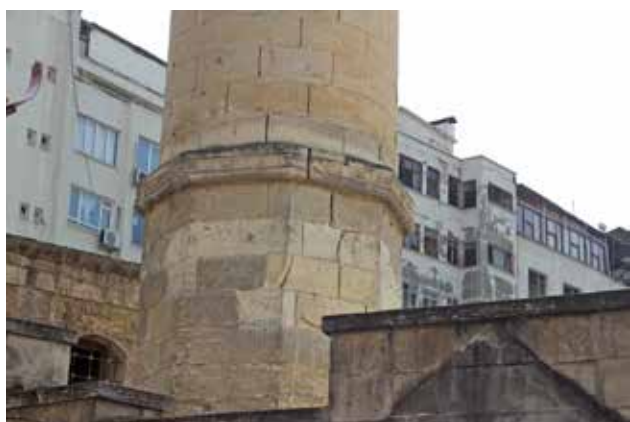
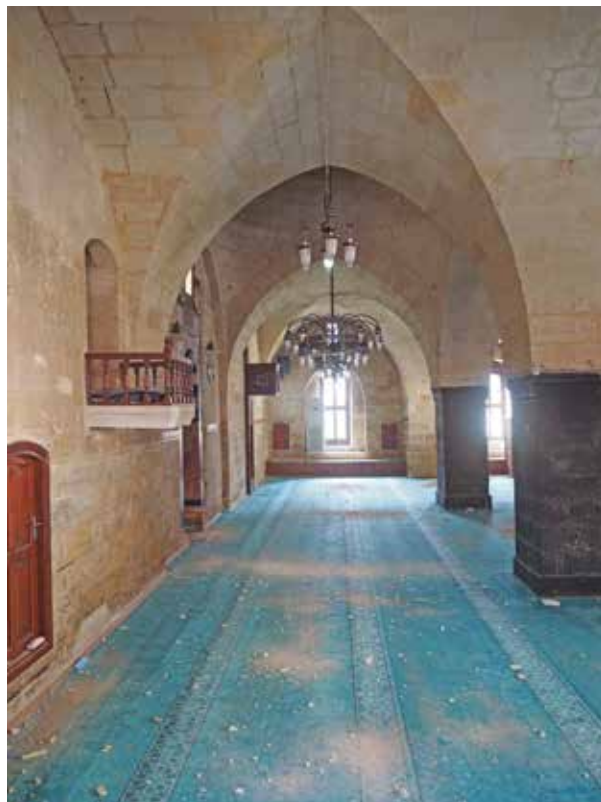
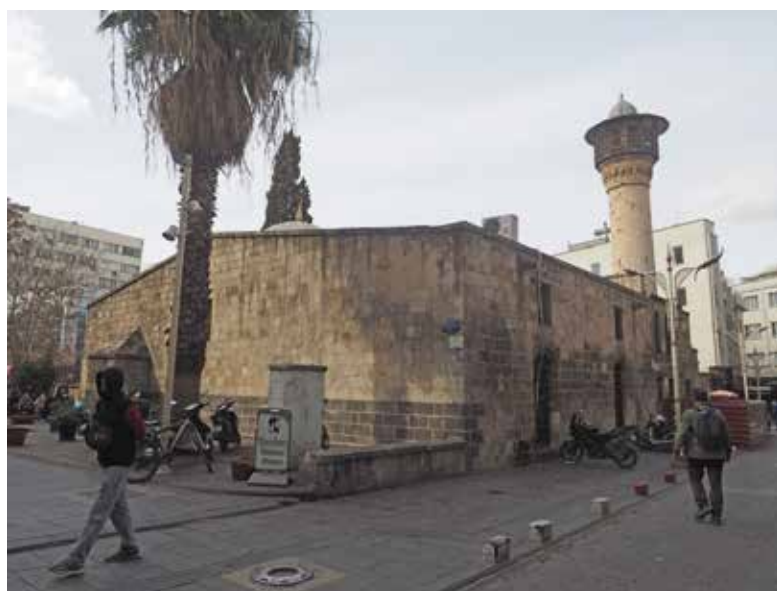
View 3.33 Ömeriye Mosque after the earthquake

The minaret of Ömeriye Mosque has bullet holes remaining from the years of the French occupation and cracks caused by the earthquake. These cracks, and some dislocations in the stone structures, are threats to its survival. Besides, pieces of stone and plaster fell off the inside walls and the vaults carry small cracks and detachments. Specialized damage and risk assessments are needed.

I
Superficial / Slight Damage
Negligible damage. Some minor cracks.

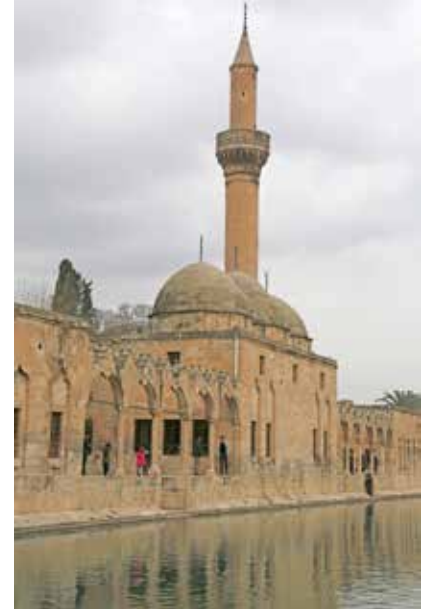
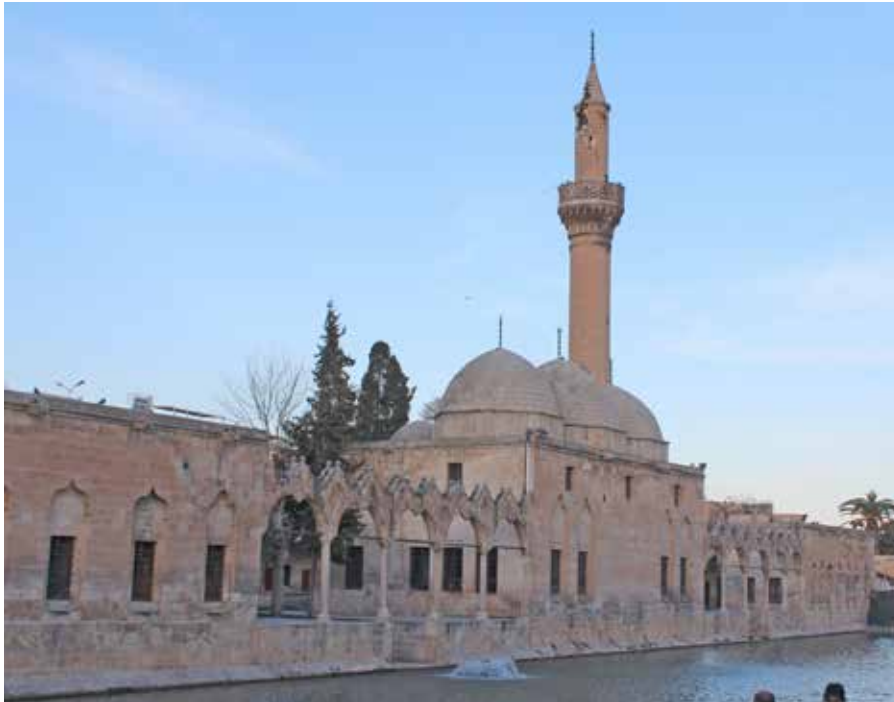
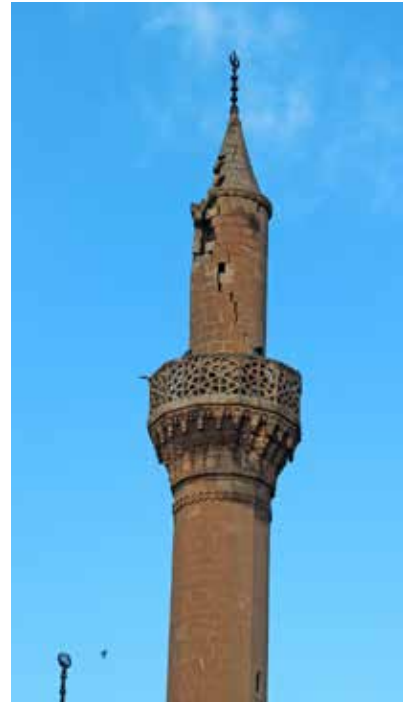
View 4.2 Rizvaniye Mosque after the earthquake

I
Superficial / Slight Damage
Negligible damage. Some minor damage on minaret.

Rızvaniye Mosque's minaret was damaged in the earthquake. The stone structure above its balcony disintegrated and part of it collapsed. This spire section threatens to entirely fall apart under any future shock.

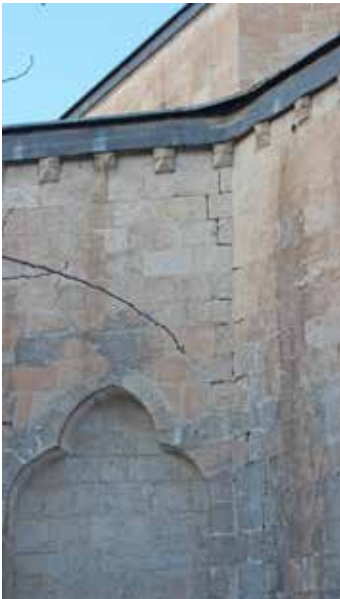
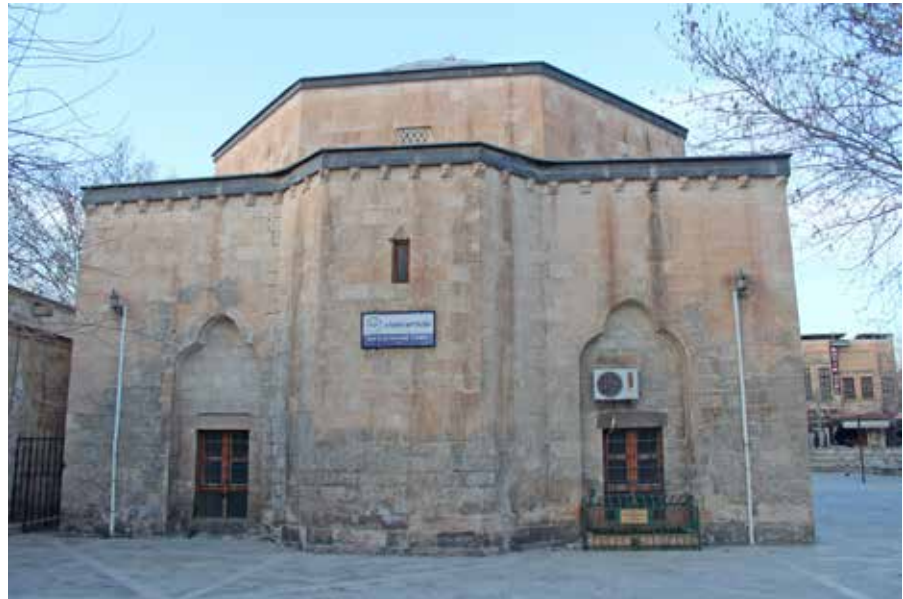
View 4.4 Mevlvihane Mosque after the earthquake

Mevlevihane Mosque's mihrab wall and entrance wall display cracks and fractures in the outside stone structures covering their walls. The mihrab niche is detached from its wall. This axis of the building was shaken, which might also have damaged the dome structure, but the inside of the building could not be inspected. The cracks visible outside need to be examined comprehensively.

I
Superficial / Slight Damage
Negligible damage. Some minor cracks.

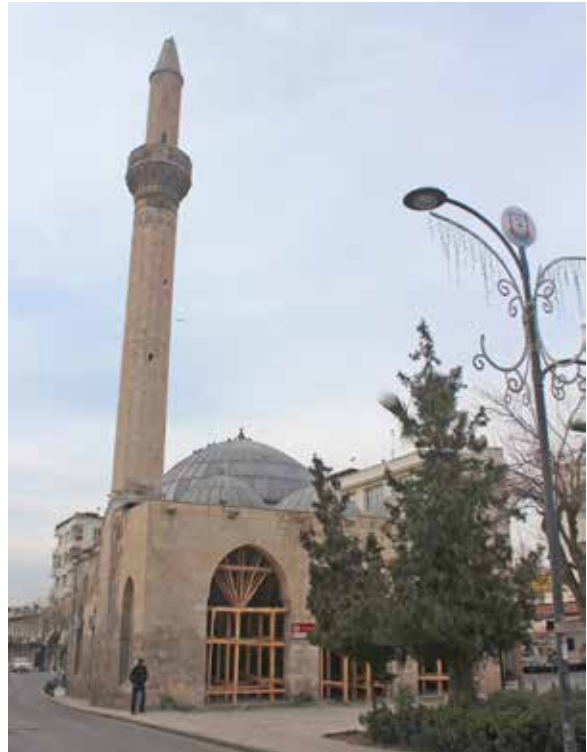
View 4.5 Hüseyin Paşa Mosque after the earthquake

The upper part of the minaret above its balcony carries cracks and displacements. Part of the spire of the stone structure is broken and the alem (finial piece) has fallen down. Due to dislocations in the outside walls of the mosque, the structure has been supported with scaffolding since the earthquake to prevent further collapses.

I
Superficial / Slight Damage
Negligible damage. Some minor damage on minaret.

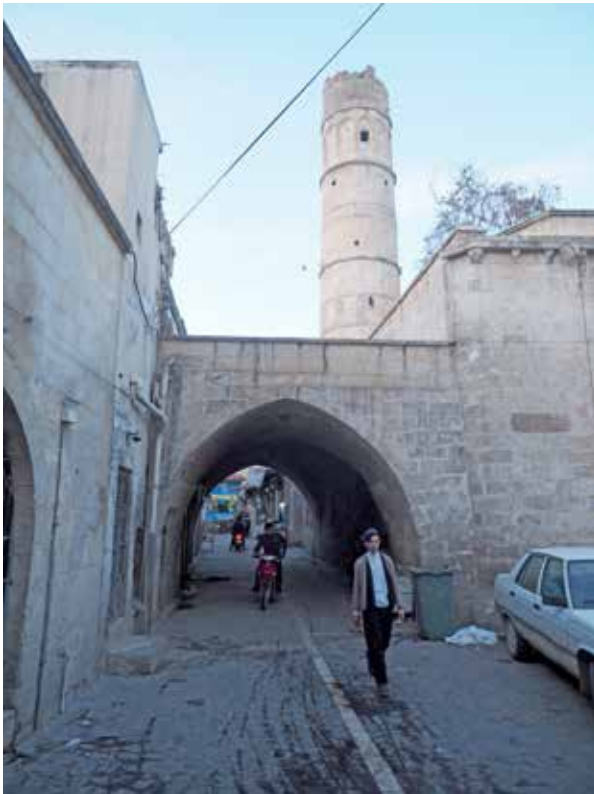
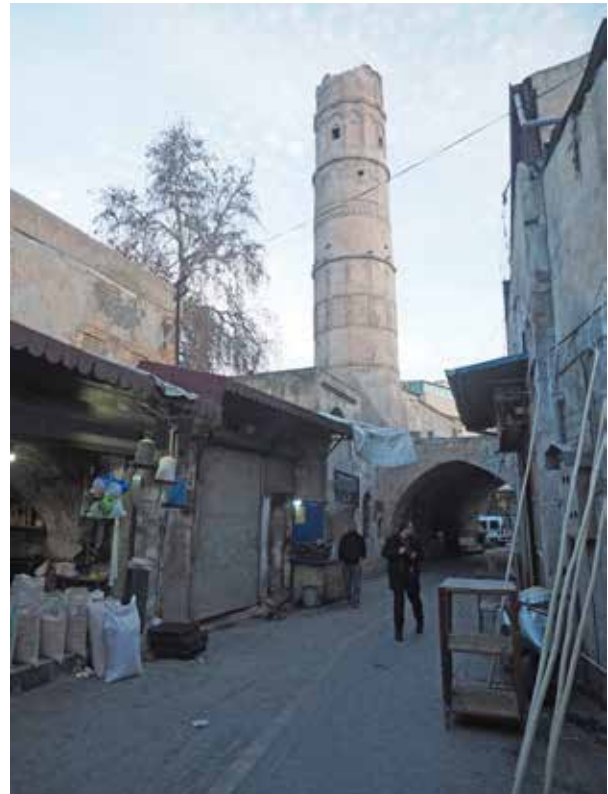
View 4.7 Dabakhane Mosque after the earthquake

The upper part of the minaret above the balcony level collapsed in the earthquake. The detached stones hit the mosque building and its surroundings, causing damage. The mosque's interior could not be inspected since no entry was allowed.

II
Stable / Moderate Damage
Local structural and non-structural damages on minaret.

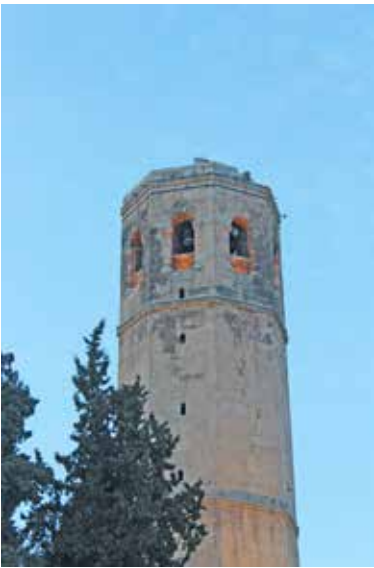
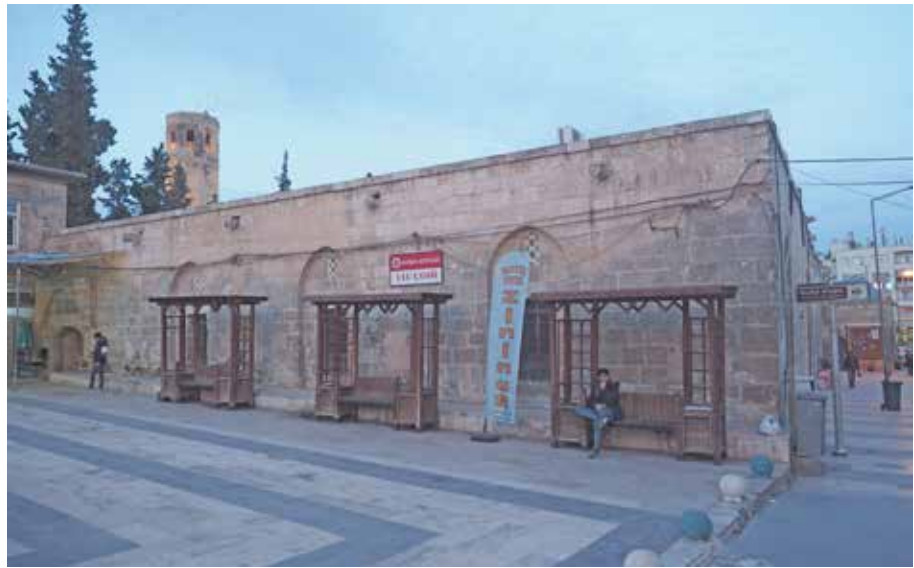
View 4.9 Ulu Mosque after the earthquake

Urfa Ulu Mosque was damaged in its inside space and its minaret, which is separate from the main building. Its dome is fractured. The mihrab wall carries tiny cracks. Its octagonal minaret also has cracks. The clock pole that was added to the minaret in the 20th century has collapsed under the shakings and its pieces fell to the courtyard. The ablution fountain covered with a stone-and-concrete structure also collapsed.

II
Stable / Moderate Damage
Local structural and non-structural damages on minaret.

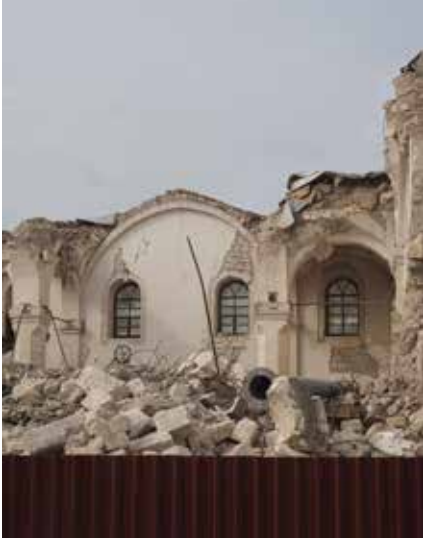
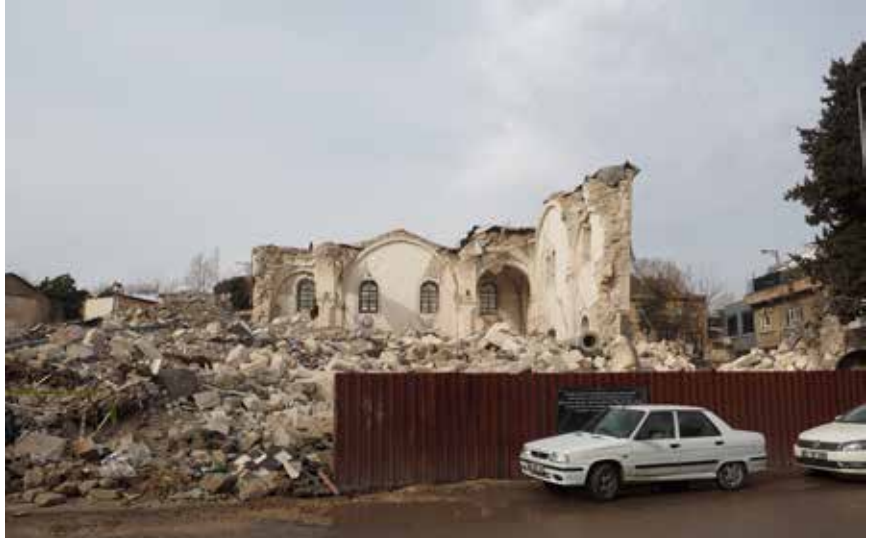
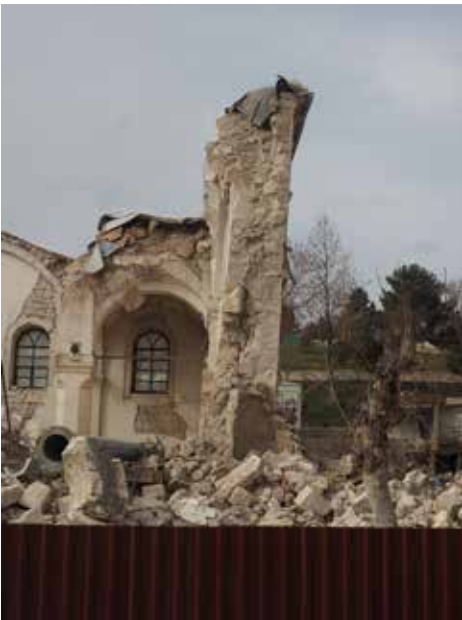
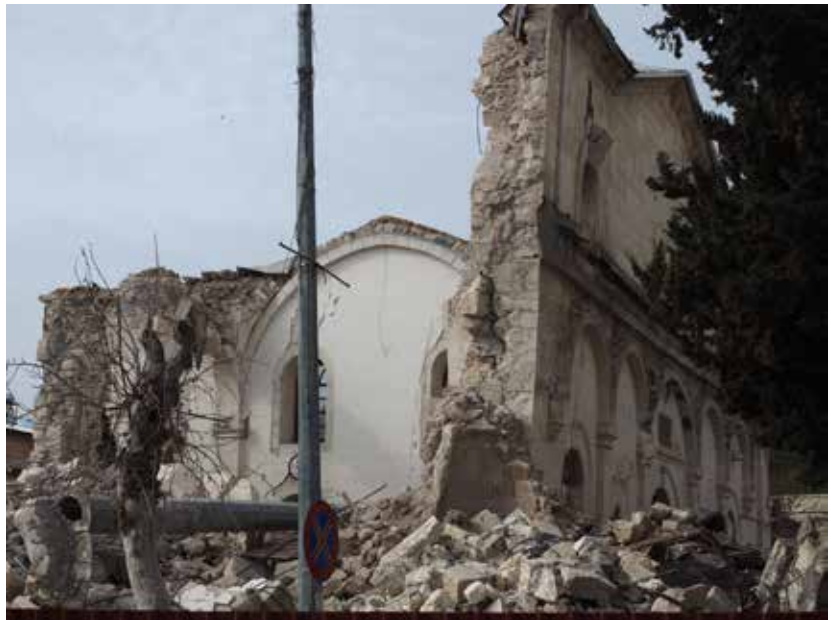
View 5.2 Adiyaman Ulu Mosque after the earthquake

v
Total Collaps / Destruction
Mosque totally damaged. The plot and the building's stones became rubble. One side of the facade wall stands unstable with heavy damage.

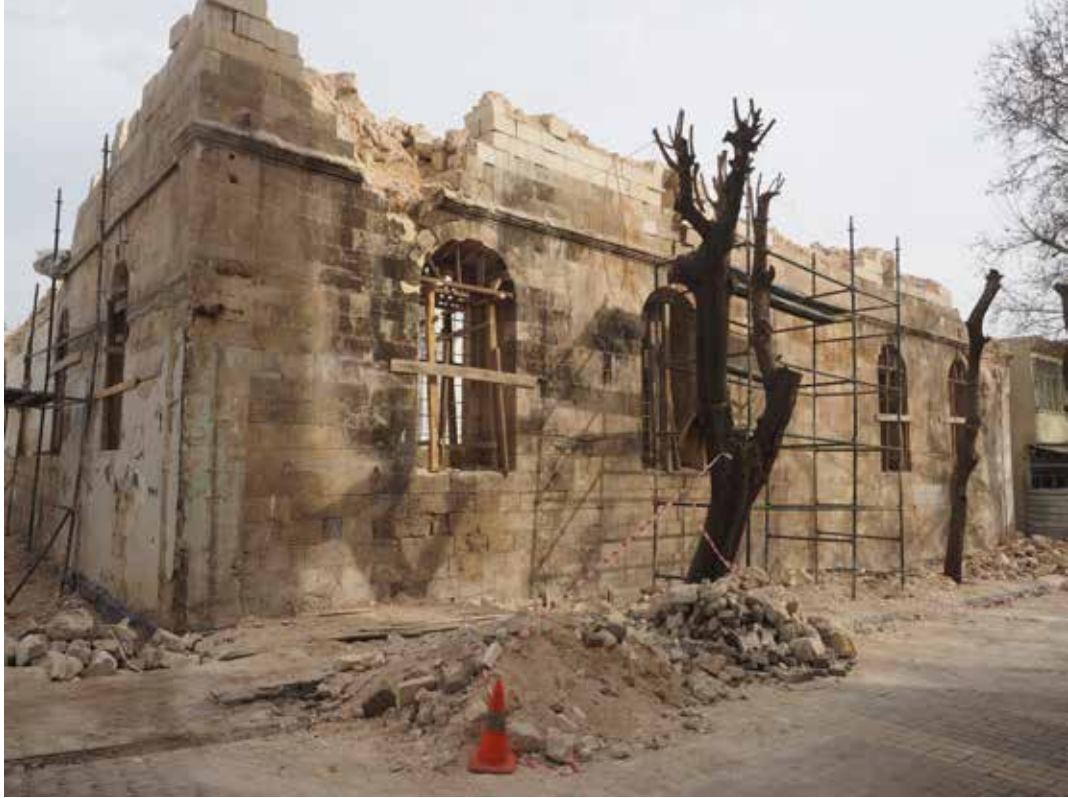
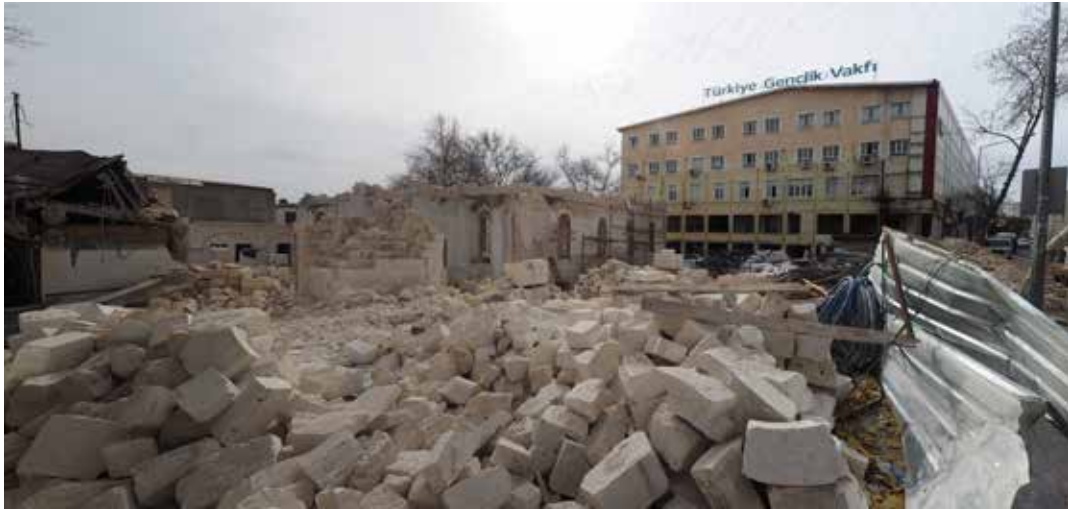
View 5.5 Çarşı Mosque after the earthquake

Restoration work was ongoing in the Çarşı Mosque since 2021; it was seriously affected by the last earthquake while under reconstruction. Its minaret collapsed before it could be restored; its roof collapsed; partial fractures occurred in most of its walls; as a result, piles of rubble accumulated in and around the mosque.

Irreversible / Very Heavy Damage

Heavy structural damage and very heavy non-structural damage.
