REPORT

ON THE DAMAGE CAUSED BY
THE FEBRUARY 2023 KAHRAMANMARAŞ EARTHQUAKE
ON ISLAMIC CULTURAL HERITAGE IN TÜRKİYE

Prepared by

Alidost Ertuğrul
Taha Zahid Özdemir
Hussein Al Ragabi

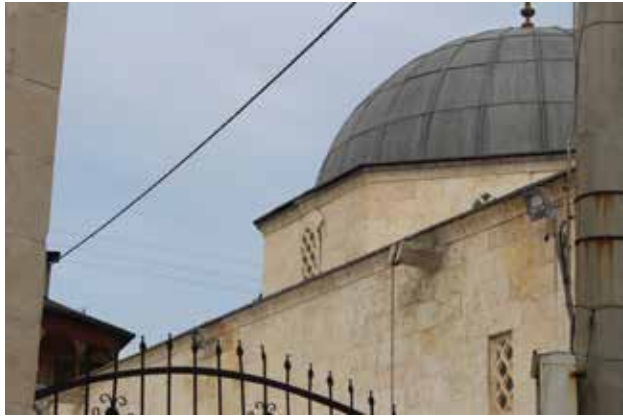
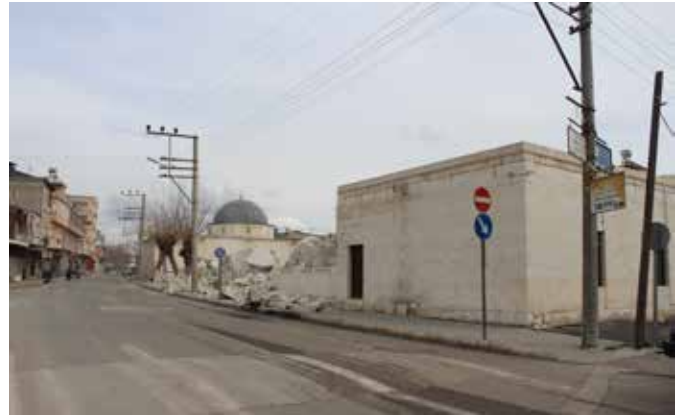
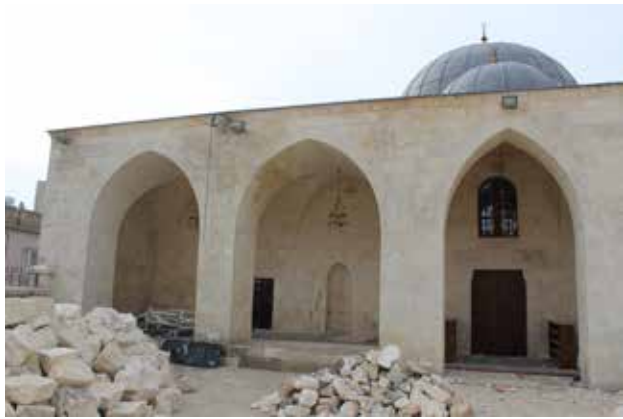
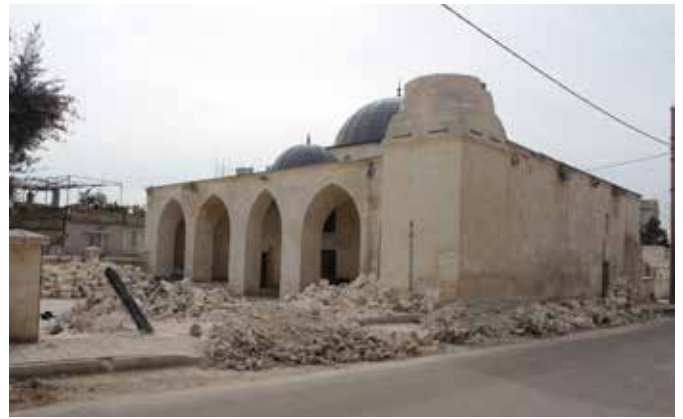
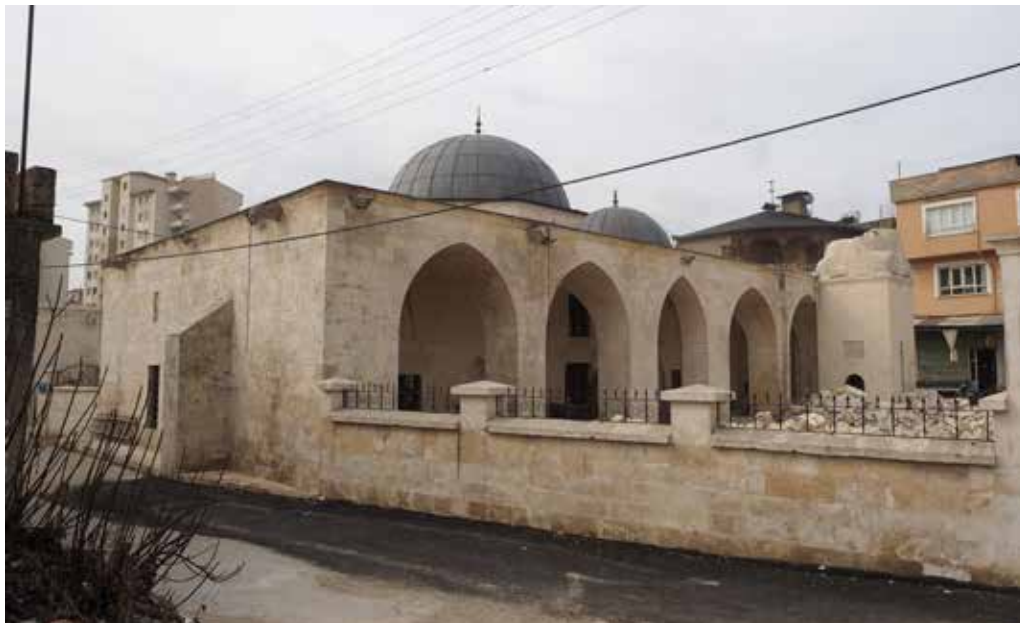
View 5.7 Musalla Mosque after the earthquake

This is one of the buildings most severely hit. Its minaret was destroyed down to the boot level, causing harm to the roof and the surroundings of the last comers' area. The inside walls and pillars of the last comers' area carry cracks. Dislocations and fractures are seen around the central dome base. The structure can be classified as heavily damaged although its sections other than the minaret are standing.

III	IV
Unstable/Heavy Damage	Irreversible/ Very Heavy Damage
Moderate structural damage on main building.	Heavy structural damage on minaret. Collapsed onto roof of the main building.

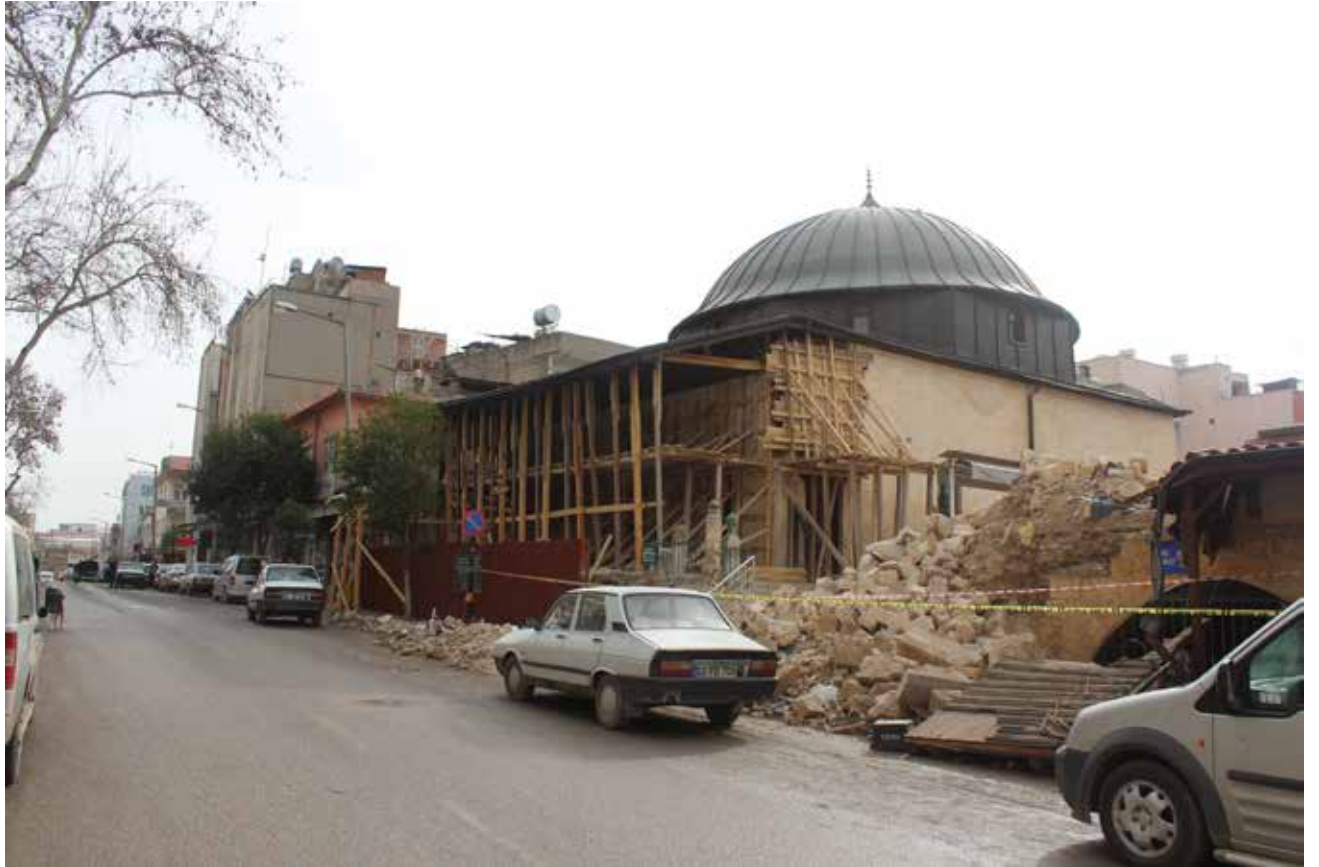
View 5.8 Kab (Hacı Ali) Mosque after the earthquake

Kab Mosque's minaret, which was repeatedly renovated in the past, was destructed in the last earthquake. Falling stones damaged the roof of the last comers' area, the surroundings of the minaret and the vaulted passage, which is used a prayer hall in the Summer. No observations could be made inside the mosque, as it could not be visited.

III	IV
Unstable/Heavy Damage	Irreversible/ Very Heavy Damage
Moderate structural damage on main building.	Heavy structural damage on minaret. Collapsed onto roof of the main building.

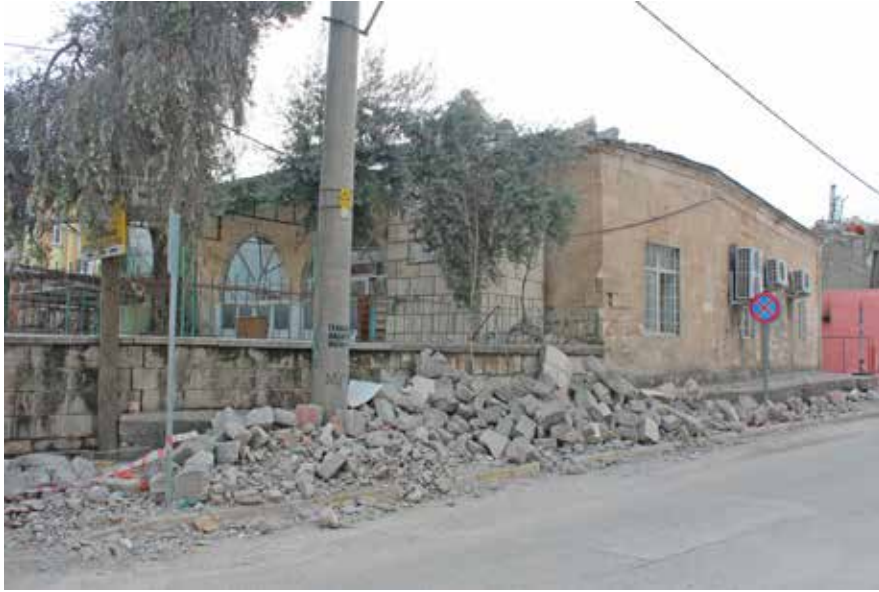
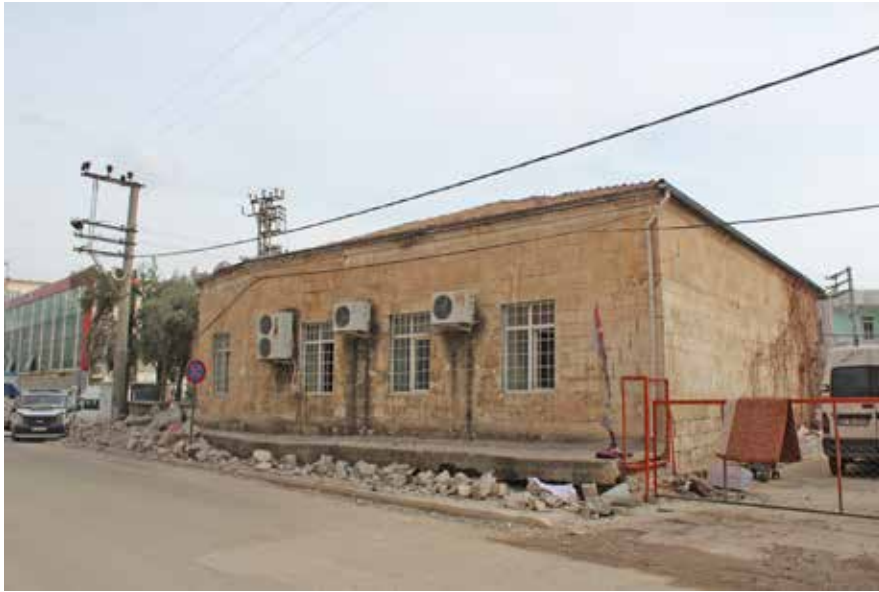
View 5.9 Hacı Süleyman Mosque after the earthquake

Information is scarce about the history of this mosque located on Musalla Avenue, in Adıyaman city center. It is a rectangular structure built with limestone and covered with a ridged brick roof. Its minaret, which looked as if built recently, was destroyed in the earthquake. Broken pieces falling from the minaret fractured the mosque roof, the minaret's surroundings, and the last comers' section.

III	IV
Unstable/Heavy Damage	Irreversible/ Very Heavy Damage
Moderate structural damage on main building.	Heavy structural damage on minaret. Collapsed onto roof of the main building.

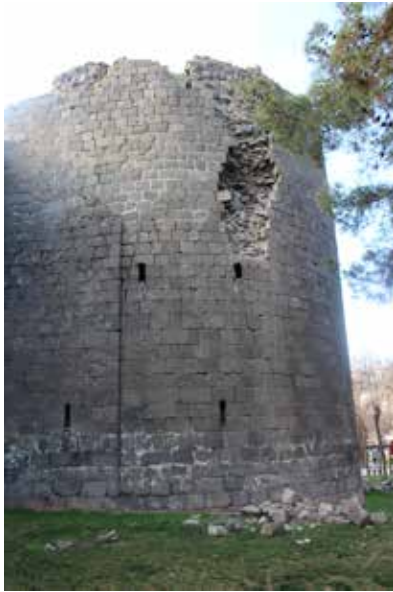
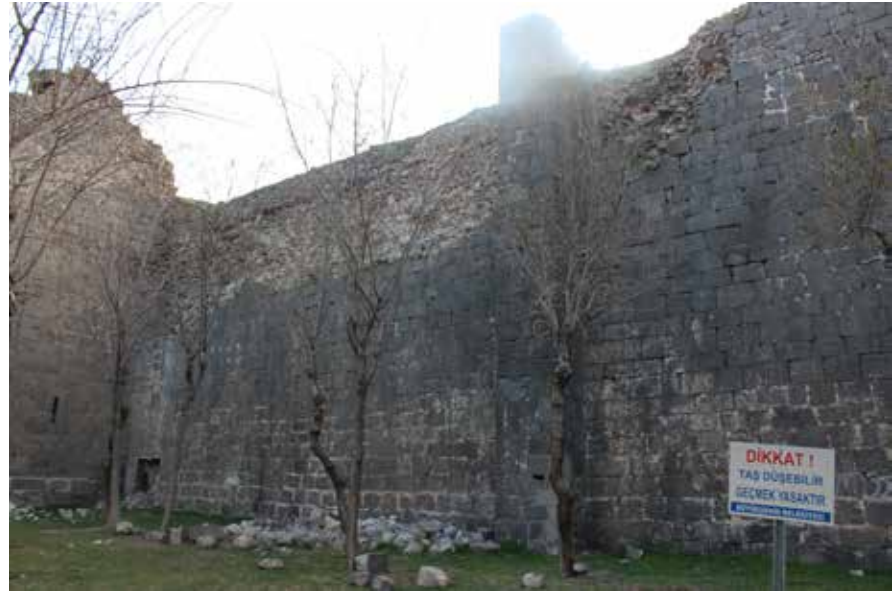
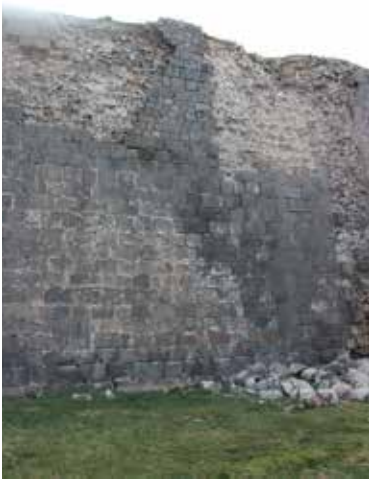
*View 6.3 Diyarbakır City Walls
after the earthquake*

II
Stable / Moderate Damage
Local structural and non-structural damages on minaret.

City walls lost their importance everywhere from the 16th century onwards, but the walls of Diyarbakır remained functional until the early 20th century. Since then, they remained in neglected physical state for many years, while adjacent buildings and roads were constructed. Inaccurate restorations were carried out occasionally. However, a regular conservation program was launched in 2010 on the basis of surveys revealing fractures, losses of stones, decay of mortar bindings, and crumpling vertical sections due to wear out. These problems were further aggravated by the earthquake, where some sections of the walls fell out, widening the breaches and cavities. No serious problems are seen in the sections that were restored before the earthquake. These problems are expected to be solved through the ongoing restoration projects.

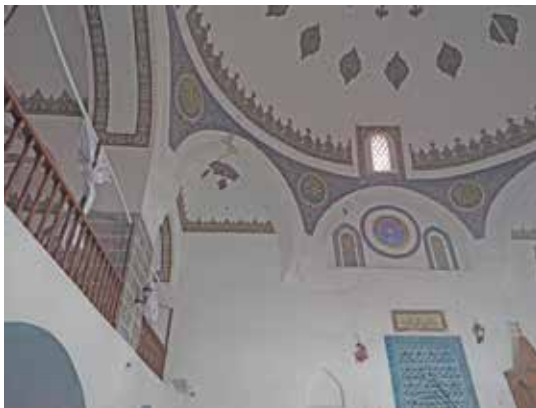
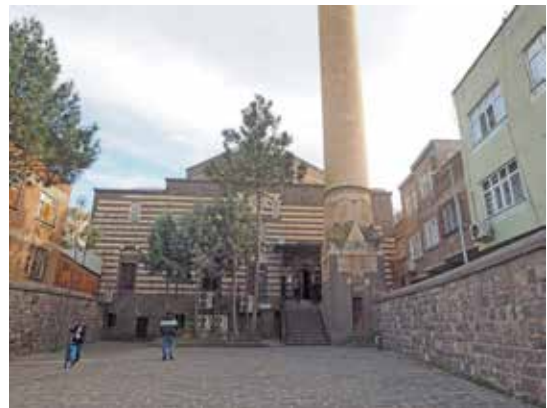
View 6.4 Melek Ahmet Paşa Mosque after the earthquake

Diyarbakır Melek Ahmet Paşa Mosque has structural cracks in the arches that carry its dome, to the side of the mihrab and on the columns which support the mahfil (preacher's place). Though the damage seems to be light at first sight, the cracks in the support elements of the roof and the dome necessitate that a comprehensive static examination and reinforcement of the structure be carried out.

II
Stable / Moderate Damage
Local structural and non-structural damages on minaret.

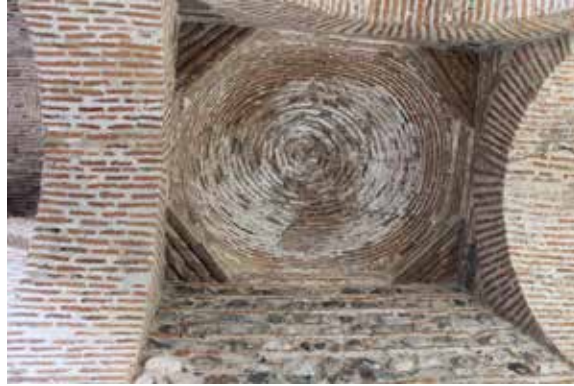
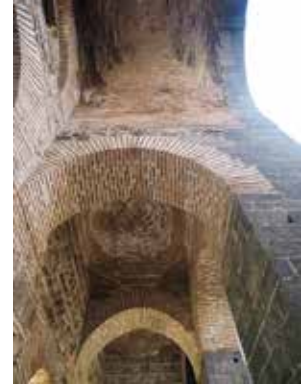
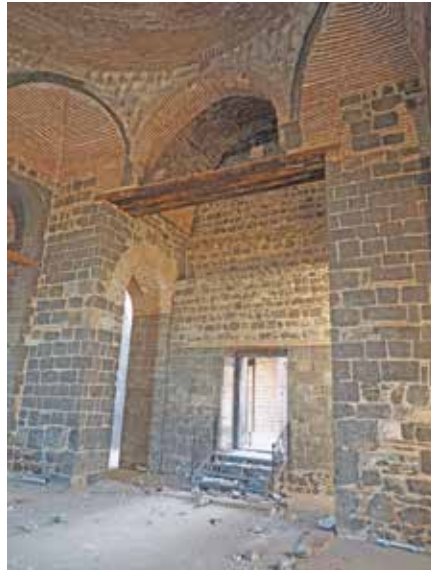
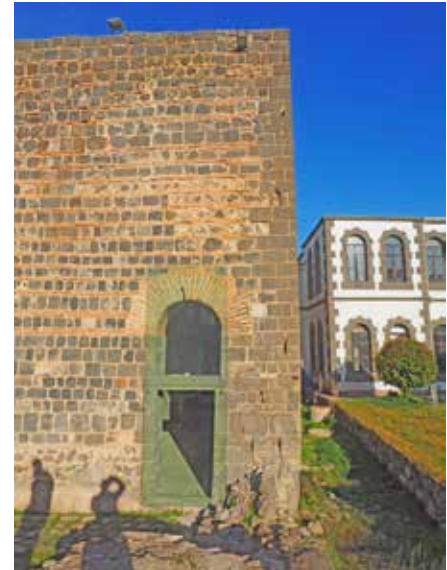
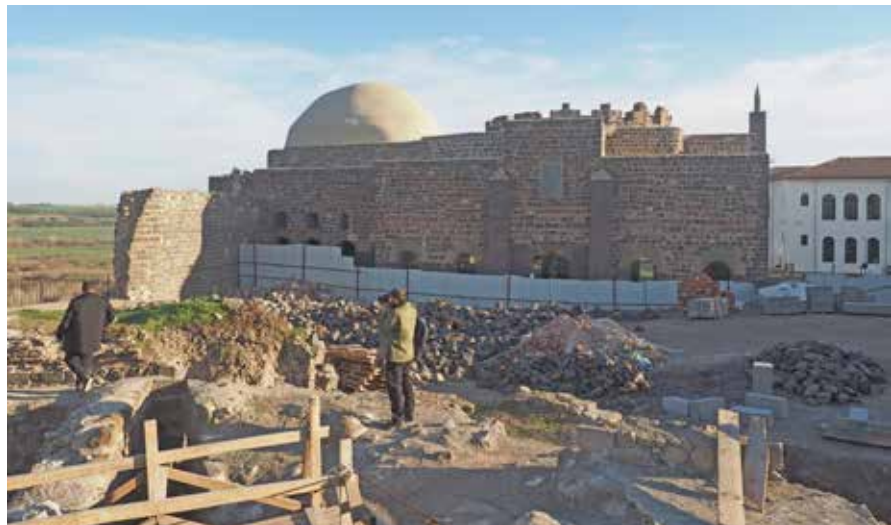
St. George Church was suffering from problems related to the unsuitability of its grounds already before the earthquake. The existing cracks in its outer walls have widened in the earthquake and new ones appeared in its inside walls, where pieces of stone and flakes of plaster fell off.

II
Stable / Moderate Damage
Local structural and non-structural damages on minaret.

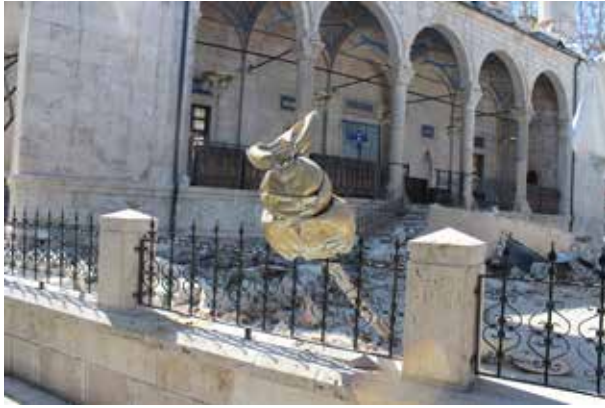
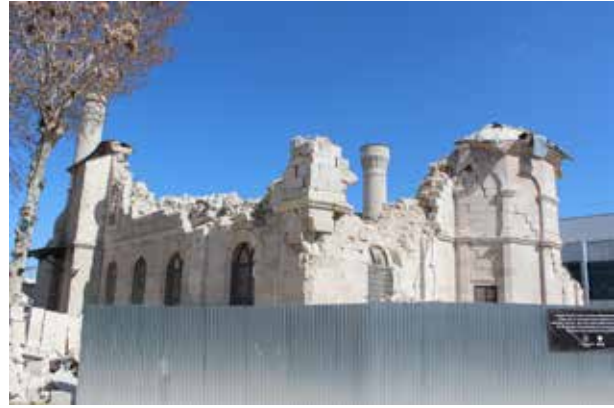
View 7.1 Yeni Mosque after the earthquake

Irreversible / Very Heavy Damage

Heavy structural damage. All ornaments, architectural and structural elements heavily damaged. Close to total destruction.

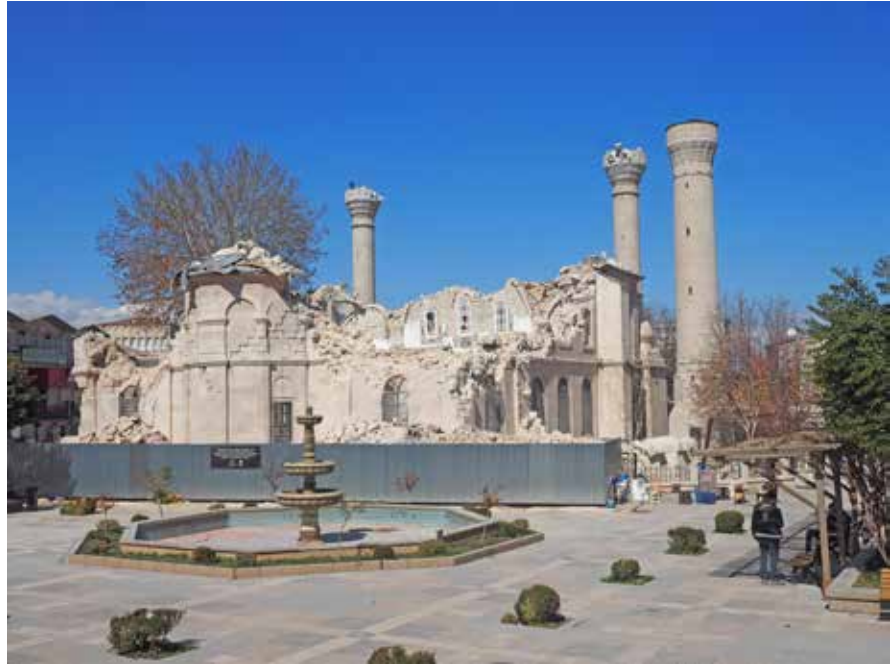
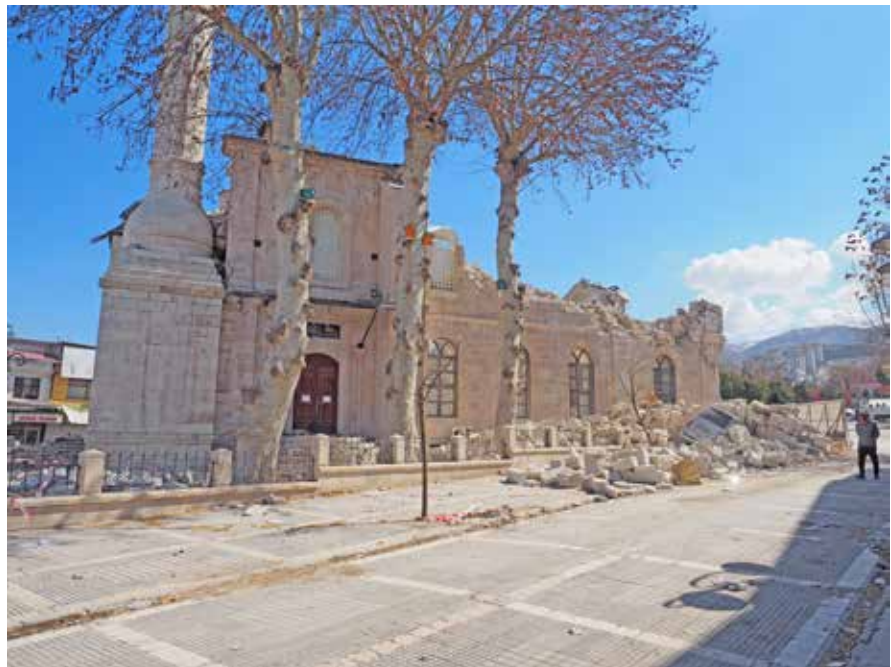
View 7.2 Yeni Mosque after the earthquake

Malatya being located in a seismic zone, most of the buildings had already experienced earthquakes. The dome and the walls of this mosque were restored after the 1964 earthquake. The building was also damaged during the Elazığ-centered 2020 earthquake. Finally, the 2023 quake razed it to the ground. Its top covering did not stand the shocks and damaged to the main building's support walls in its collapse. The minaret that was inherited from the very first structure survived with a few cracks, while the two other minarets were destroyed from top to their balcony level. What remains from the site is only a small section of the last comers' area. An almost total reconstruction of the site is needed.

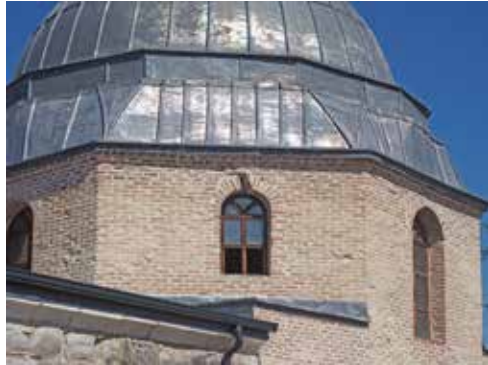
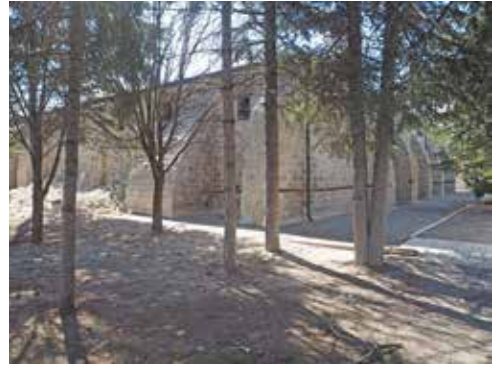
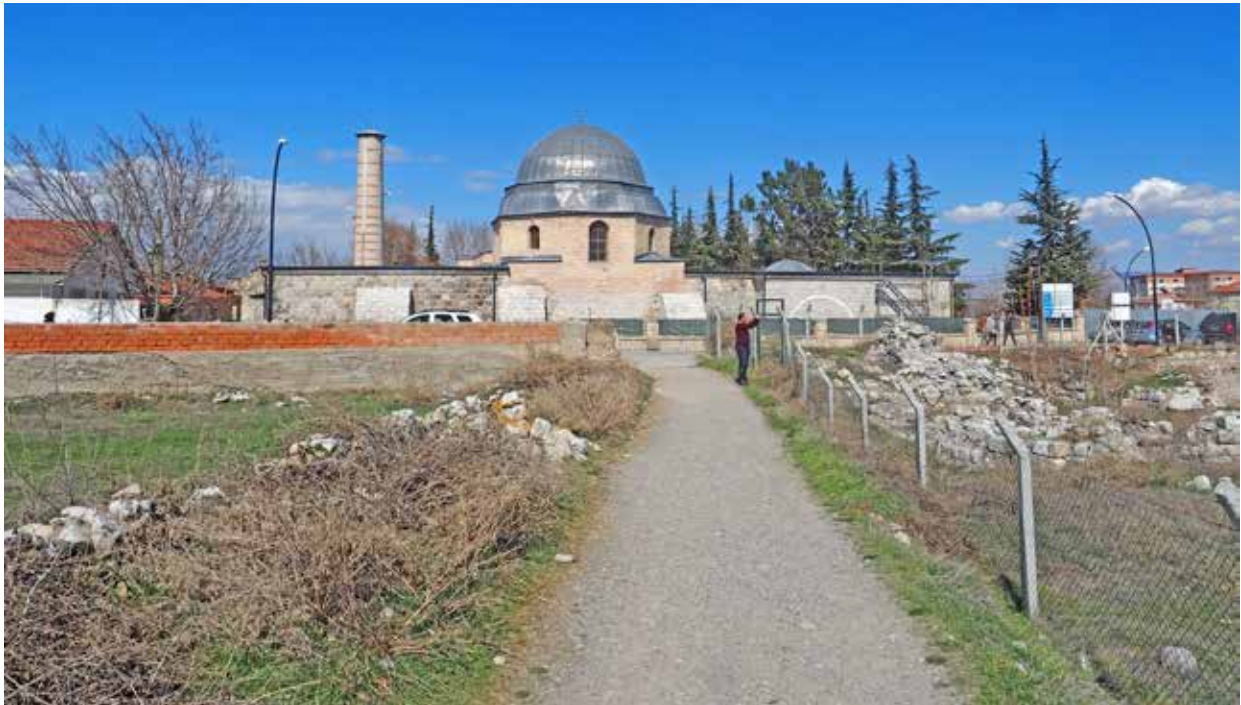
View 7.3 Battalgazi Ulu Mosque after the earthquake

Since Malatya Ulu Mosque was closed after the 2023 earthquake, some observations were made from outside. The brick frame of the window on its dome has cracks and dislocations. Two of the piers in the eastern part of the mosque, which were restored earlier, collapsed because they were not properly connected to the main building. Other facades of the building lost some stones and have cracks.

II
Stable / Moderate Damage
Local structural and non-structural damages.

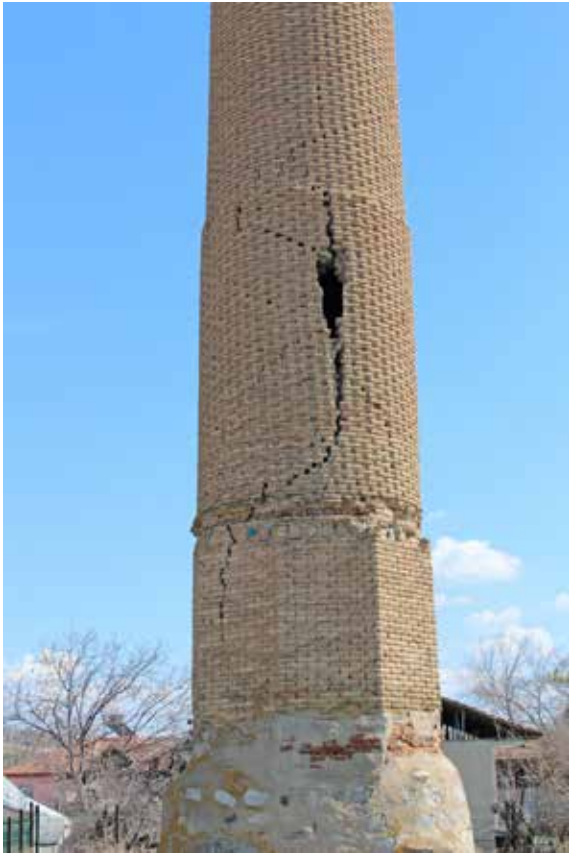
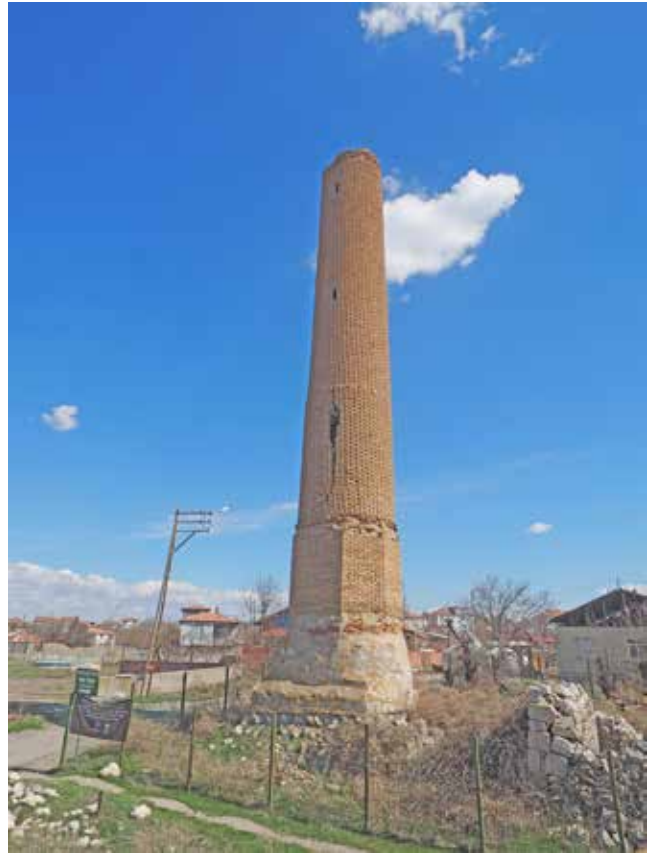
View 7.4 Halfetih (Hötüm Dede) Minaret after the earthquake

The seismic shocks caused a major crack along a line crossing from its octagonal boot towards its cylindrical body. This fundamental fracture may cause a total collapse. An intervention is urgently needed to restore this authentic structure.

II
Stable / Moderate Damage
Local structural and non-structural damages.

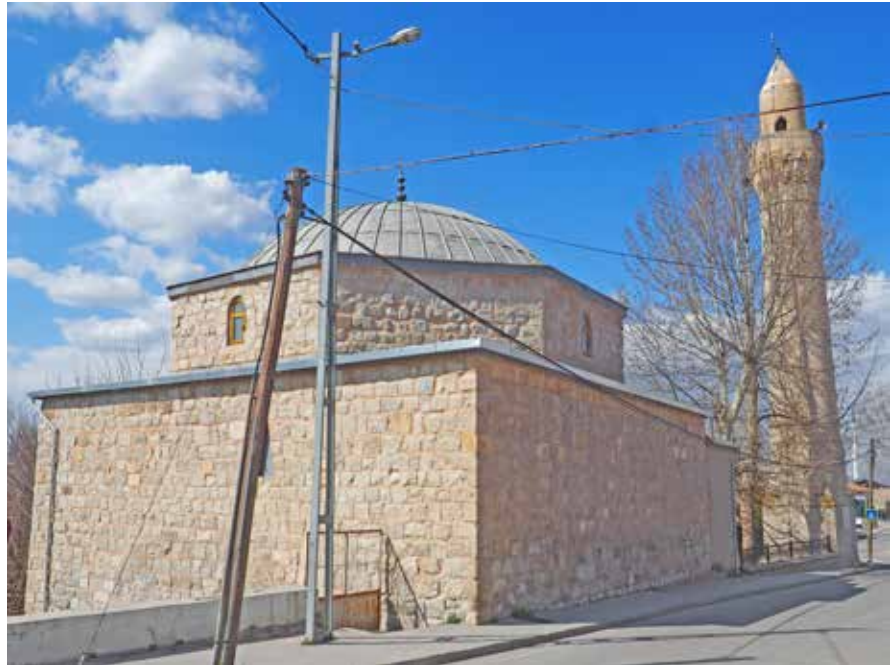
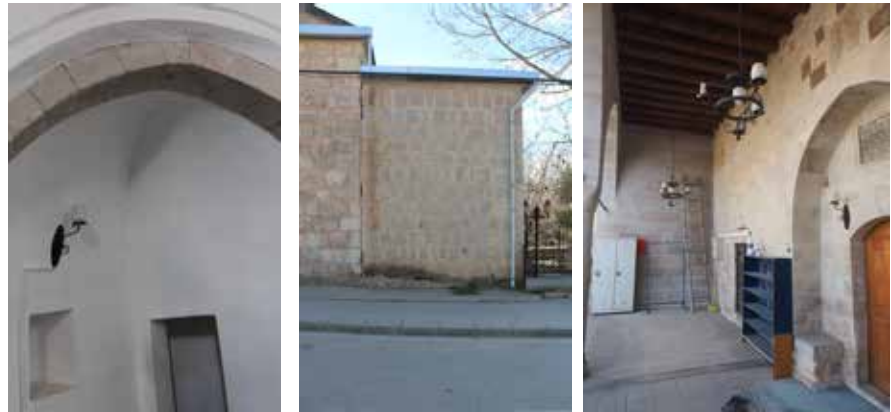
View 7.5 Ak Minaret Mosque after the earthquake

II
Stable / Moderate Damage
Local structural and non-structural damages.

The last earthquake caused cracks and splits at the corner where the walls of the main prayer hall and the restored last comers' place meet. Cracks also occurred in the tromp arches and the prayer hall's wall corners. Pieces of stone were detached from the arches topping the windows on each side of the prayer hall entrance. Though the damage was not severe, the crevices and dislocations that occurred in this building must be monitored and suitable interventions must be planned in the long run.

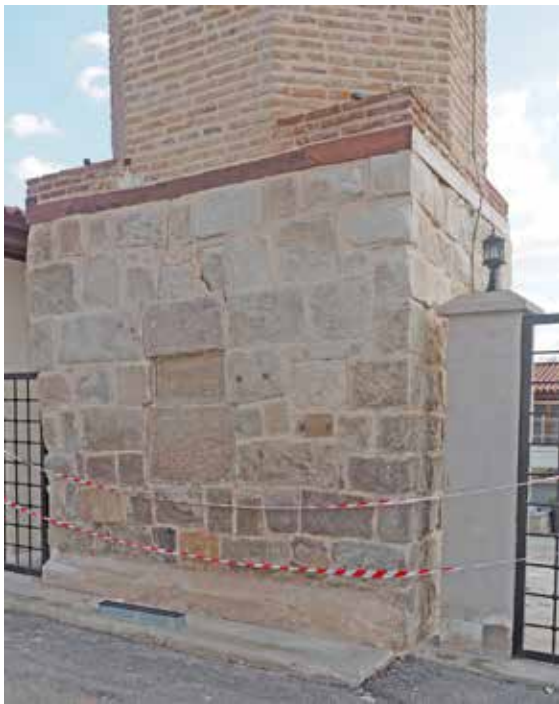
View 7.7 Vaizhoca Mosque -Melik Sunullah Mosque after the earthquake

The last quake caused fractures in the stone surface structure that layers the minaret boot which is an original element of the mosque. The upper part of the minaret was not affected.

I
Superficial / Slight Damage
Negligible damage. Some minor damage on minaret.

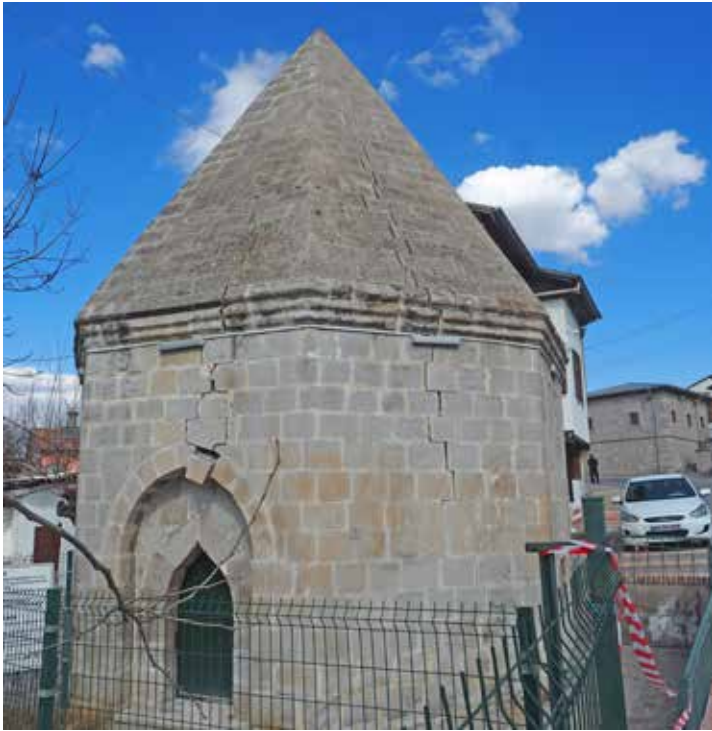
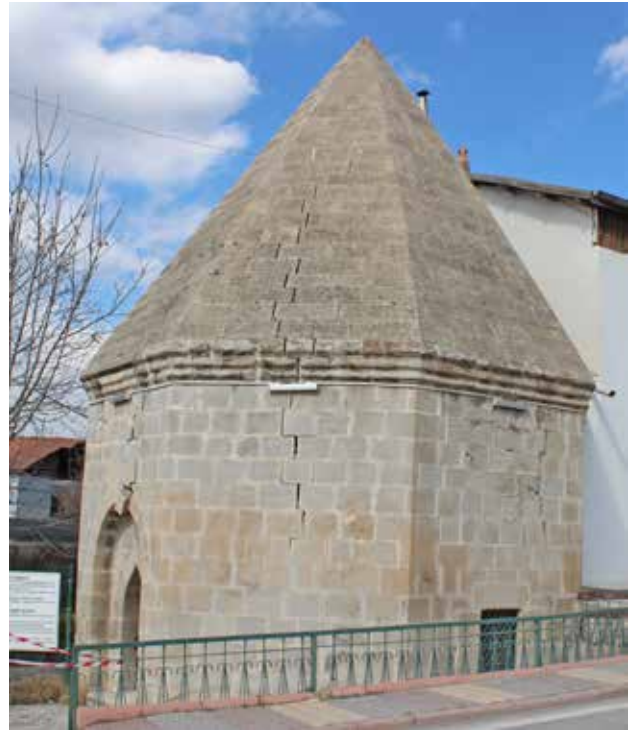
View 7.8 Siddi/Sitti Zeynep Tomb after the earthquake

The tomb has deep cracks, most of them vertical. Stones are detached, especially from the upper frame of the entrance gate. The inside could not be visited. An examination of the cracks suggests they occurred due to dislocations caused by the top-level traditional structures swaying downwards. A realistic assessment can be reached only after through static analyses of the inside and outside elements and the adjoining house.

I
Superficial / Slight Damage
Negligible damage. Some minor damages.

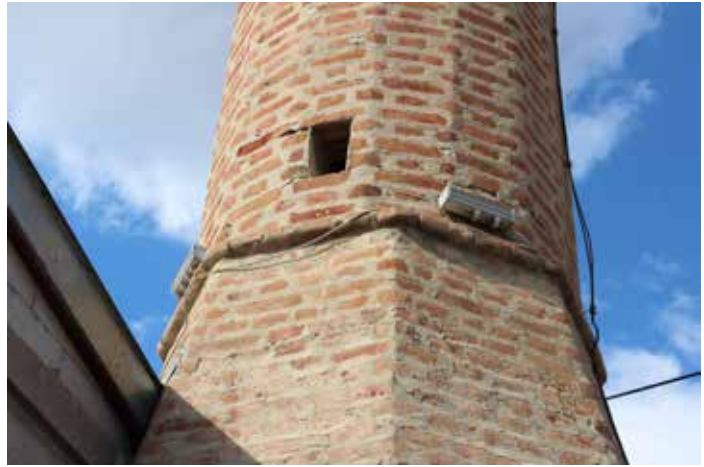
View 7.9 Karahan Mosque after the earthquake

The restored mosque survived the earthquake; no damage was assessed except a few simple losses of plaster layering between the minaret's boot and the front alley.

I
Superficial / Slight Damage
Negligible damage. Some minor damages between minaret and main building.

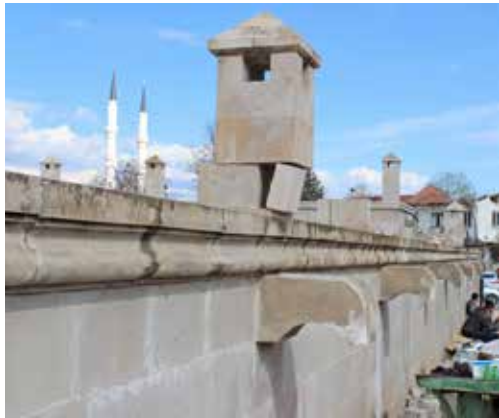
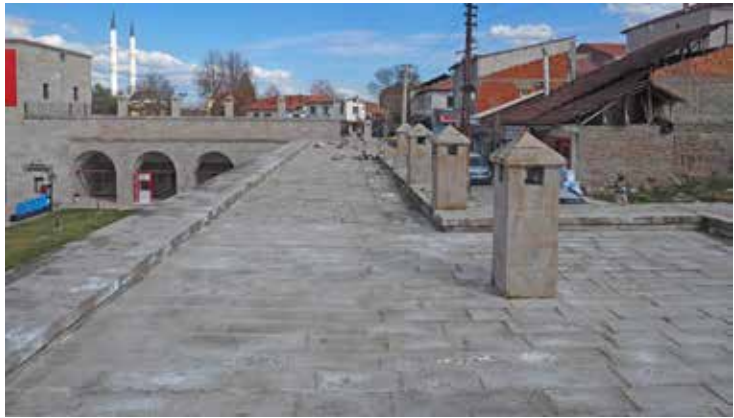
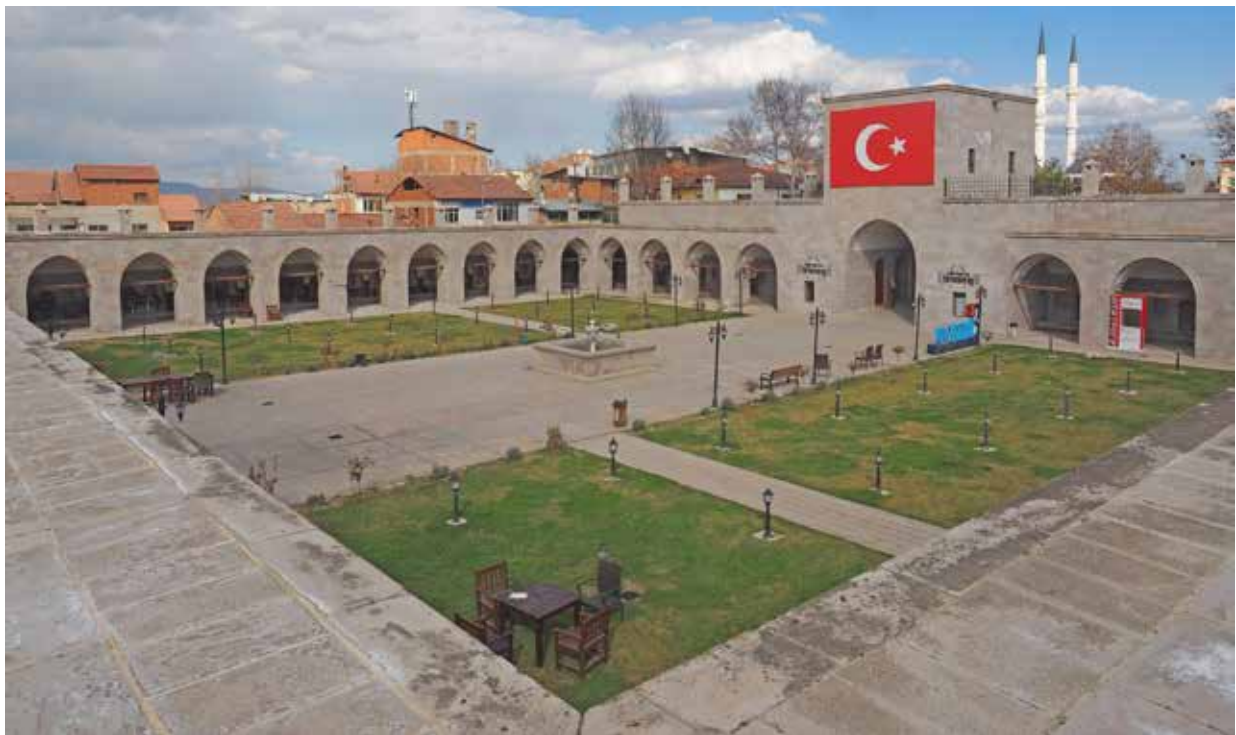
View 7.10 Silahtar Mustafa Paşa Caravanserai after the earthquake

It was seen during the survey that the chimneys, which were a later addition on the riwaqs, were either displaced or broken. No other trace of the earthquake is visible from outside. The inside could not be visited.

II
Stable / Moderate Damage
Local structural and non-structural damages.

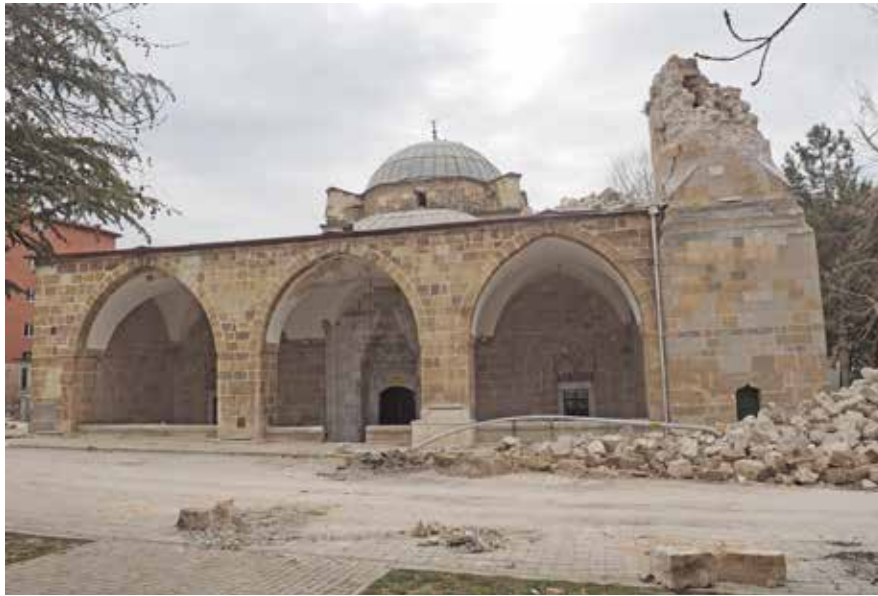
View 8.2 Elbistan Ulu Mosque after the earthquake

Irreversible / Very Heavy Damage

Heavy structural damage.

collapsed onto the mosque and towards the tombs of Alaüddevlé Bozkurt Bey, one of the Dulkadir Beys, and Osman Necip Efendi of Bukhara which are located in the garden, causing some damage. The dome base carries fractures and distortions. Additionally, some of the flying buttresses that support the dome base are broken and destroyed. There are cracks in the mosque's facades and dislocations in its walls. The transversal vaults of the last comers' prayer place bear cracks; their plaster coating detached here and there. The ablution fountain in the garden, which was a later addition, and part of the support wall on the mihrab side of the garden, have collapsed. These are indications of the serious damage and destruction in the site.

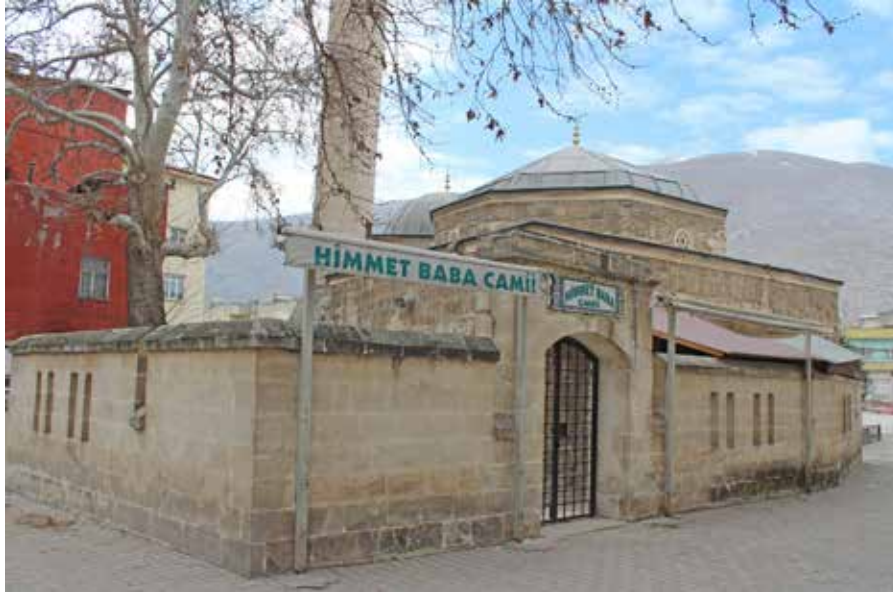
View 8.3 Elbistan Himmet Baba Mosque after the earthquake

The last earthquake caused serious damage in the lower part of the minaret section that was restored in 1952 which rested on the base remaining from the original construction; broken pieces

II
Stable / Moderate Damage
Local structural and non-structural damages on minaret.

of stone have dispersed. Due to this problem in its lower part, the minaret threatens to collapse under aftershocks. Actually, the news media have announced sometime after the field trip that the General Directorate of Waqfs had demolished the minaret, classified and stored its pieces in view of a future restoration.²

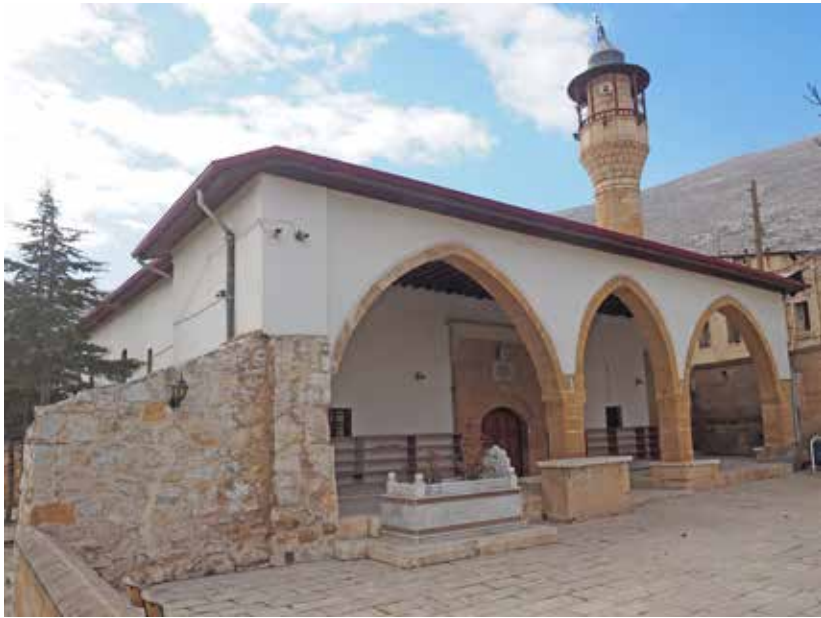
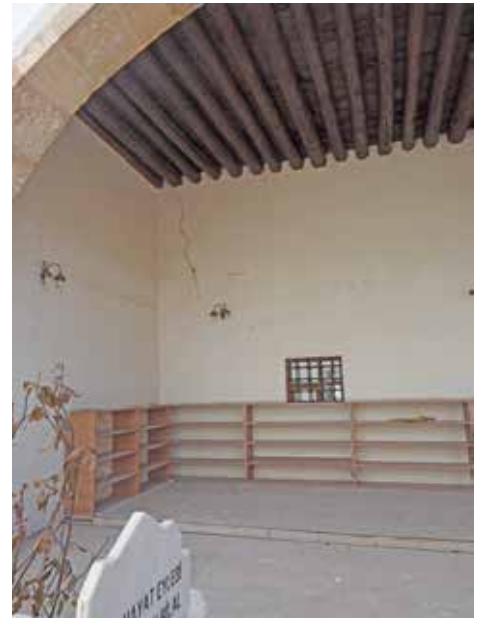
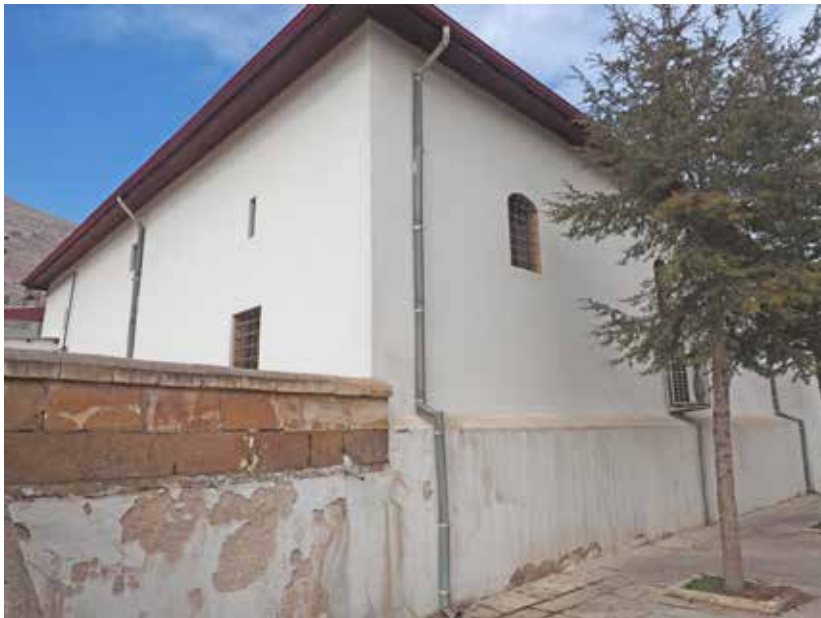
View 8.4 Elbistan Kızılcaoba Mosque after the earthquake

Kızılcaoba Mosque withstood the earthquake in general terms, but cracks appeared inside the last comers' hall and on the mihrab side. It was noted during the examination of the cracks that their positions are parallel to the internal axis of the wall structures between the last comers' hall and the mihrab wall. The method of intervention would be defined after removing the plasters, measuring the depths and movements of the cracks. There are also fractures and dislocations in some parts of the courtyard's walls.

II
Stable / Moderate Damage
Local structural and non-structural damages on minaret.

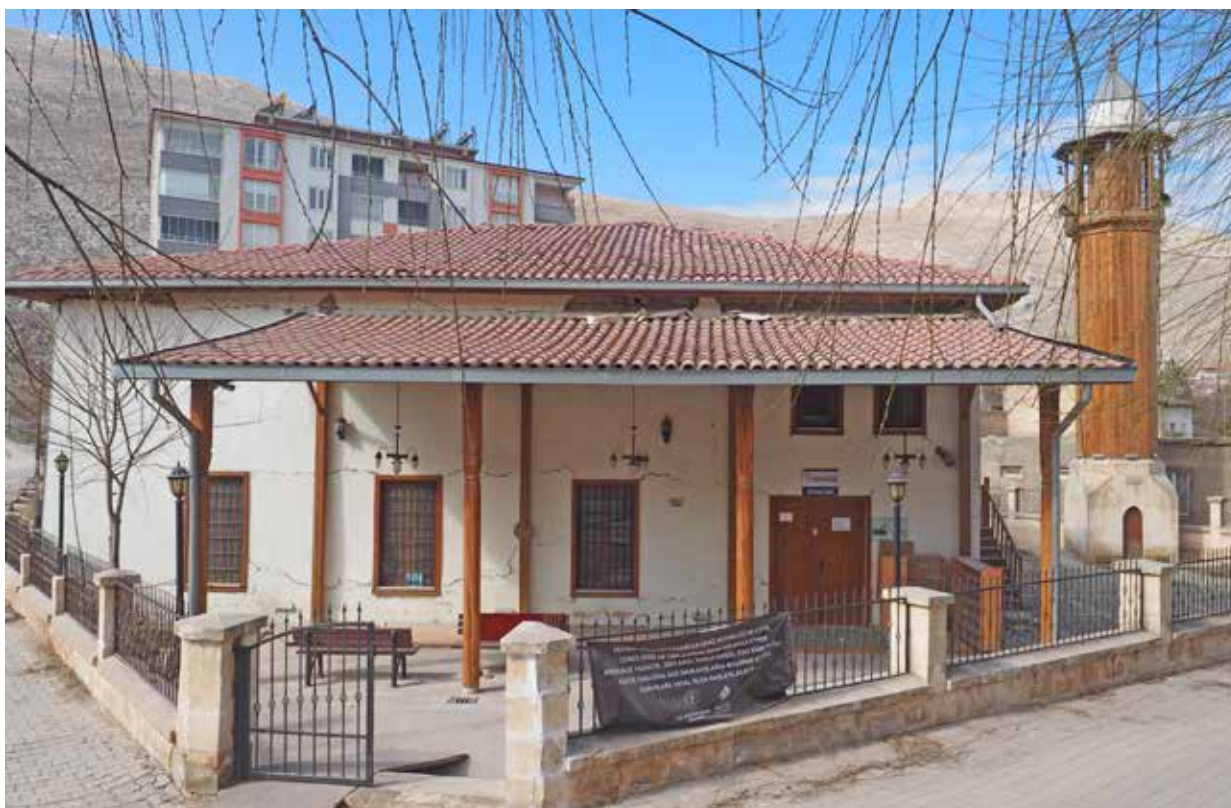
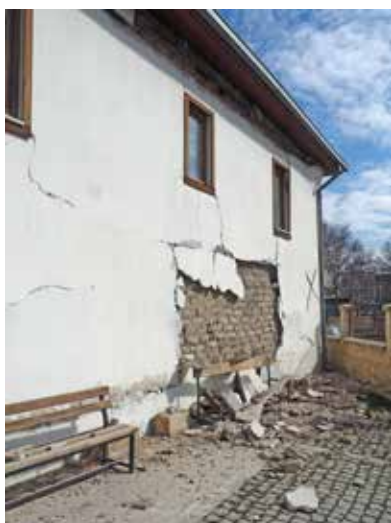
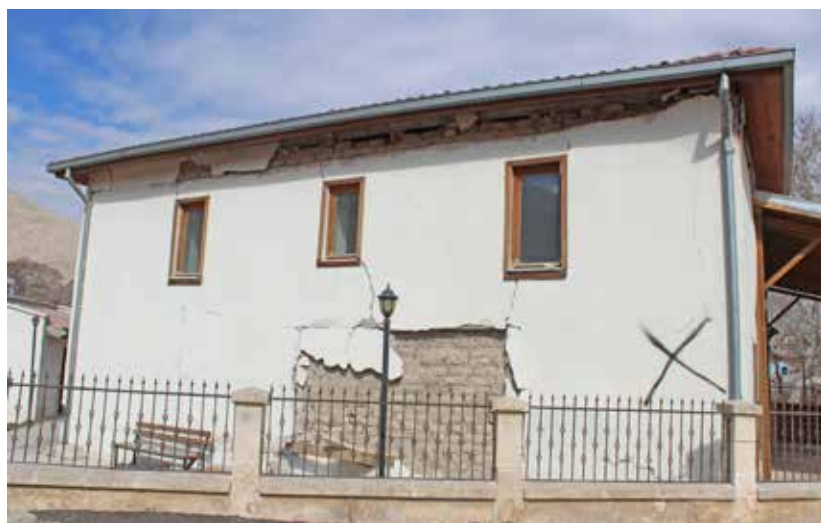
View 8.5 Elbistan Ceyhan Mosque after the earthquake

The quake caused cracks and partial fall outs throughout the cement-based outside layering of the mosque's adobe walls. Dislocations occurred at the junctures of the walls and the roof. The monument withstood the devastating earthquake with some damages.

II
Stable / Moderate Damage
Local structural and non-structural damages on minaret.
