REPORT

ON THE DAMAGE CAUSED BY
THE FEBRUARY 2023 KAHRAMANMARAŞ EARTHQUAKE
ON ISLAMIC CULTURAL HERITAGE IN TÜRKİYE

Prepared by

Alidost Ertuğrul
Taha Zahid Özdemir
Hussein Al Ragabi

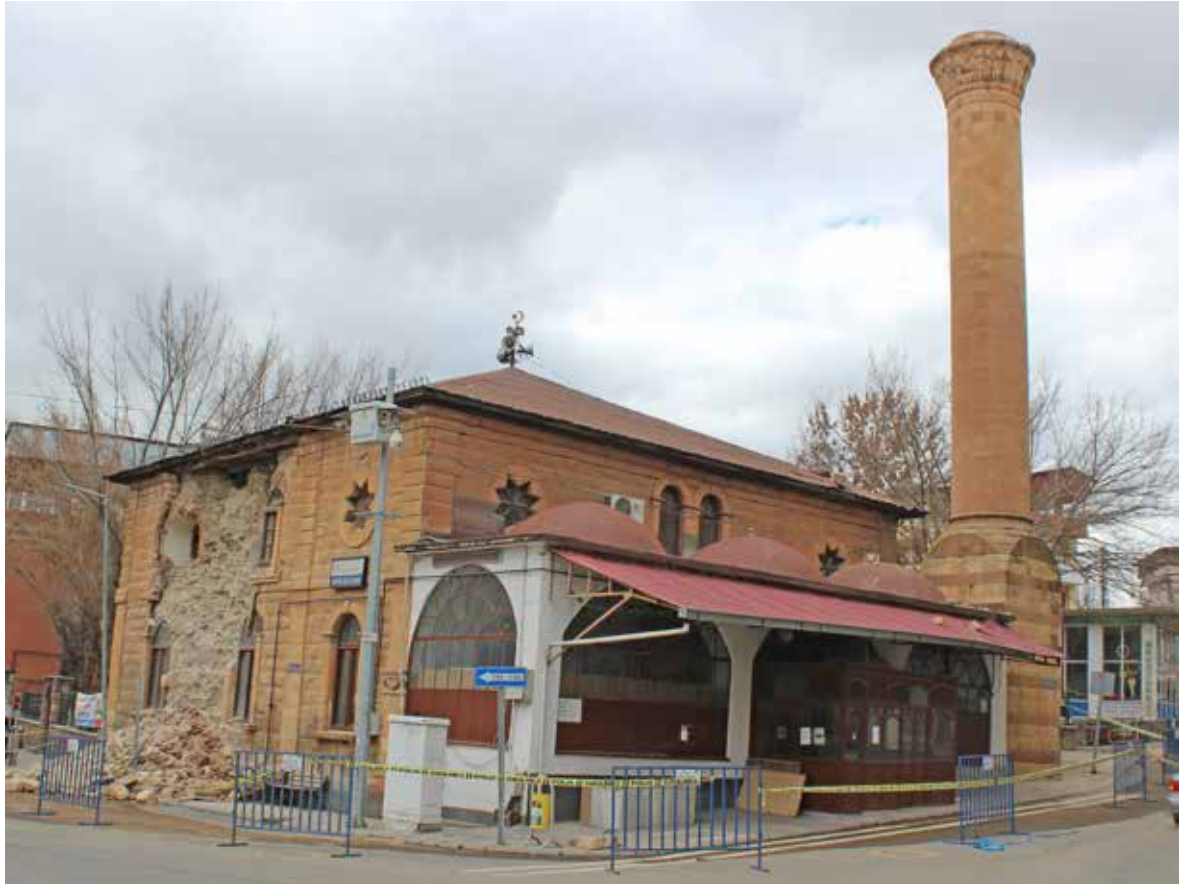
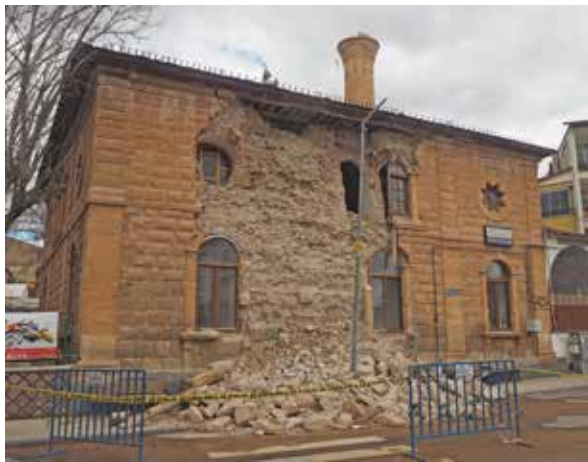
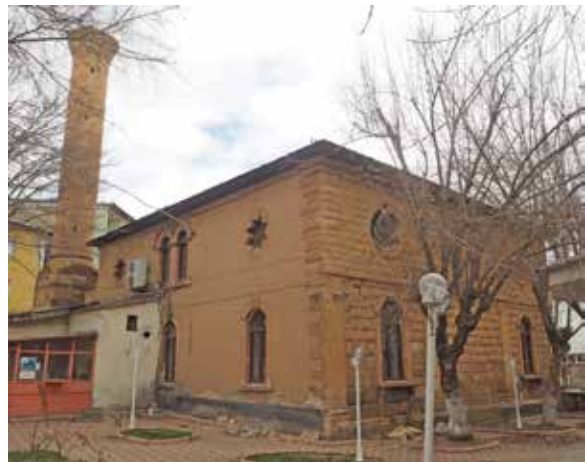
View 8.6 Göksun Ulu (Merkez) Mosque after the earthquake

The mosque was heavily damaged during the earthquake. There are cracks and missing pieces on its facades. Great damage is observed on its eastern facade that looks onto the main avenue. The upper part of its minaret was broken from the balcony level and its pieces fell onto the mosque roof and grounds. The falling stones pierced the roof. In sum, the site was seriously affected by the earthquake.

III	IV
Unstable/Heavy Damage	Irreversible/ Very Heavy Damage
Moderate structural damage on main building.	Heavy structural damage on minaret. Collapsed onto roof of the main building.

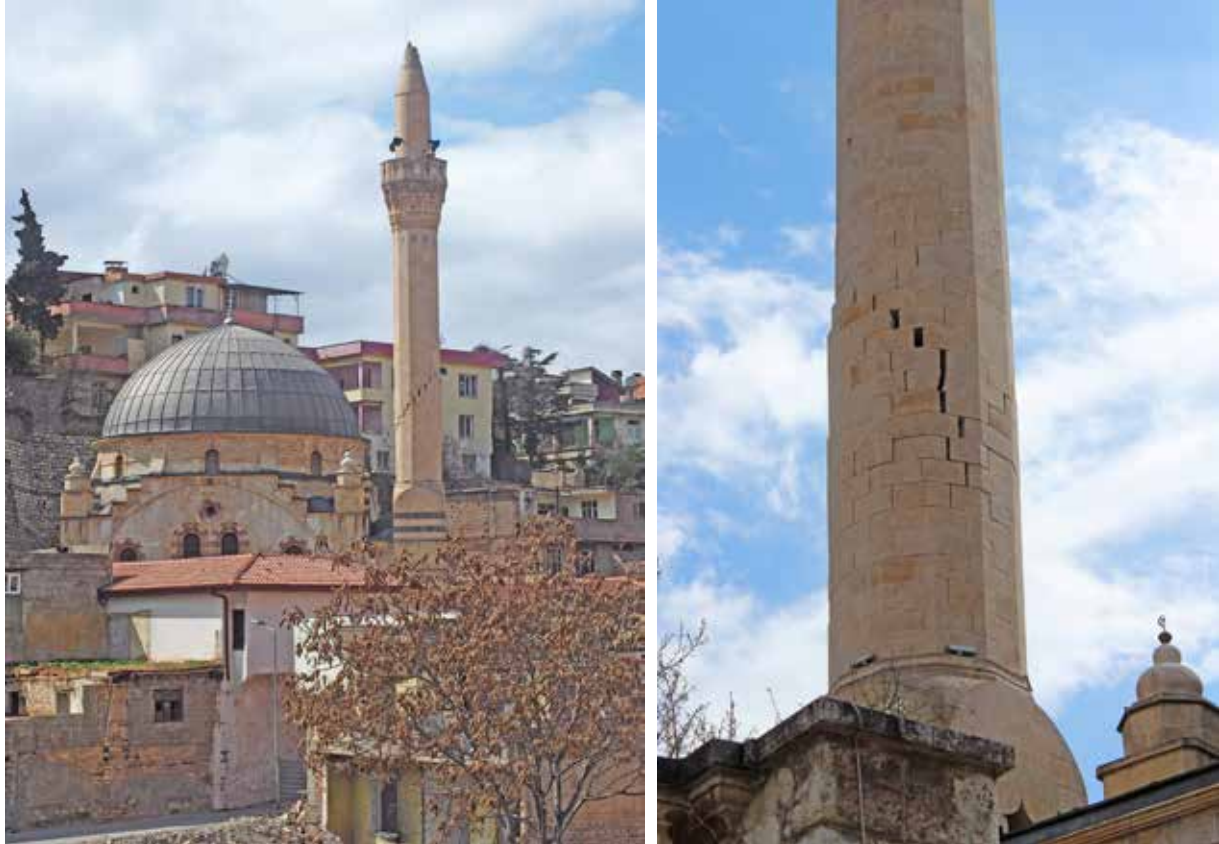
View 8.7 Acemli Mosque after the earthquake

II
Stable / Moderate Damage
Local structural and non-structural damages on minaret.

The mosque, on the whole, was lightly damaged in the earthquake, but the minaret carries deep fractures and dislocations of stones in its bottom course; it threatens to collapse under eventual aftershocks. Its alem (finial piece) dropped down, along with stones from its main body parts. The minaret's stone structure must be undone from top to foot and classified in view of a future reconstruction, to safeguard this and other components of the mosque site.

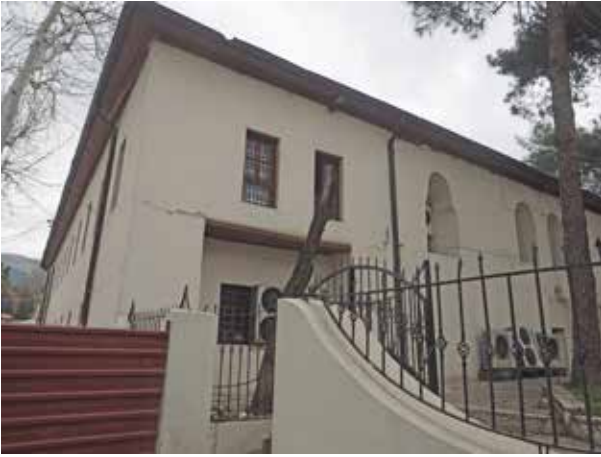
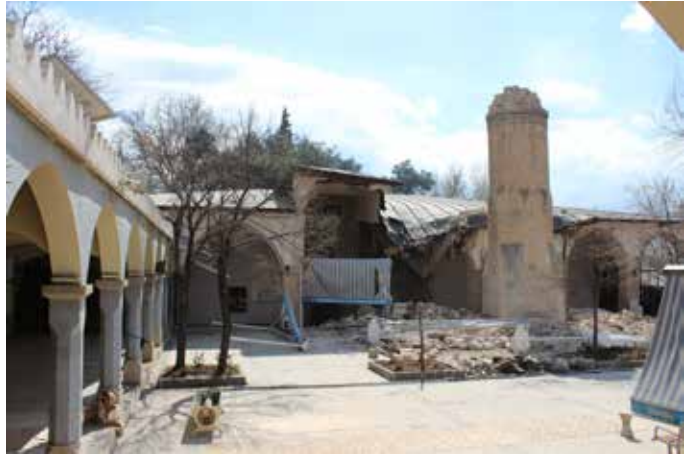
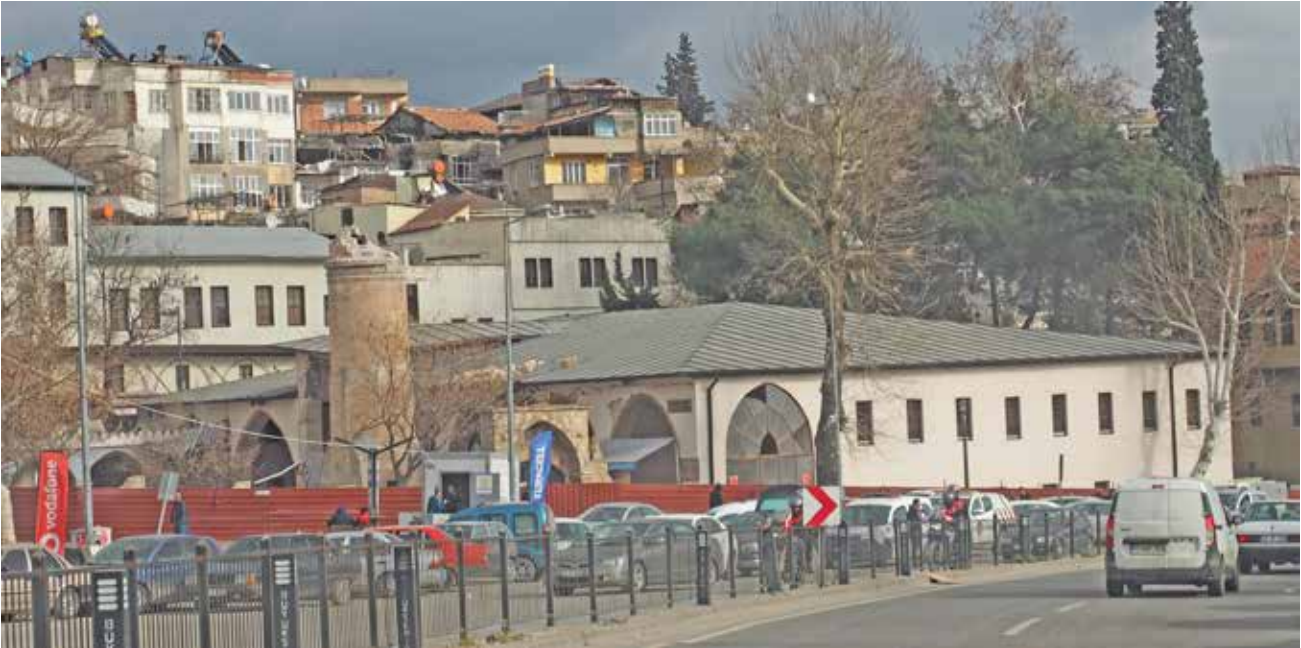
View 8.9 Kahramanmaraş Ulu Mosque after the earthquake

The mosque was largely damaged by the earthquake. The minaret placed in its courtyard collapsed; its stones falling onto the mosque's roof and entrance damaged the roof and the main entrance arcade. Fractures occurred in the walls of the last comers' hall and the mosque's side facade. Ulu Mosque, one of the landmark structures of Kahramanmaraş, needs to be safeguarded.

III	IV
Unstable/Heavy Damage	Irreversible/ Very Heavy Damage
Moderate structural or heavy non-structural damage on main building.	Heavy structural damage on minaret. Collapsed onto entrance of the mosque.

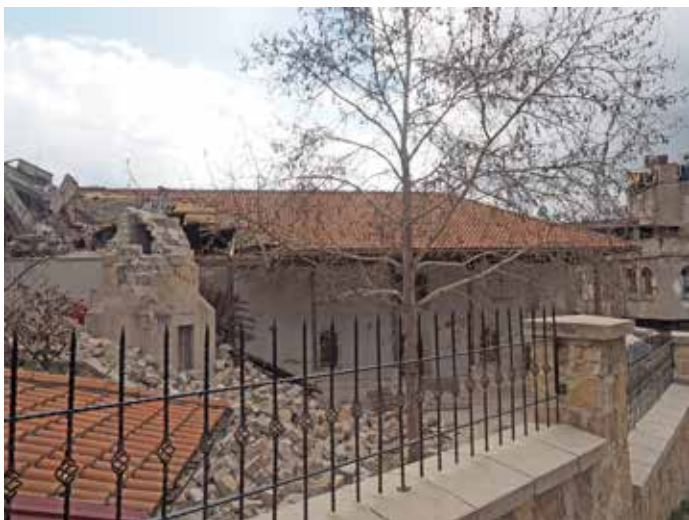
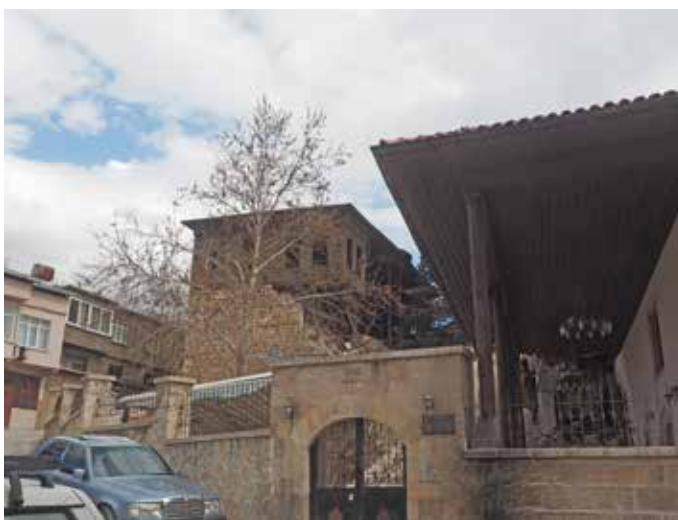
View 8.12 Hatuniye Mosque after the earthquake

The earthquake caused the minaret to collapse onto the mosque. As a result, the mosque' roof and some parts of its front wall were destructed. Additionally, there are cracks and crevices on its road-side facade. A comprehensive restoration is needed.

III	IV
Unstable / Heavy Damage	Irreversible /Very Heavy Damage
Moderate structural or heavy non-structural damage on main building.	Heavy structural damage on minaret. Collapsed onto entrance of the mosque.

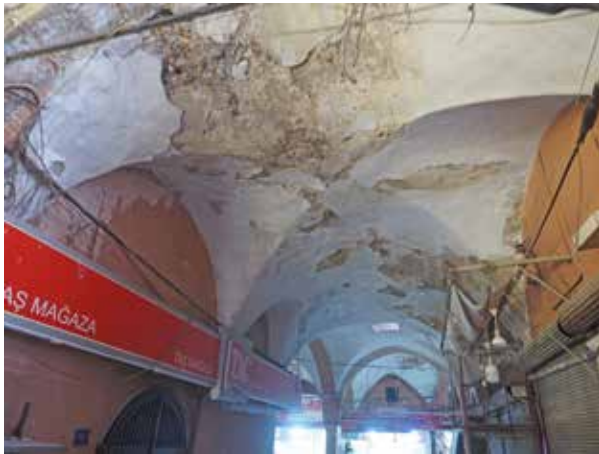
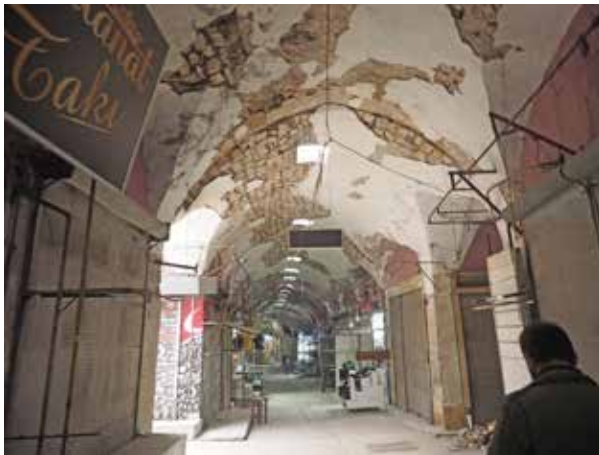
View 8.13 Covered Bazaar after the earthquake

The incidence of earthquake damage was small and partial considering the expanse of the building; it was hit but did not collapse. Cracks occurred in its vaults and plaster fell off in some places. Some of the shops also have cracks on their walls, while some of the stone and wooden structures around this historical mall collapsed. It is understood that no maintenance work was carried out in the mall or the individual shops. Repairs and reinforcements are needed.

II
Stable / Moderate Damage
Local structural and non-structural damages.

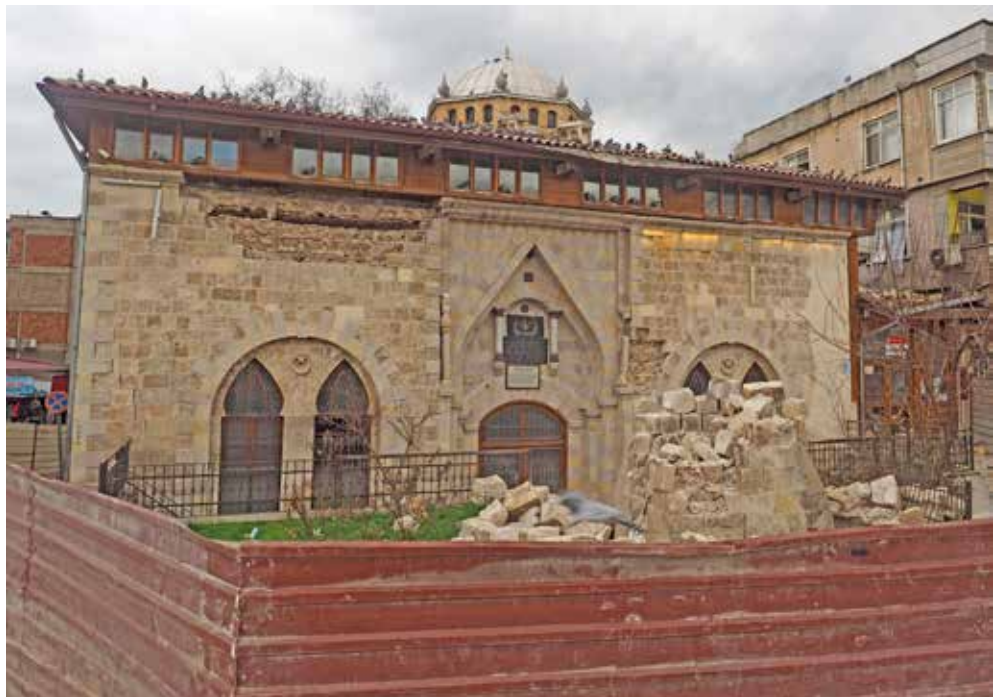
View 8.15 Arasa Mosque after the earthquake

Heavy damage occurred in the mosque in the earthquake. Its old minaret collapsed into itself. Additionally, the stone layering of the outer surface of the entrance wall dating from the 19th century broke away and dispersed on the ground. As to the minaret of the more recent reinforced concrete mosque building, it collapsed onto the mosque, damaging its various sections. Restorations are needed, to rebuild the original minaret and the pieces that remain from the northern facade.

III	IV
Unstable / Heavy Damage	Irreversible /Very Heavy Damage
Moderate structural or heavy non-structural damage on main building.	Heavy structural damage on minaret. Collapsed onto the courtyard.

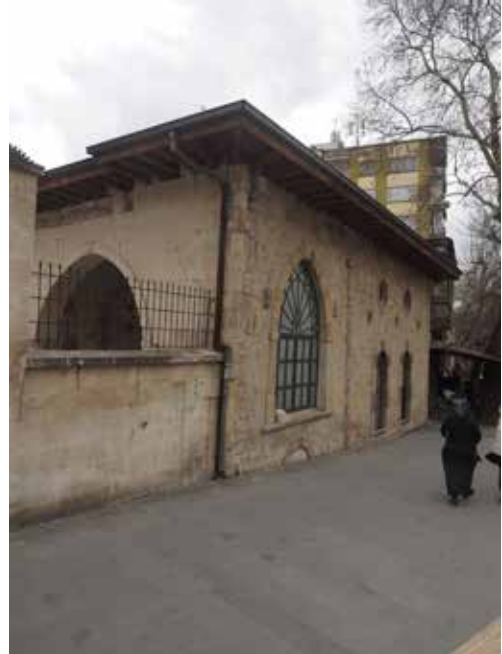
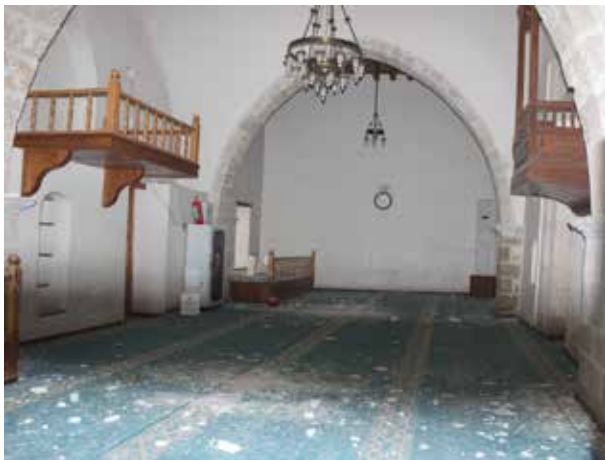
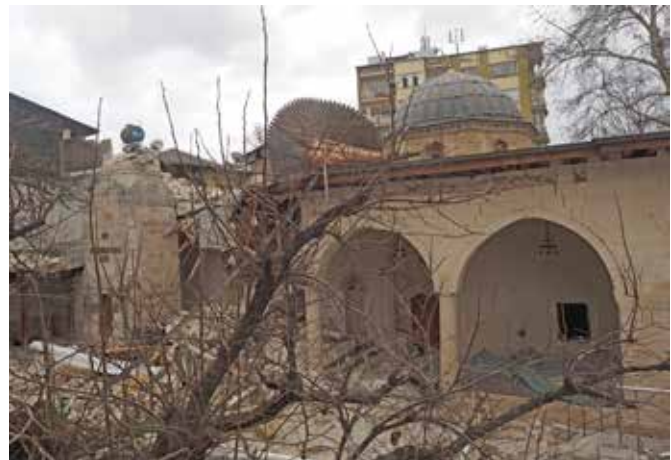
View 8.17 Boğazkesen Mosque after the earthquake

The earthquake caused the single-balcony minaret to fall onto the last comers' section breaking apart part of it. Cracks, visible on outer surfaces of the walls of the prayer place and the pendentives that support its dome, caused the plastering to flake off.

III	IV
Unstable /Heavy Damage	Irreversible /Very Heavy Damage
Moderate structural or heavy non-structural damage on main building.	Heavy structural damage on minaret. Collapsed onto entrance of the mosque.

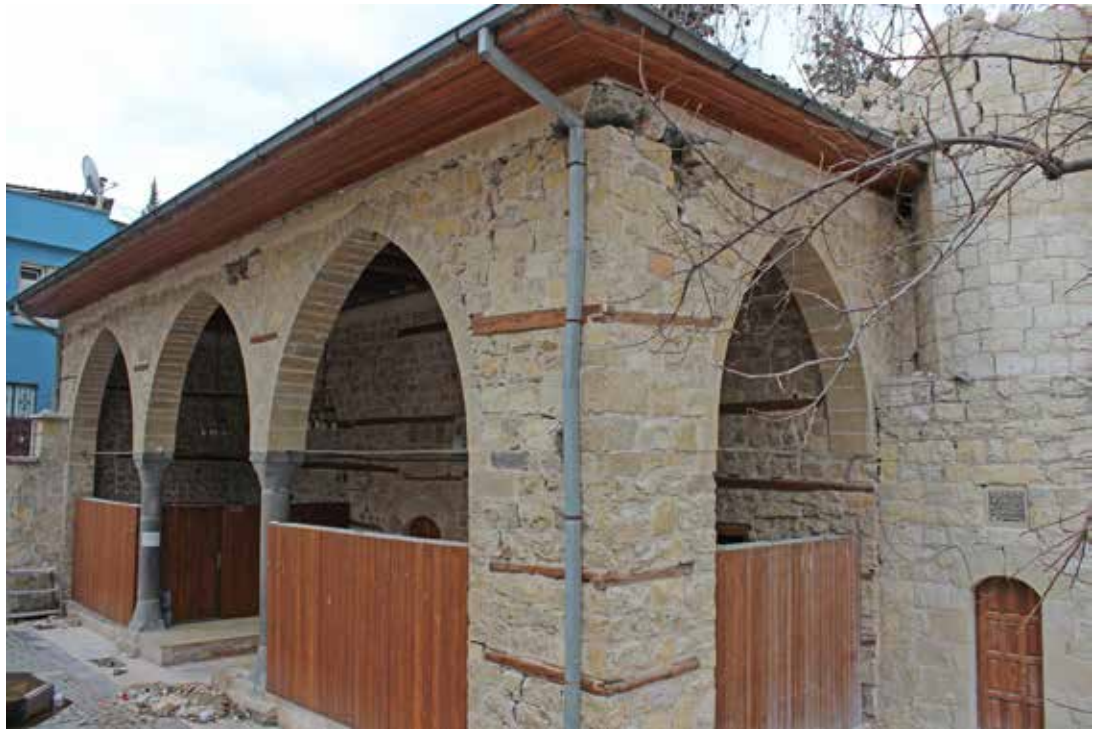
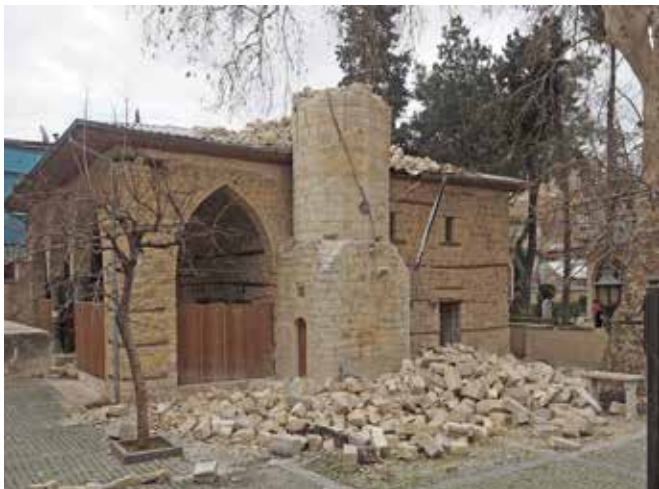
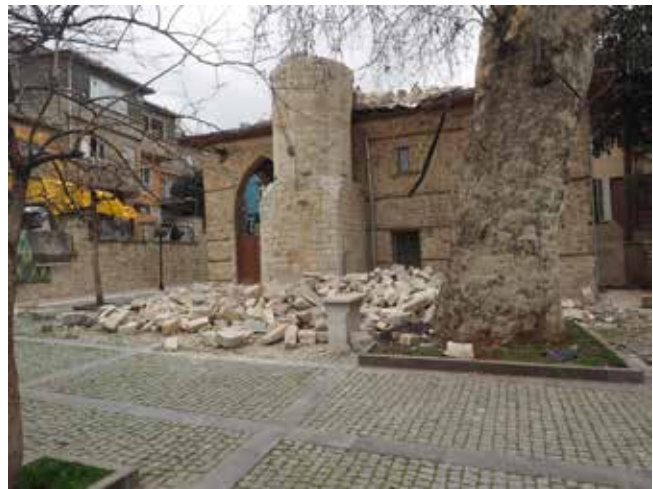
View 8.18 Bektutiye Mosque after the earthquake

As is the case for many places of worship in Kahramanmaraş, the minaret is the most problematic component of this site. The minaret of Bektutiye Mosque was destroyed above the level of the mosque's canopy, falling onto the mosque and the courtyard. The last comers' place has cracks, mostly on its arches; stones dropped from its walls. All of the mosque walls carry fractures except the mihrab wall facade. Its adjoint pilasters must have supported this facade, preventing further destruction.

III	IV
Unstable / Heavy Damage	Irreversible /Very Heavy Damage
Moderate structural or heavy non-structural damage on main building.	Heavy structural damage on minaret. Collapsed onto the mosque.

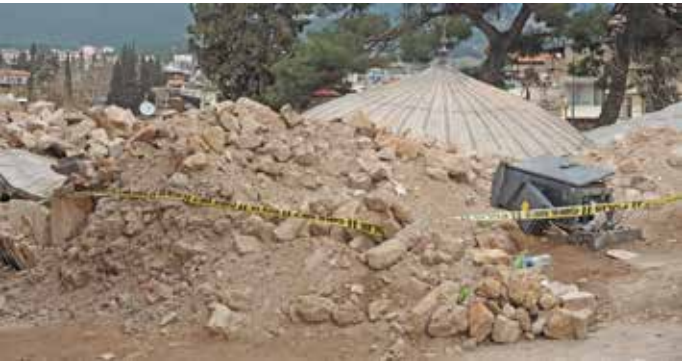
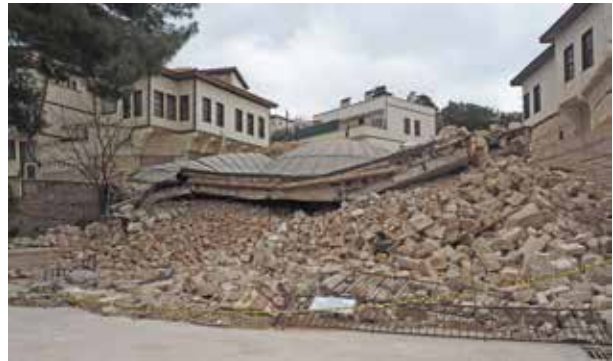
View 8.20 Şeyh Mosque after the earthquake

V
Total Collaps / Destruction
The mosque totally damaged. The plot and the building's stones became rubble.

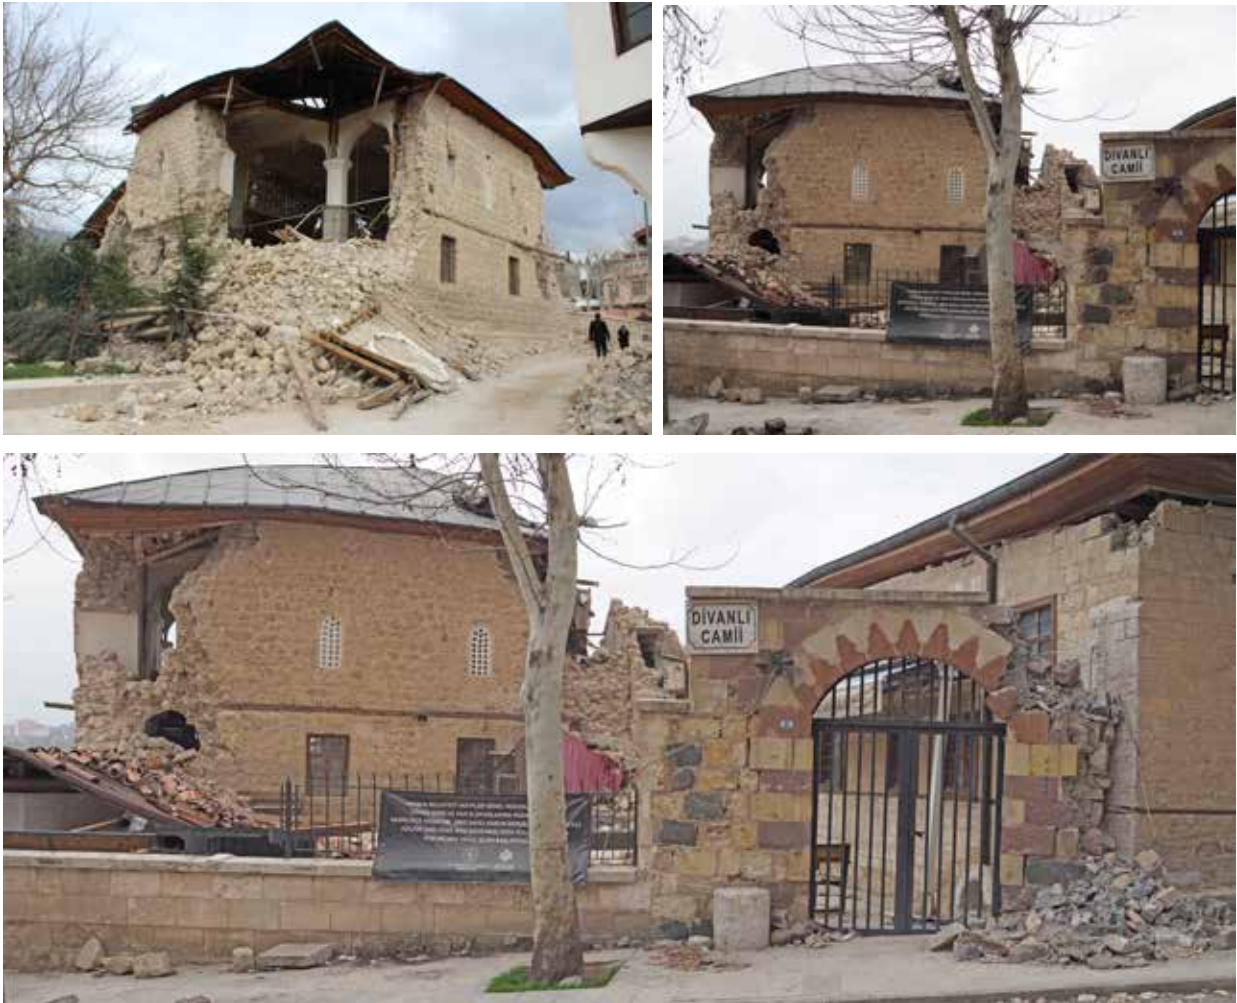
View 8.21 Divanli Mosque after the earthquake

IV
Irreversible / Very Heavy Damage
Heavy structural damage on the building and minaret.

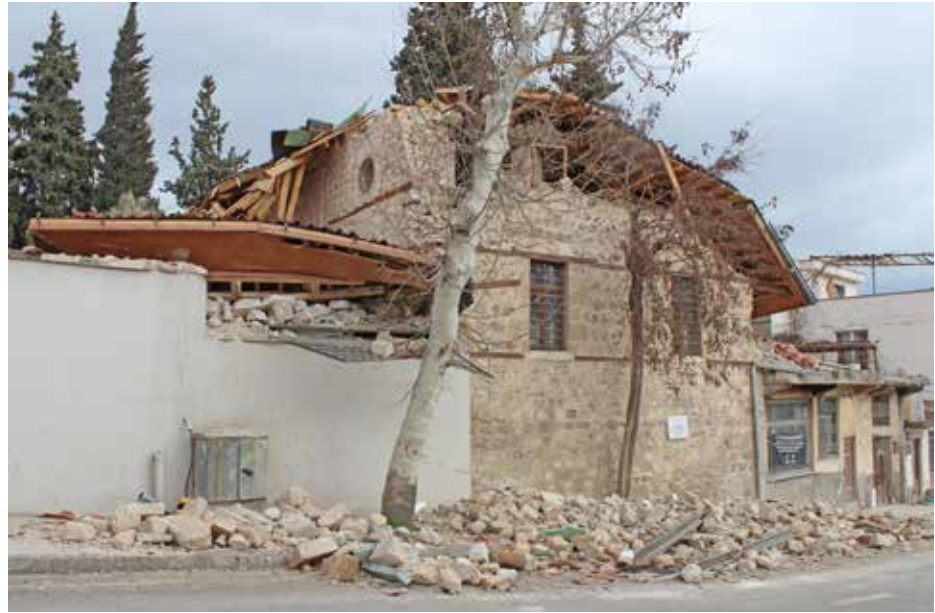
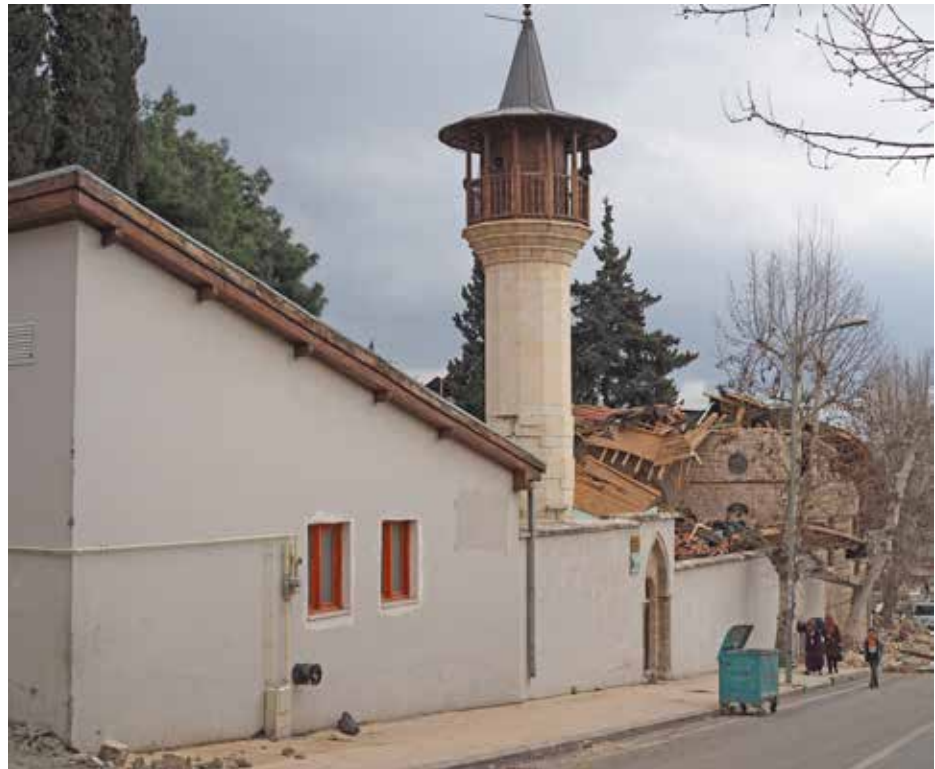
View 8.22 Kazancı Mosque after the earthquake

Kazancı Mosque was seriously damaged in the earthquake. A larger part of the pitched roof collapsed due to the disintegration of the prayer area walls especially at their corners. The last comers' section was also destroyed. The minaret was displaced from its axis which dislocated its main body. The minaret threatens to collapse under an eventual ground shaking. A restoration process has to start in this heavily damaged mosque by maintaining each element in its place.

IV
Irreversible / Very Heavy Damage
Heavy structural damage on the main building.

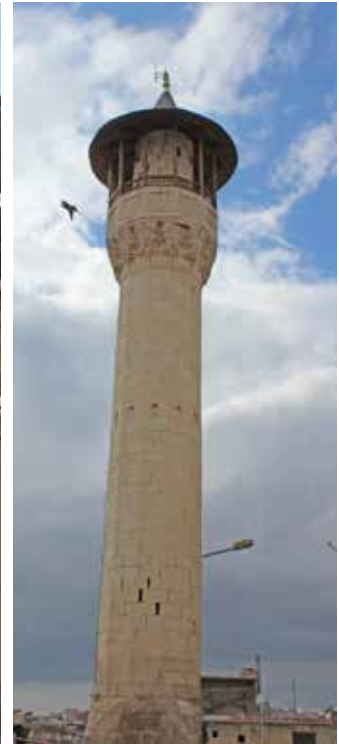
View 8.23 İsa Divanli Mosque after the earthquake

III
Unstable / Heavy Damage
Moderate structural or heavy non-structural damage on minaret.

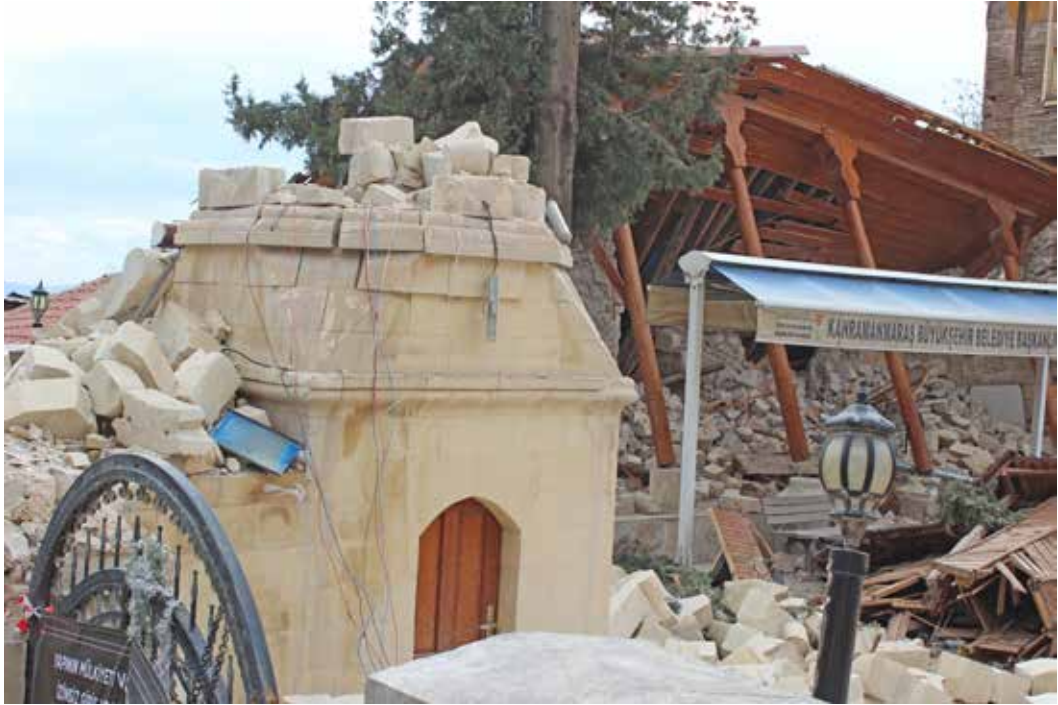
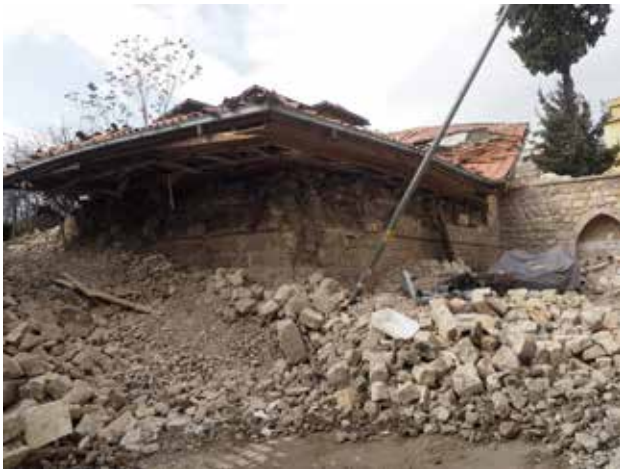
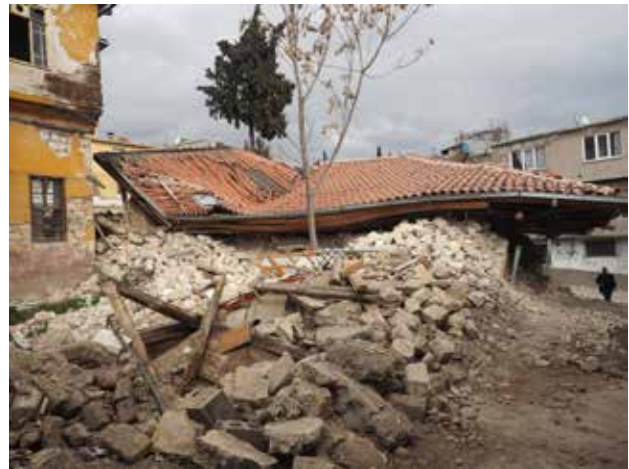
View 8.24 Nuh Mosque after the earthquake

V
Total Collaps / Destruction
The mosque totally collapsed.

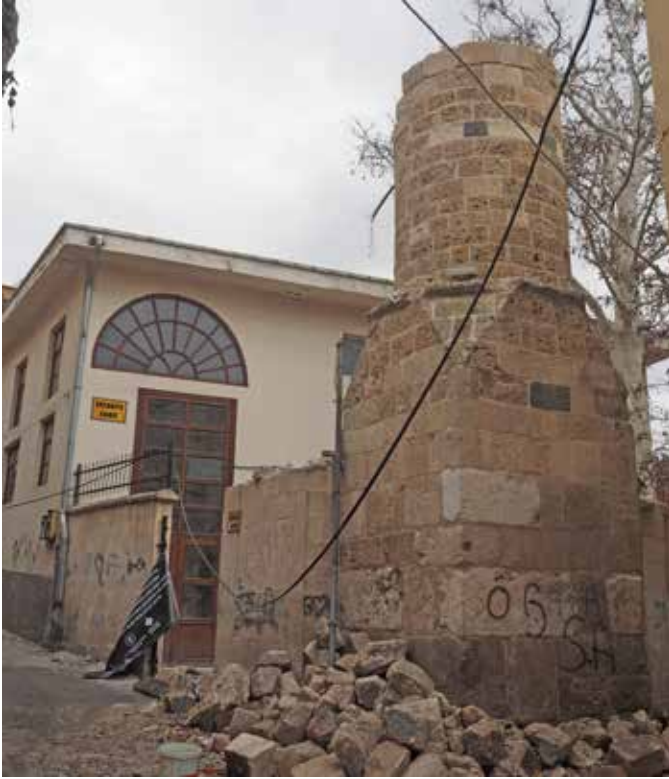
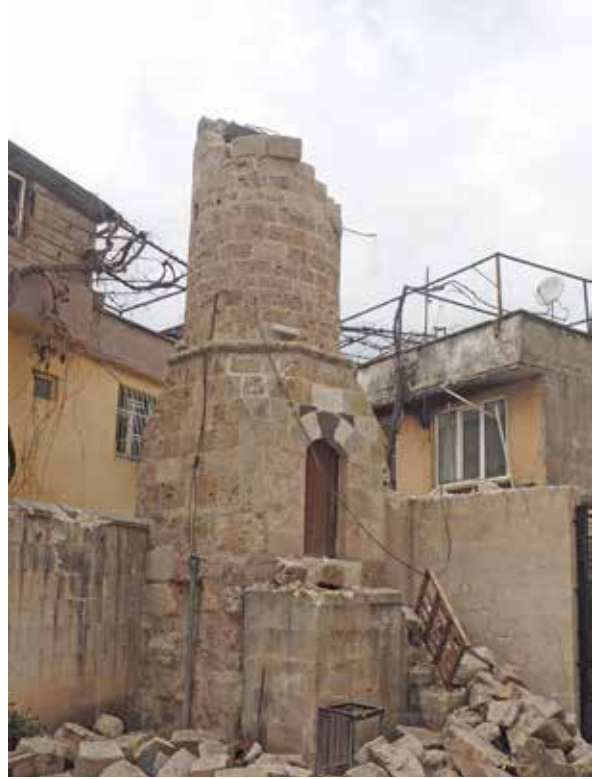
View 8.25 Evzaniye Mosque after the earthquake

IV
Irreversible / Very Heavy Damage
Heavy structural damage on the minaret.

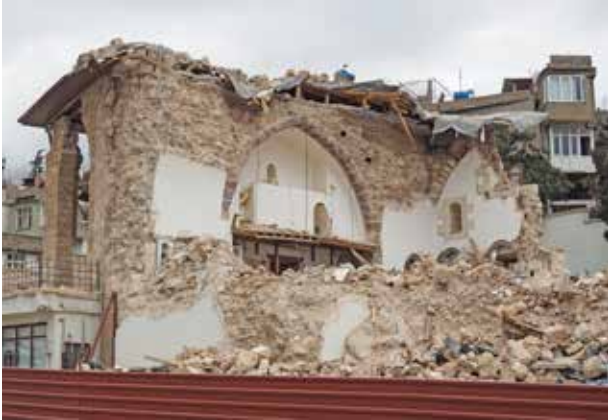
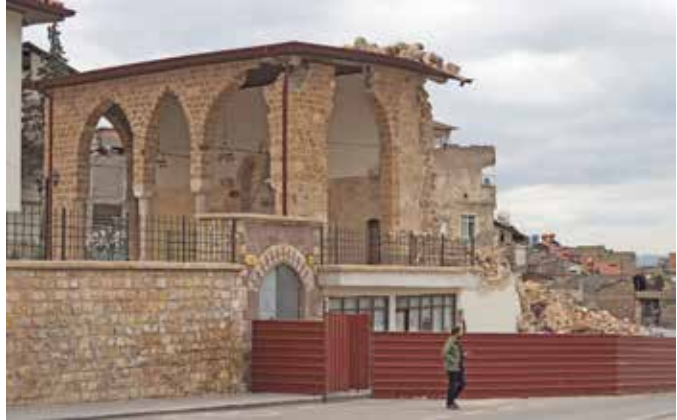
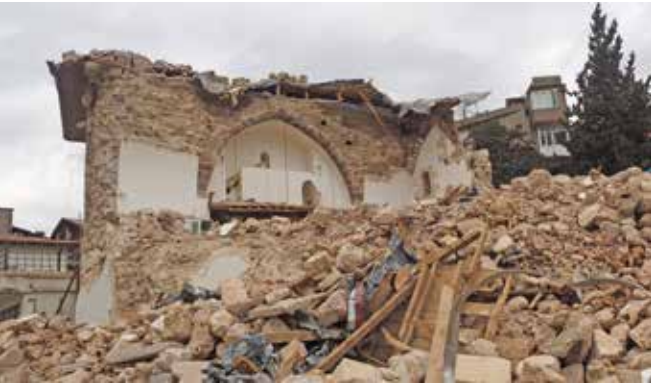
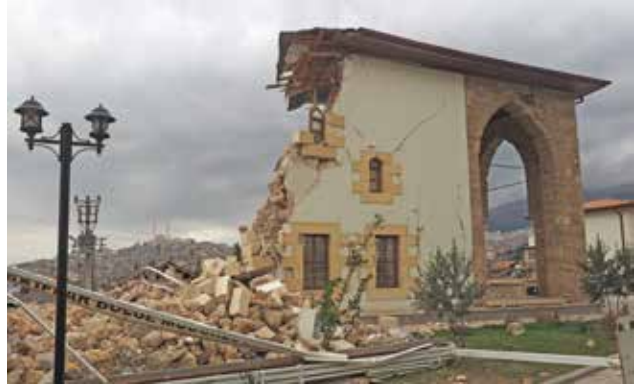
View 8.26 Şekerli Mosque after the earthquake

The mosque was heavily stricken, almost entirely destroyed in the earthquake. Surviving sections are the piers that support the last comers' section and the entrance gate wall. The arches of the last comers' section have serious cracks and fractures and threaten to collapse.

V
Total Collaps / Destruction
The mosque close to total collapsion.

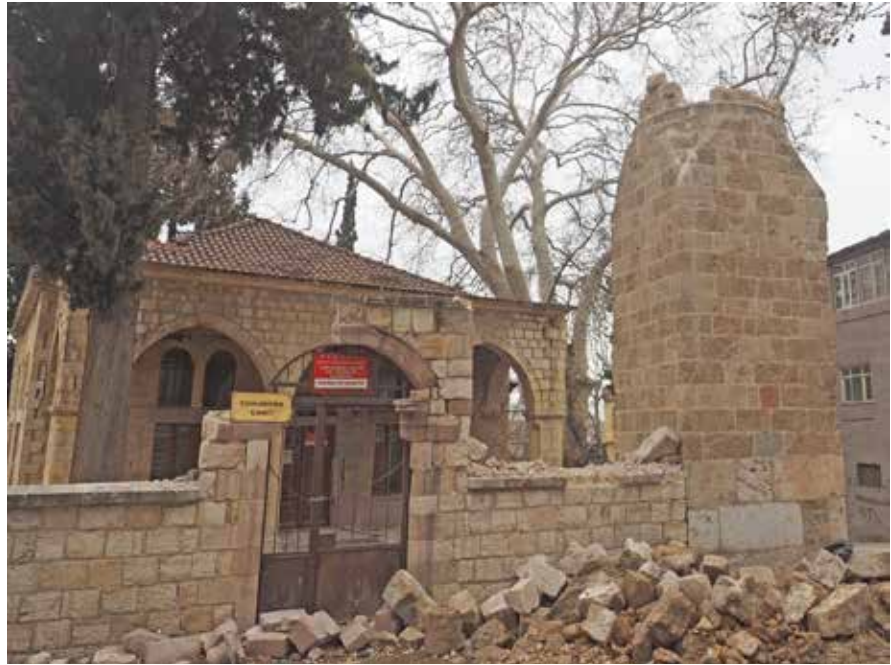
View 8.27 Çukuroba Mosque after the earthquake

The renovated mosque building suffered medium-range damage in the earthquake. Its minaret, on the other hand, collapsed throughout its body down to its boot level; its broken pieces scattered around the road may soon disappear since it is a busy main line.

III	IV
Unstable / Heavy Damage	Irreversible /Very Heavy Damage
Moderate structural or heavy non-structural damage on main building.	Heavy structural damage on minaret. Collapsed onto the courtyard.

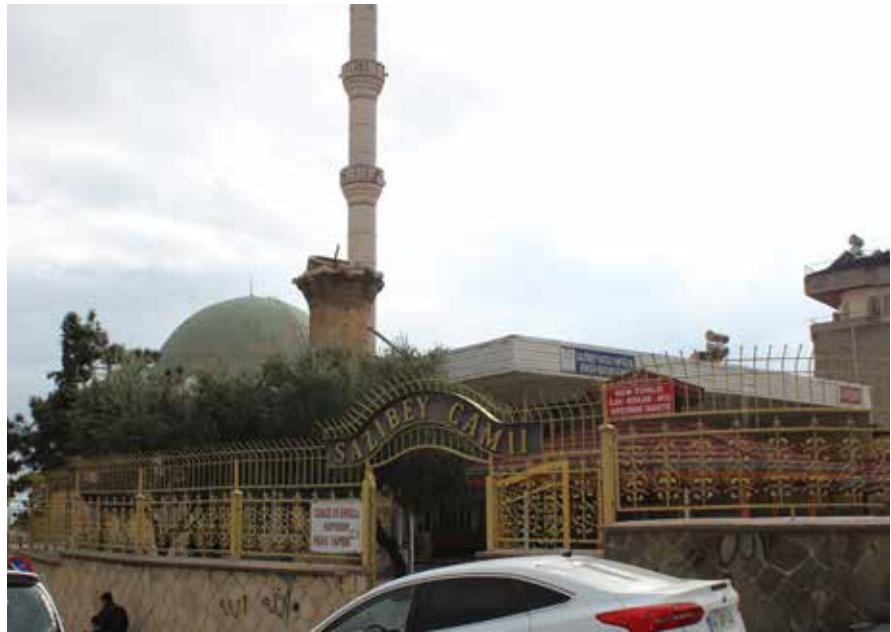
View 8.28 Şazi Bey Mosque after the earthquake

It was seen during the field survey that the historical minaret, a midcourse addition in the mosque's history, was broken at its balcony level. The mosque building, which is more recent, is also damaged.

III
Unstable / Heavy Damage
Moderate structural or heavy non-structural damage on minaret.

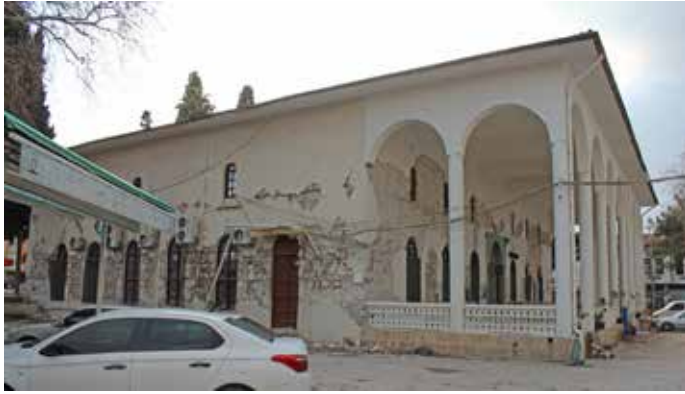
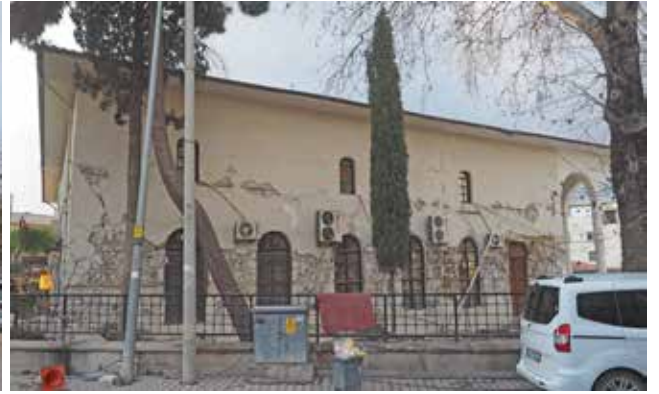
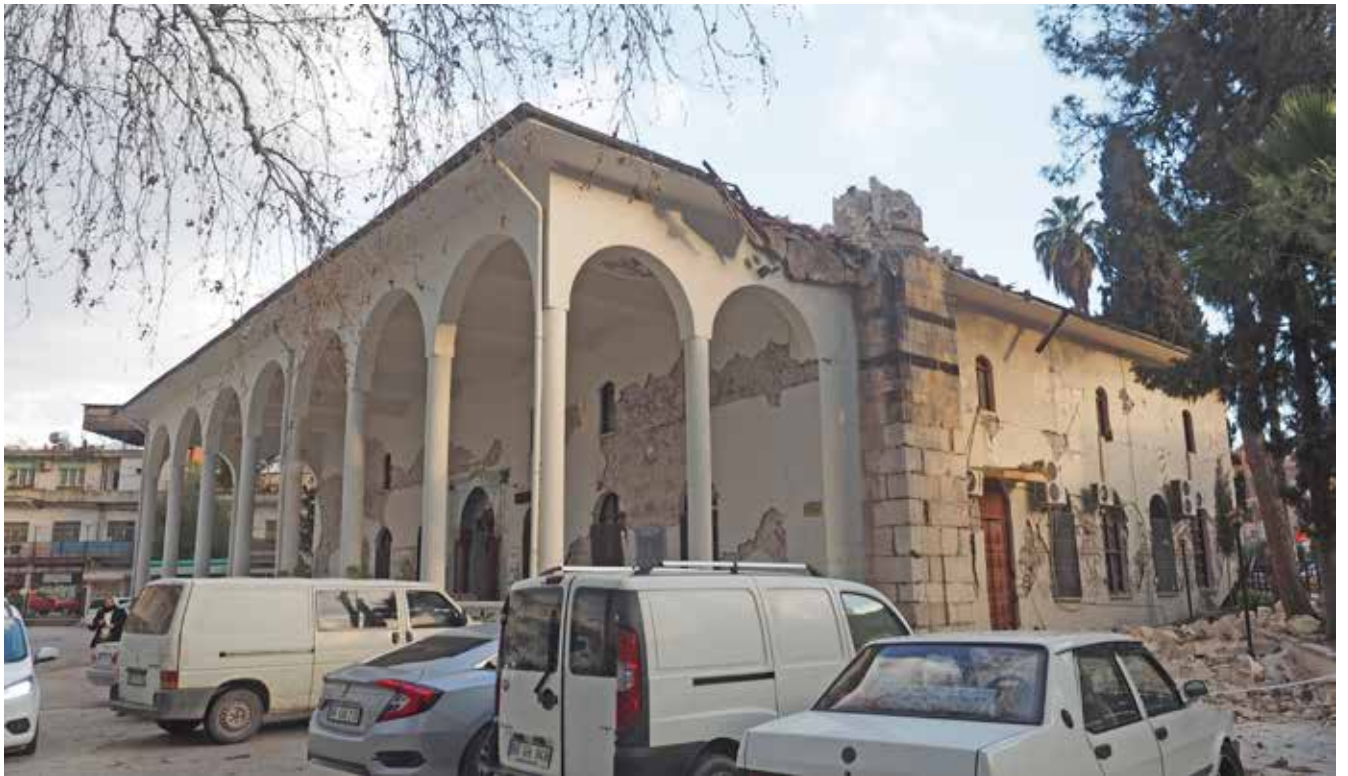
View 9.1 Osmaniyè Envarül Hamit Mosque after the earthquake

Envarül Hamid Mosque was seriously damaged in the earthquake. Its minaret dropped down and fell onto the mosque's roof, damaging its ceilings and upper floor. Most of the plaster covering its internal and external wall surfaces is falling off due to cracks. Traces of the original wall structures made of cut stone in the corners and rubble stone and timber girders in between are discernible. It is understood that the presence of those girders is what kept the walls of the prayer hall relatively safe, protecting them from collapsing.

Unstable / Heavy Damage

Moderate structural or heavy non-structural damage on minaret.
